**Butte Incident**

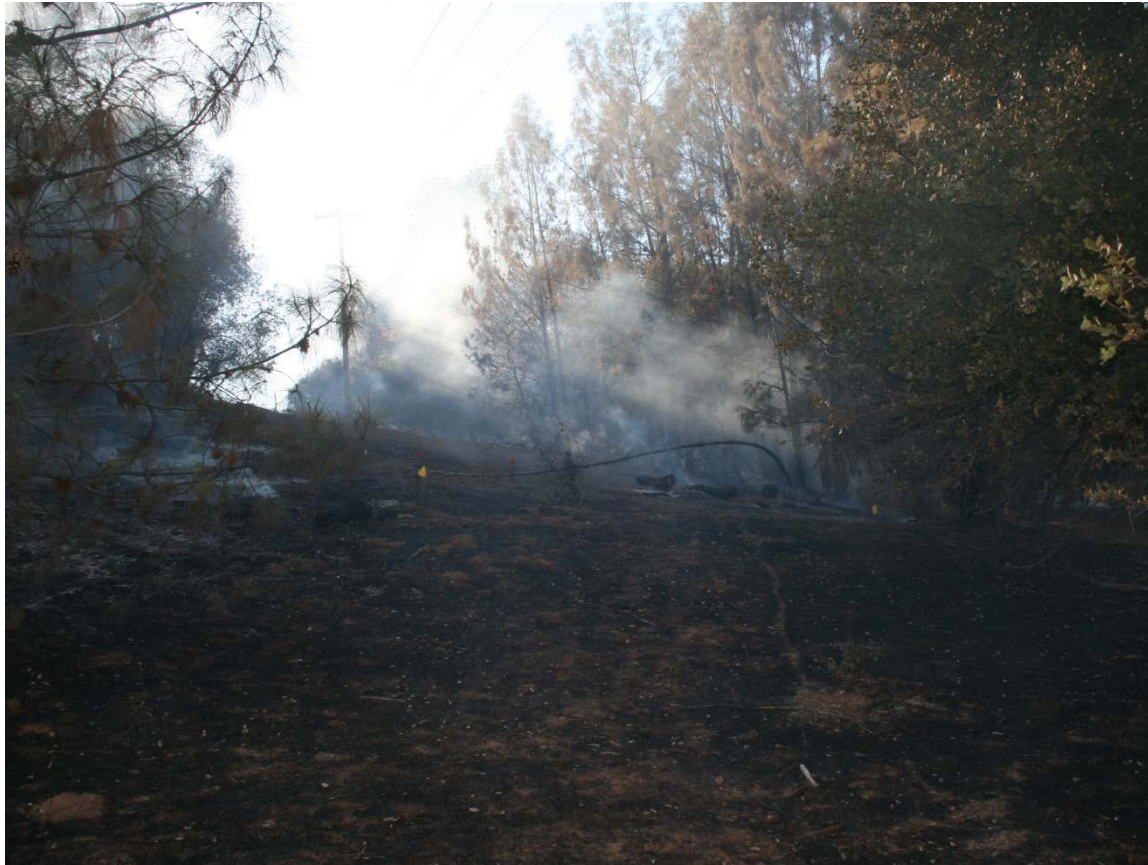
**Photo 1**

Facing west looking at the General Origin Area.

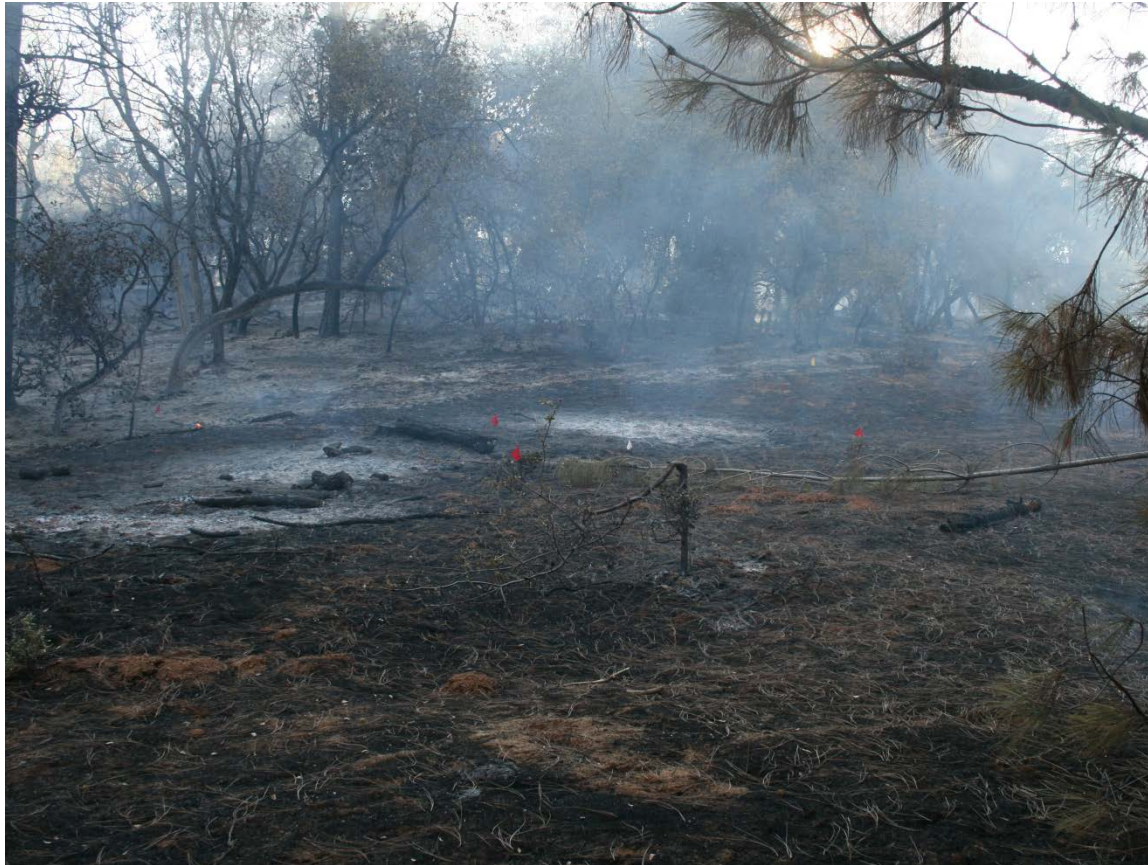
**Photo 2**

Facing southwest looking at the General Origin Area.

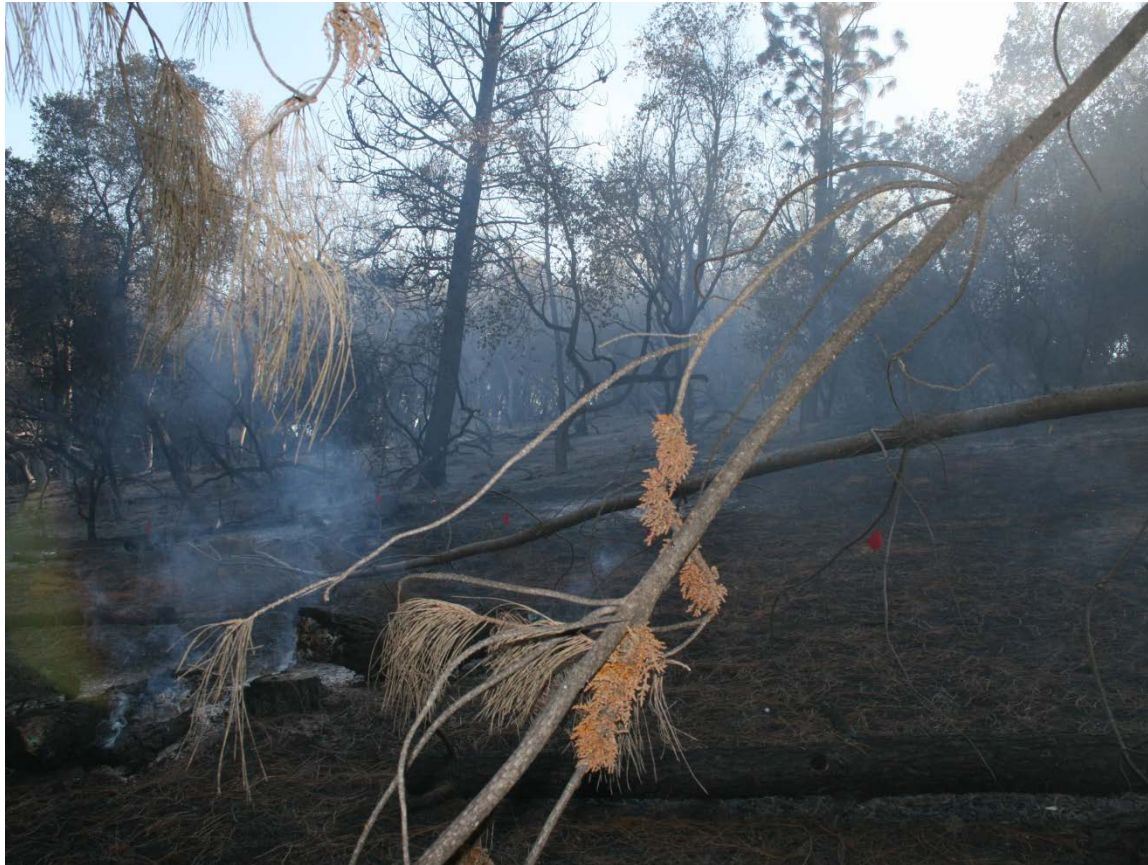
**Photo 3**

Facing south looking at the General Origin Area.

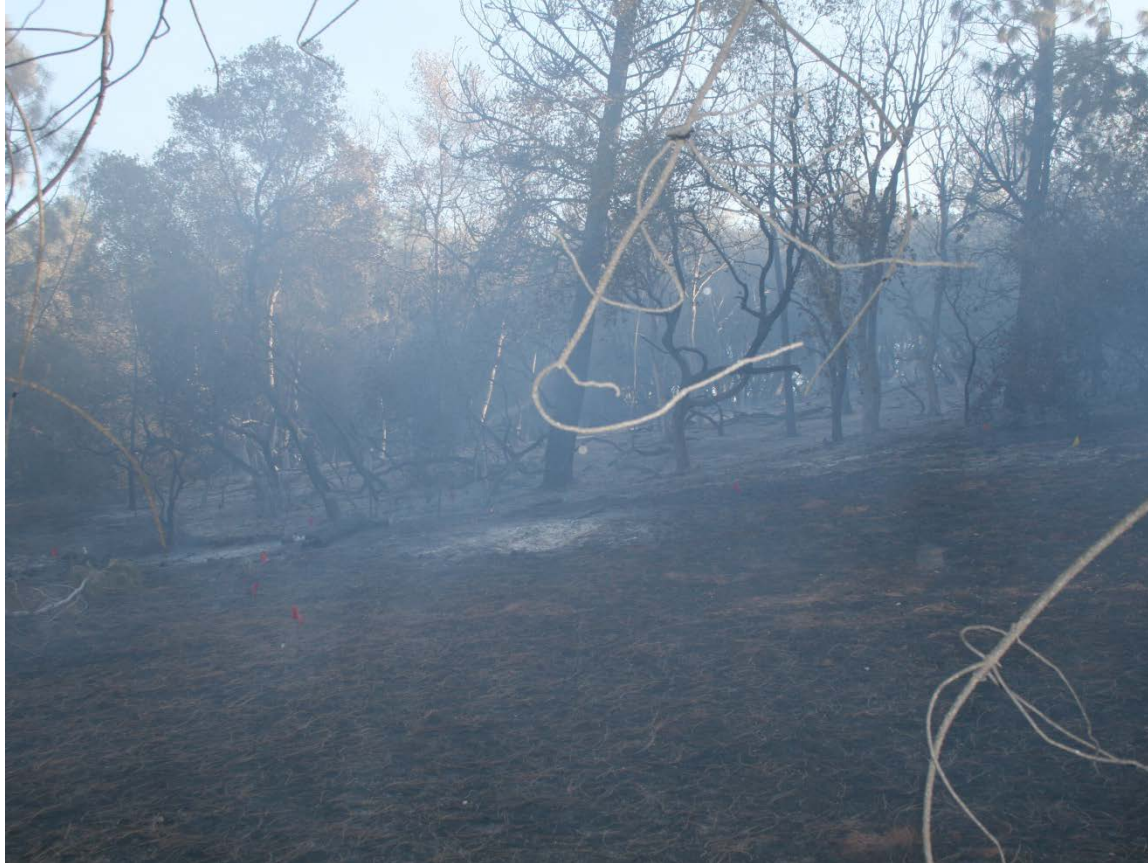
**Photo 4**

Facing south looking at the General Origin Area.

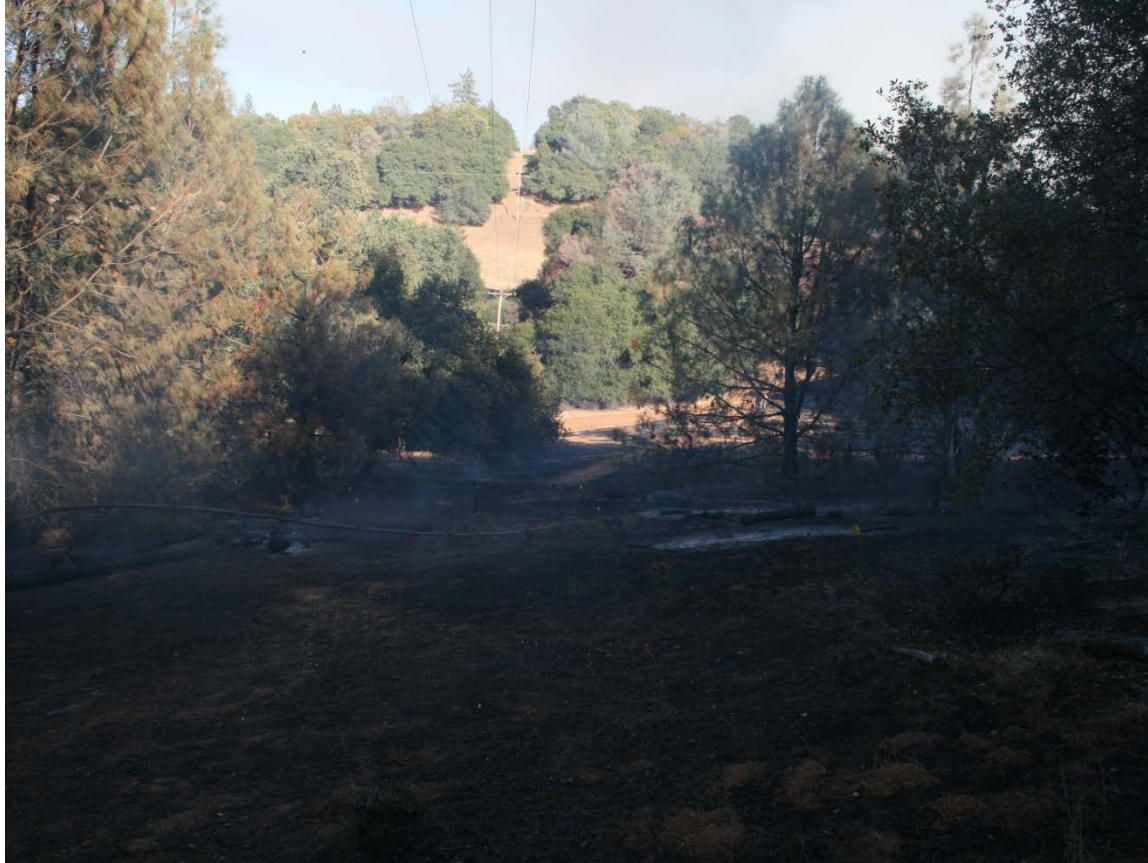
**Photo 5**

Facing east looking at the General Origin Area from below the powerlines.

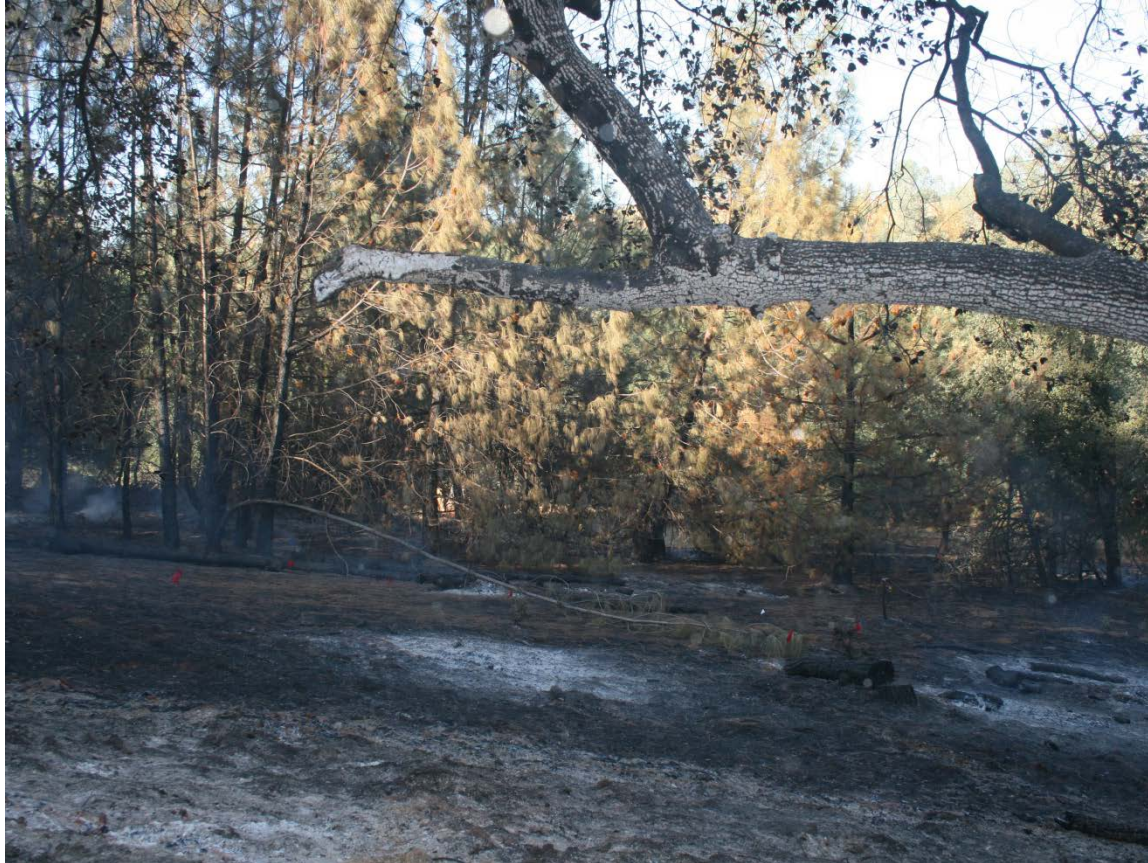
**Photo 6**

Facing northeast looking at the General Origin Area.

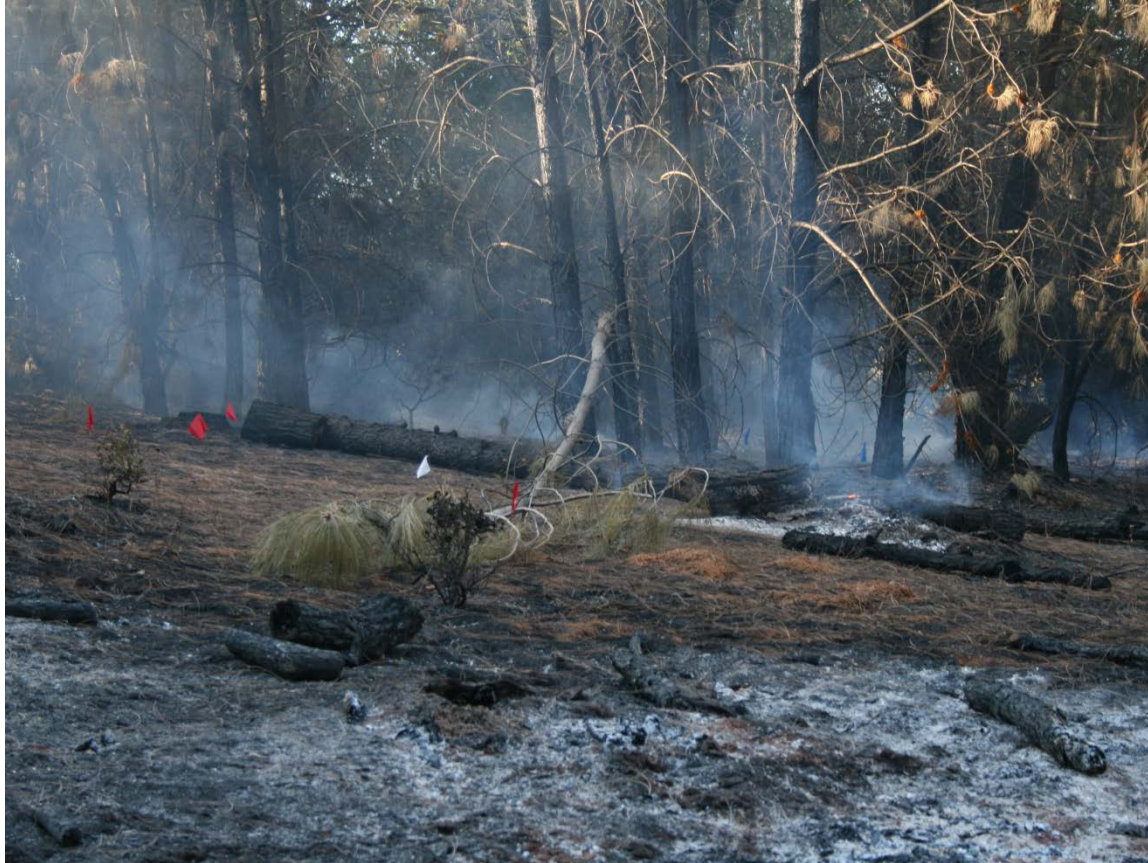
**Photo 7**

Facing north looking at the General Origin Area.

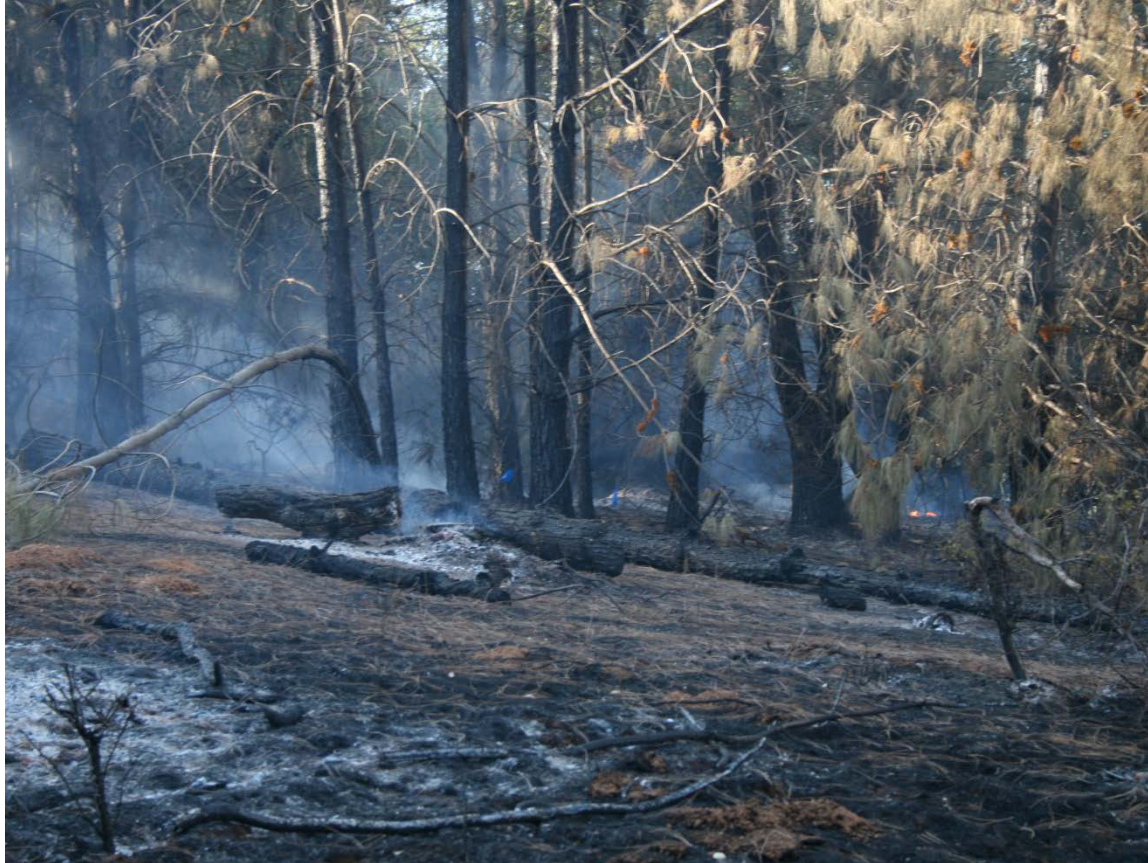
**Photo 8**

Facing north looking at the General Origin Area.

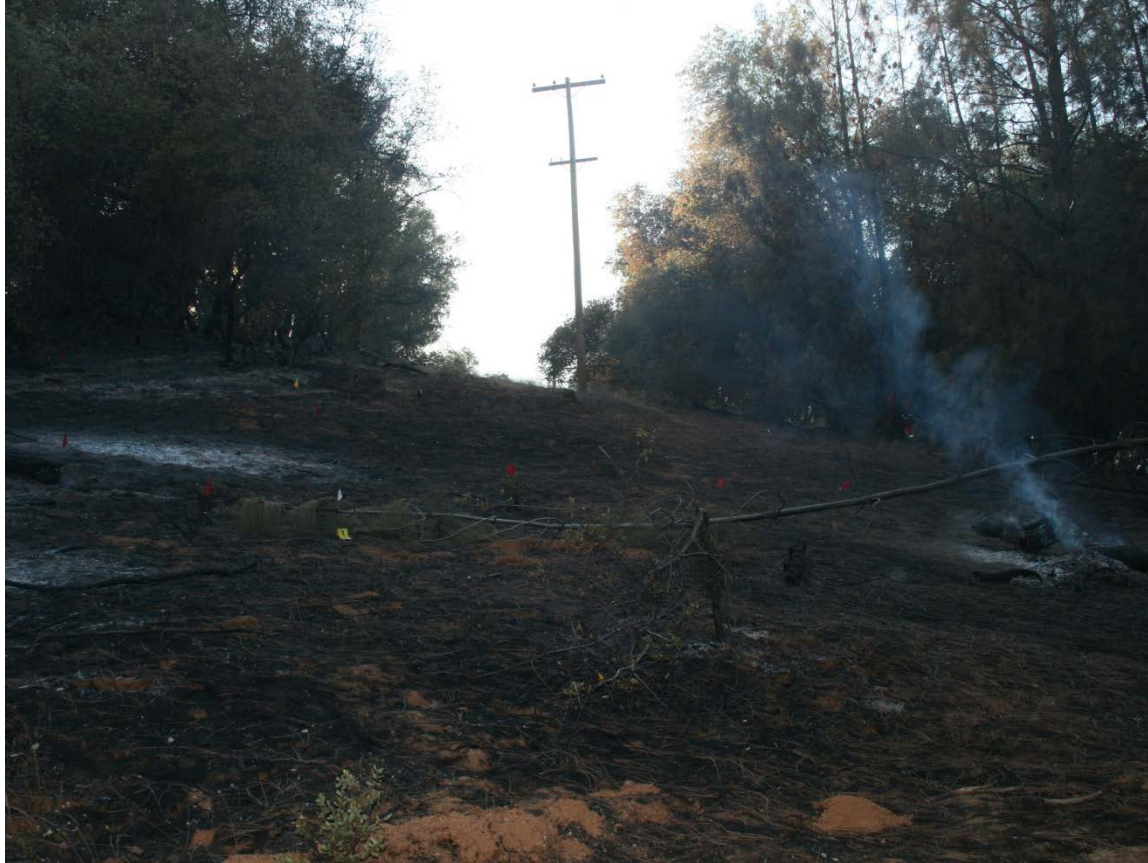
**Photo 9**

Facing west, looking at Grey pine (Evidence Item 1) laying within the General Origin Area below the powerline conductors.

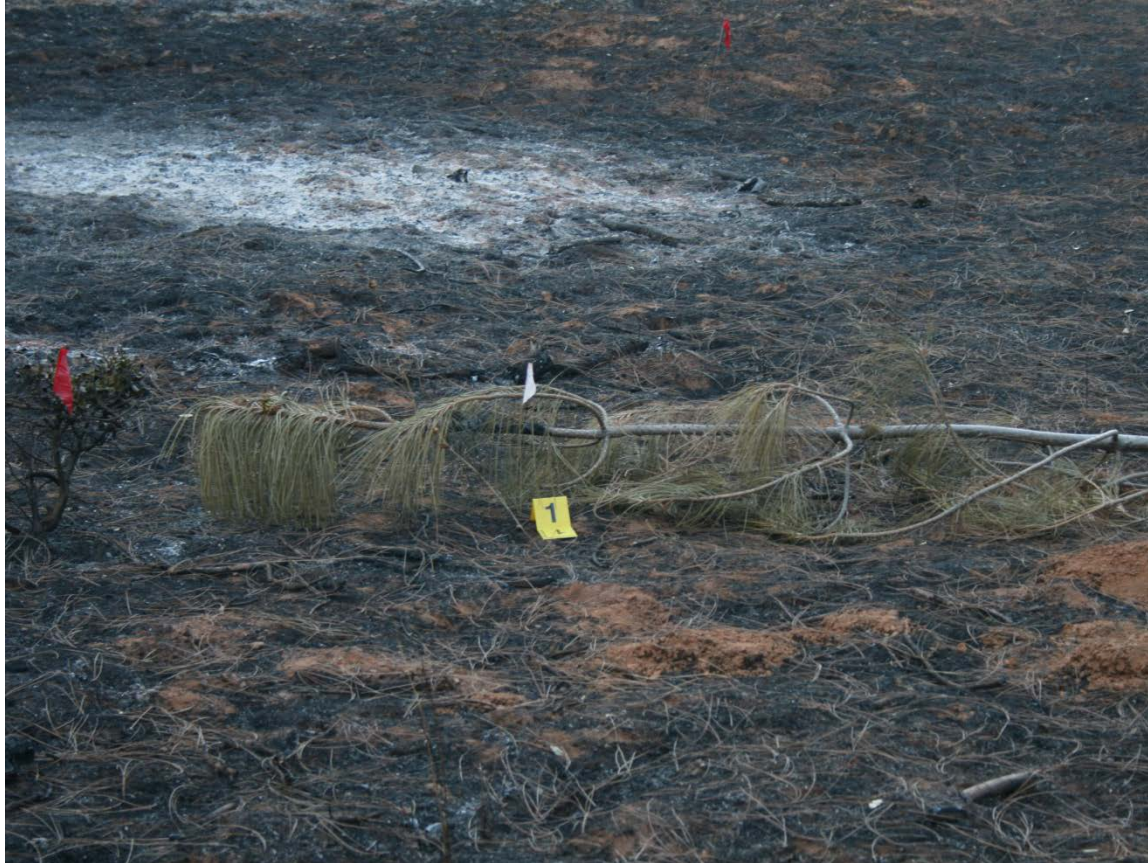
**Photo 10**

Top portion of Grey pine (Evidence Item 1) laying within the General Origin Area.

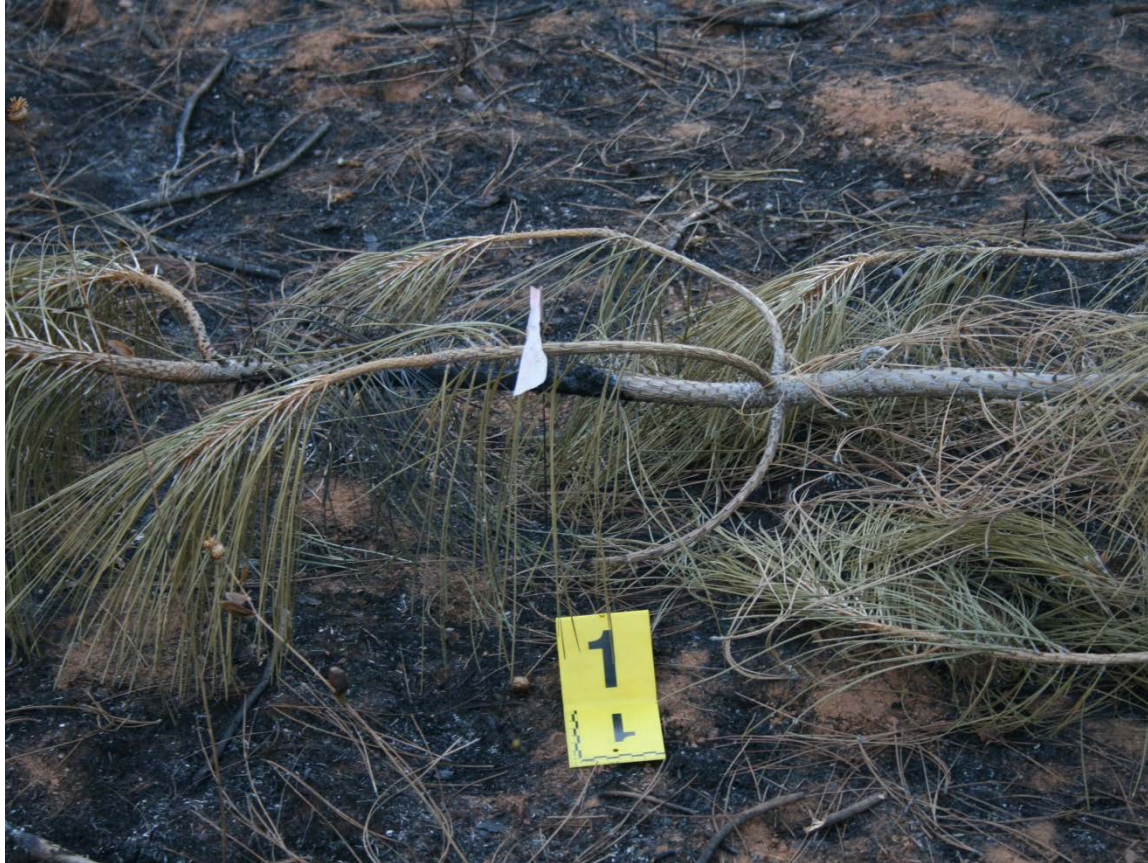
**Photo 11**

Close up of Grey pine (Evidence Item 1) showing top portion of tree is unburned except for two small branches and stem of the tree that contacted the powerline conductor.

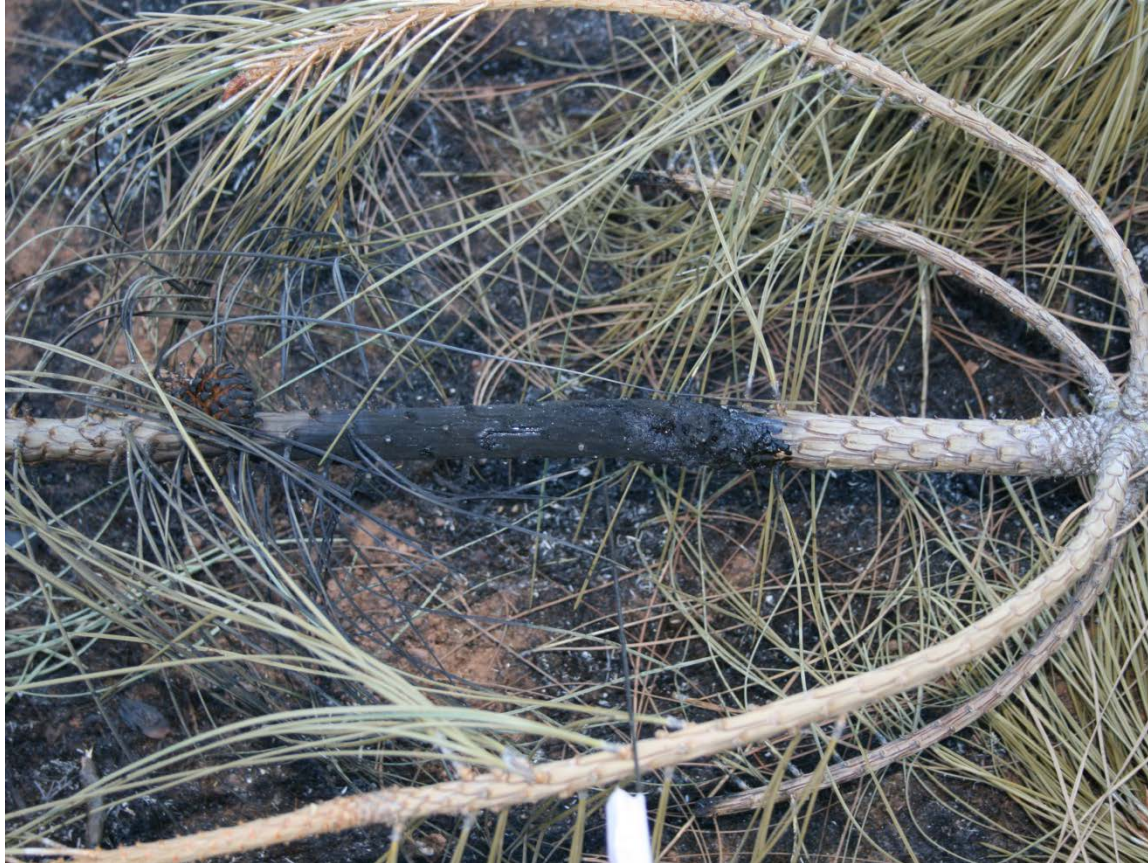
**Photo 12**

Evidence Item 1: Close up of burned stem with pitch (sap) bubbles and the burned tips of two branches.

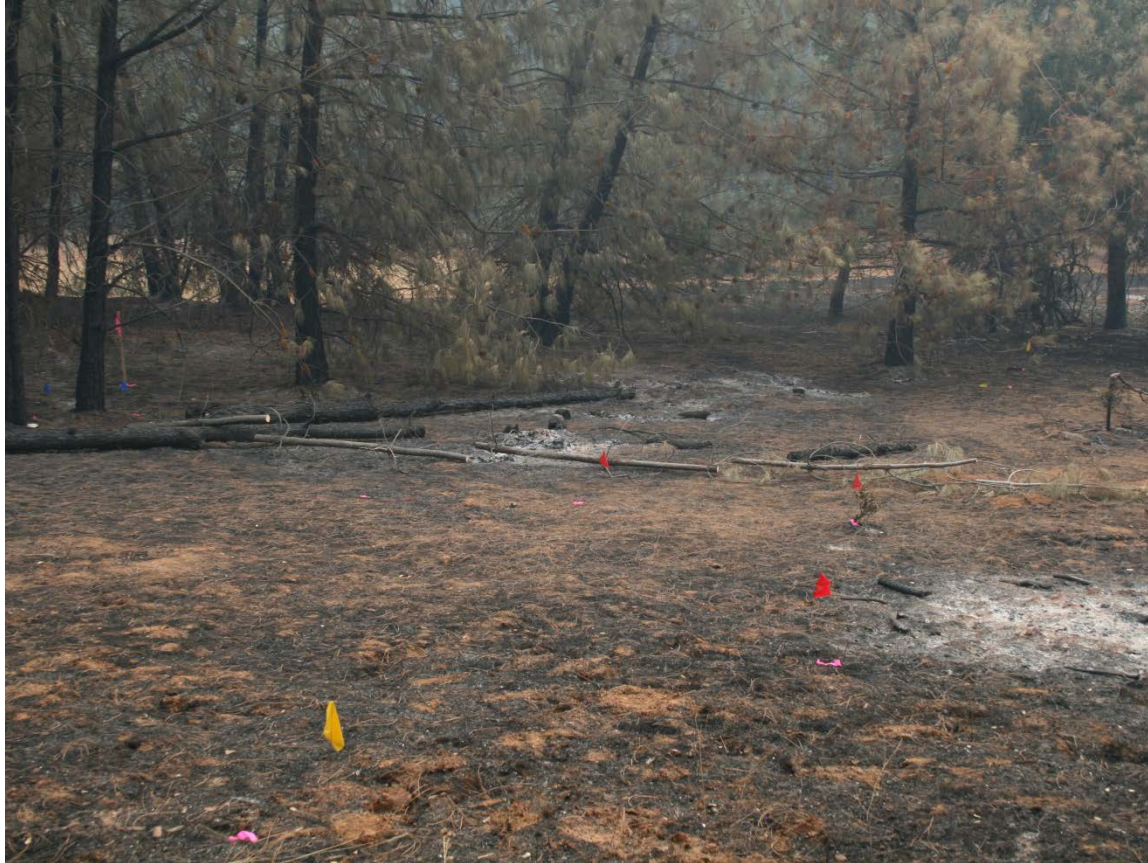
**Photo 13**

Evidence Item 1: Cut into sections for collection as evidence.

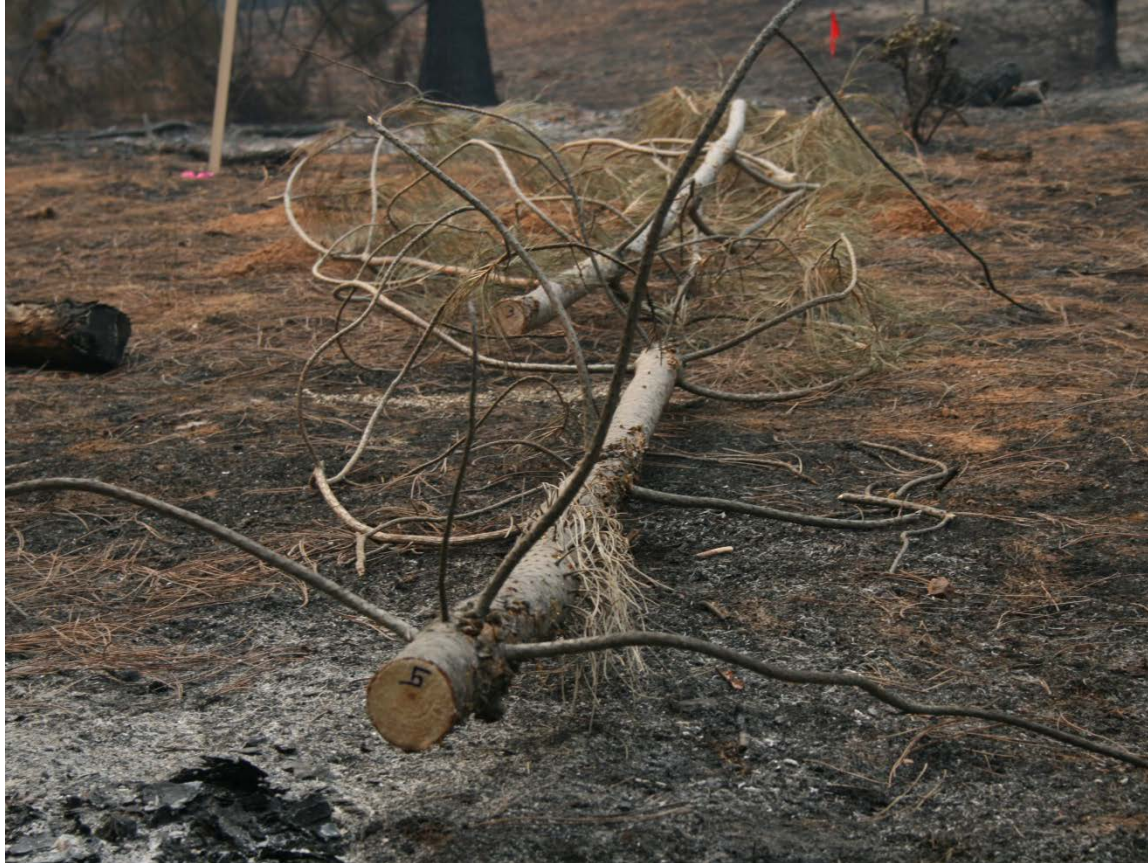
**Photo 14**

Evidence Item 1: Each cut was numerically marked.

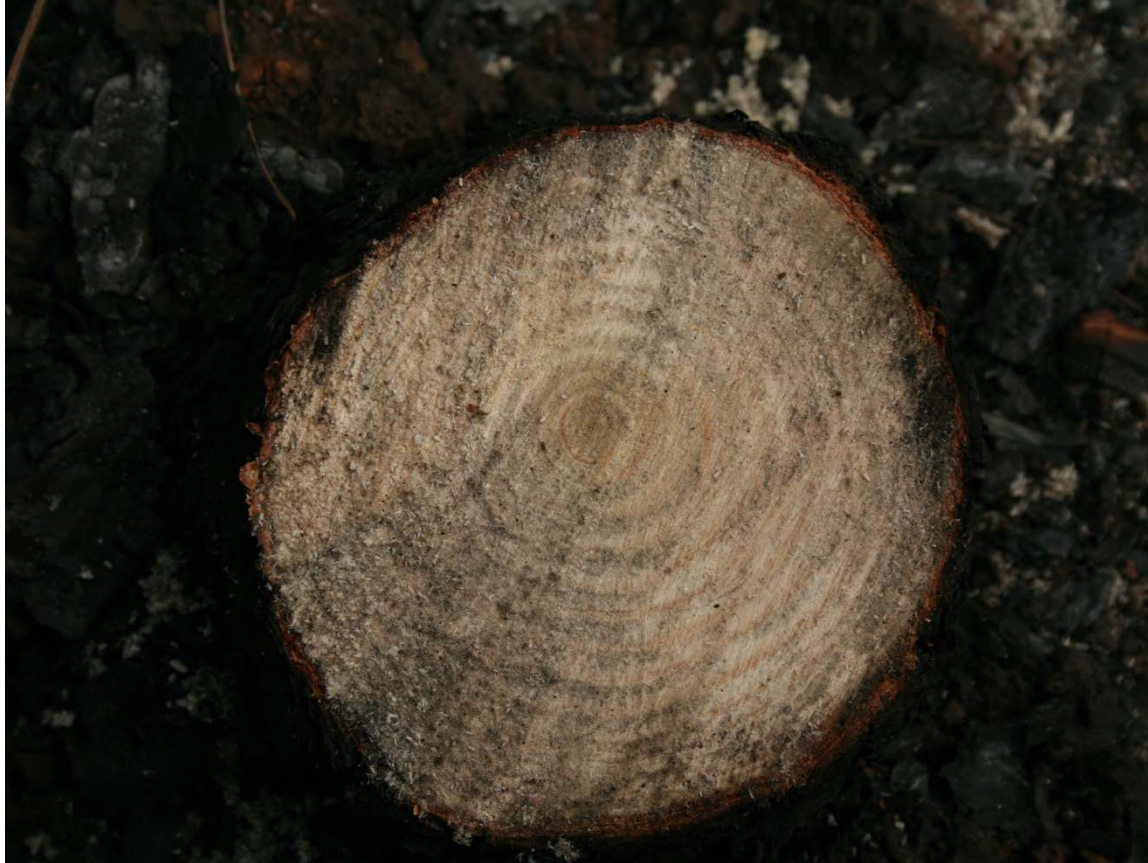
**Photo 15**

The base (stump) of Evidence Item 1.

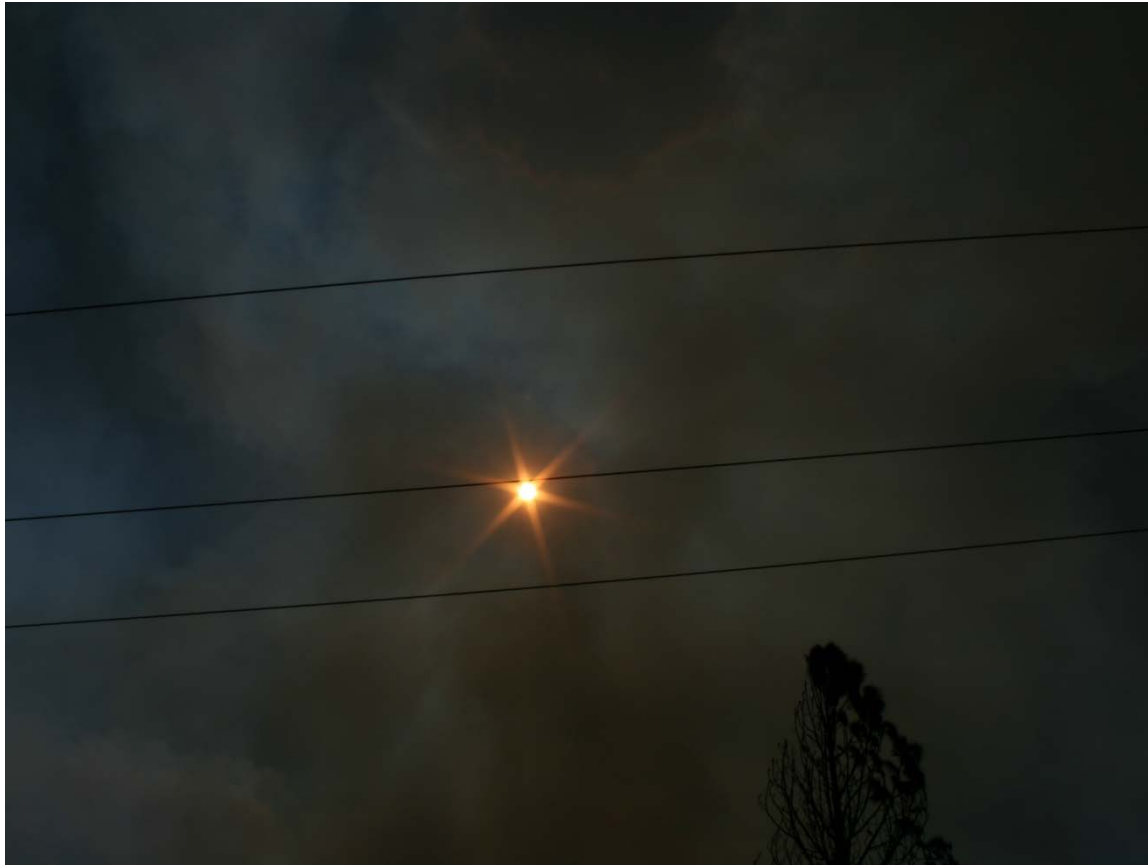
**Photo 16**

Overhead powerlines above the Specific Origin Area.

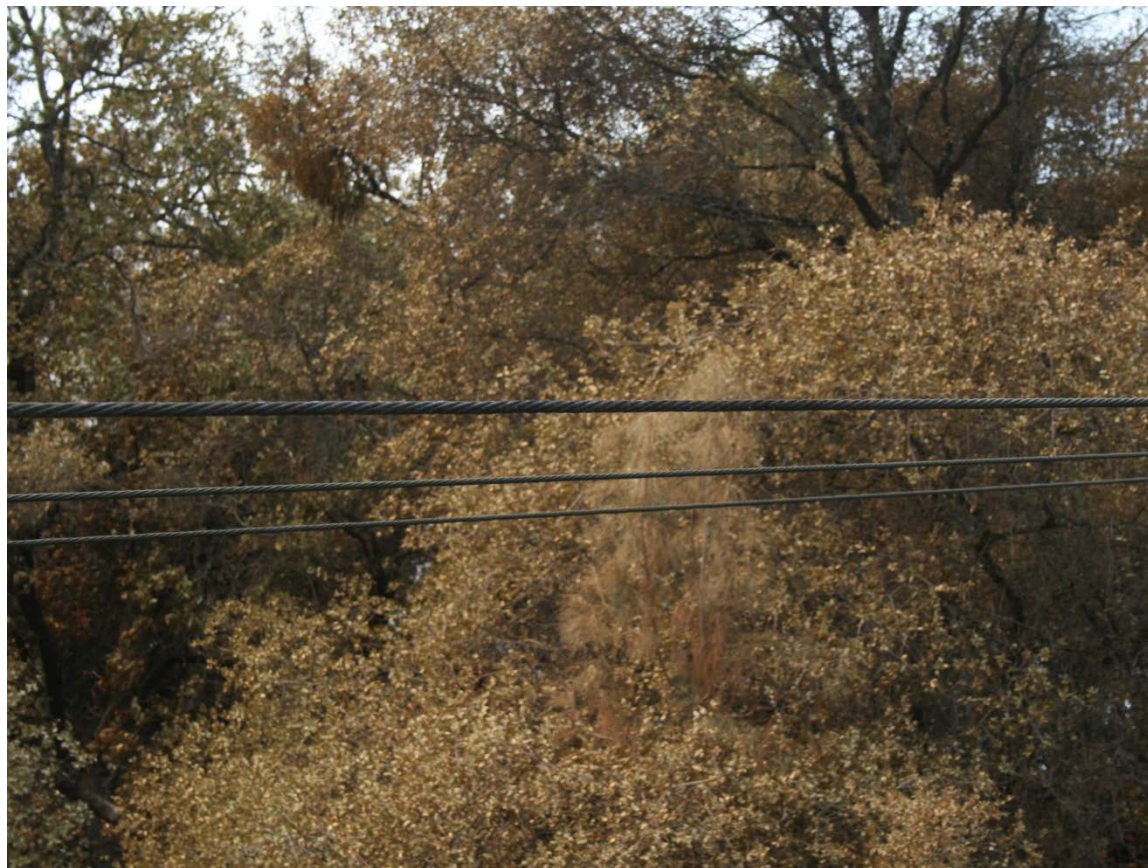
**Photo 17**

Facing south, view of the powerline conductors over the Specific Origin Area from Trees Inc. bucket truck. Discoloration is visible on the northern (closest) conductor.

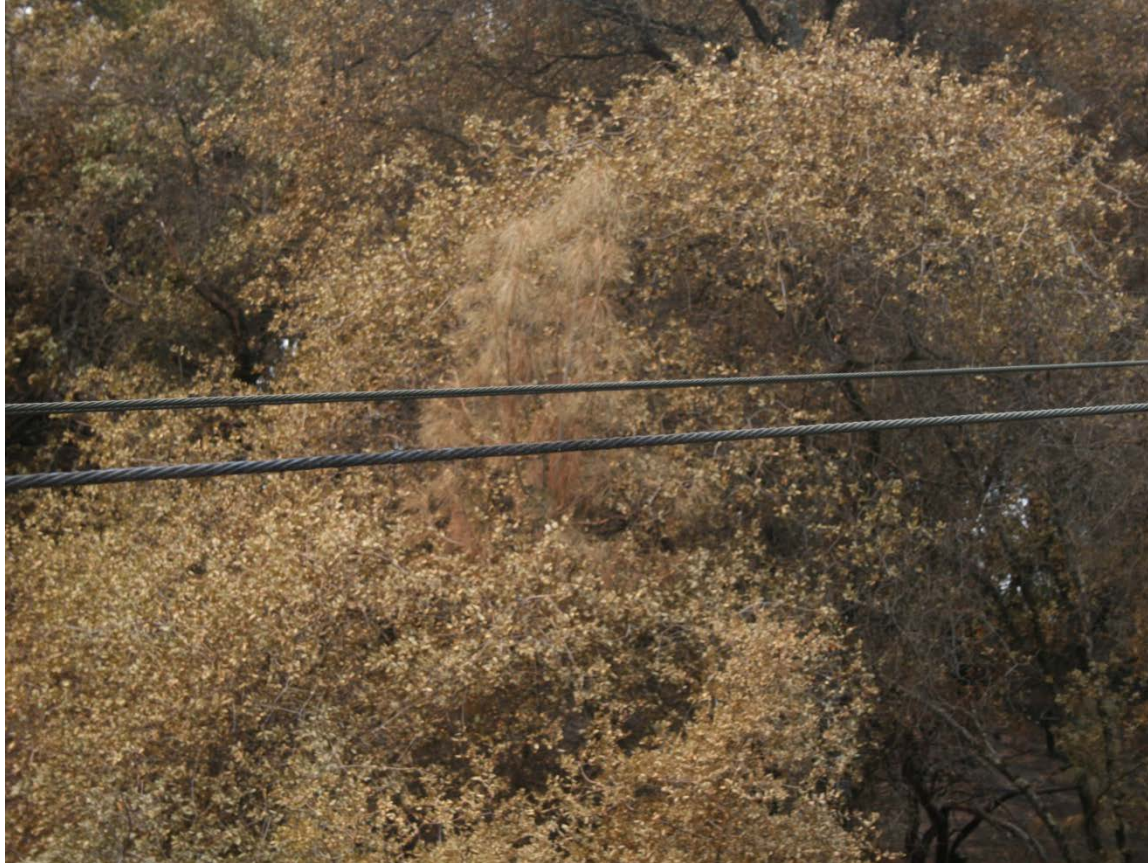
**Photo 18**

Facing south, view of discoloration on northern most powerline conductor over the Specific Origin Area.

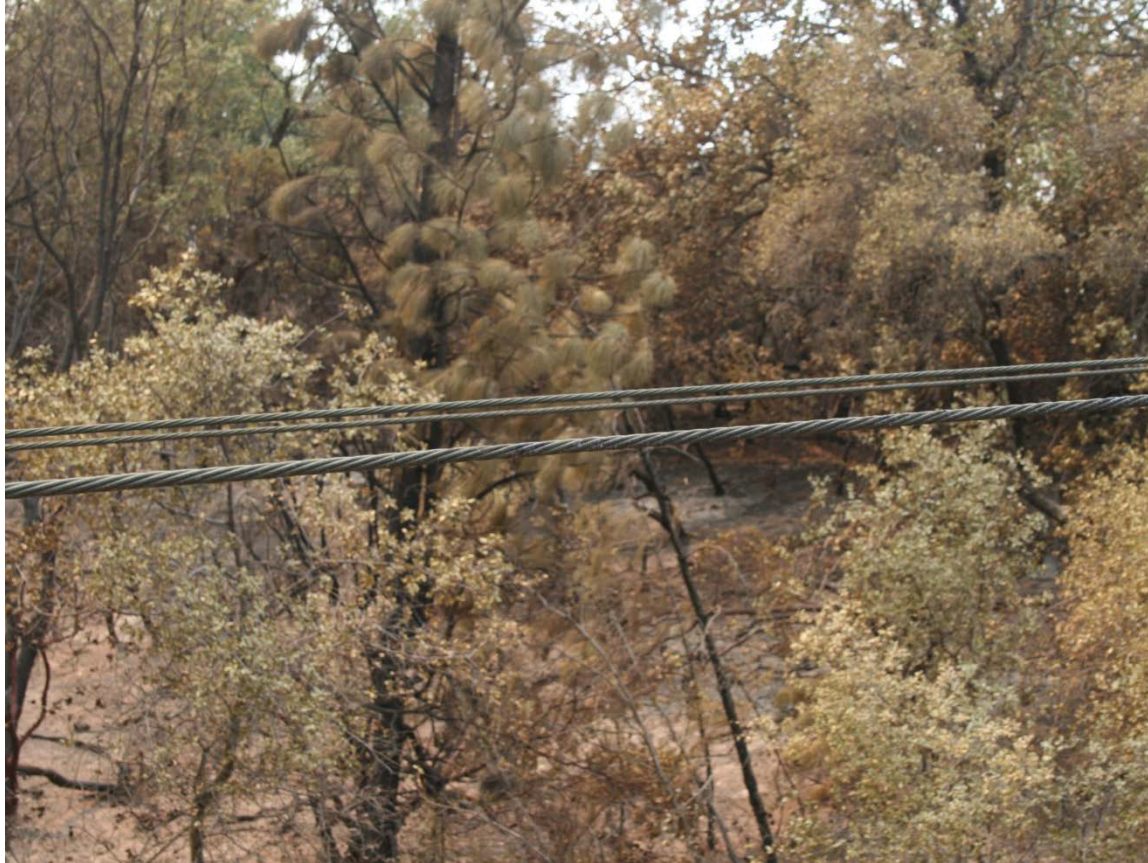
**Photo 19**

Facing south, looking at additional discoloration on northern most powerline conductor over the Specific Origin Area.

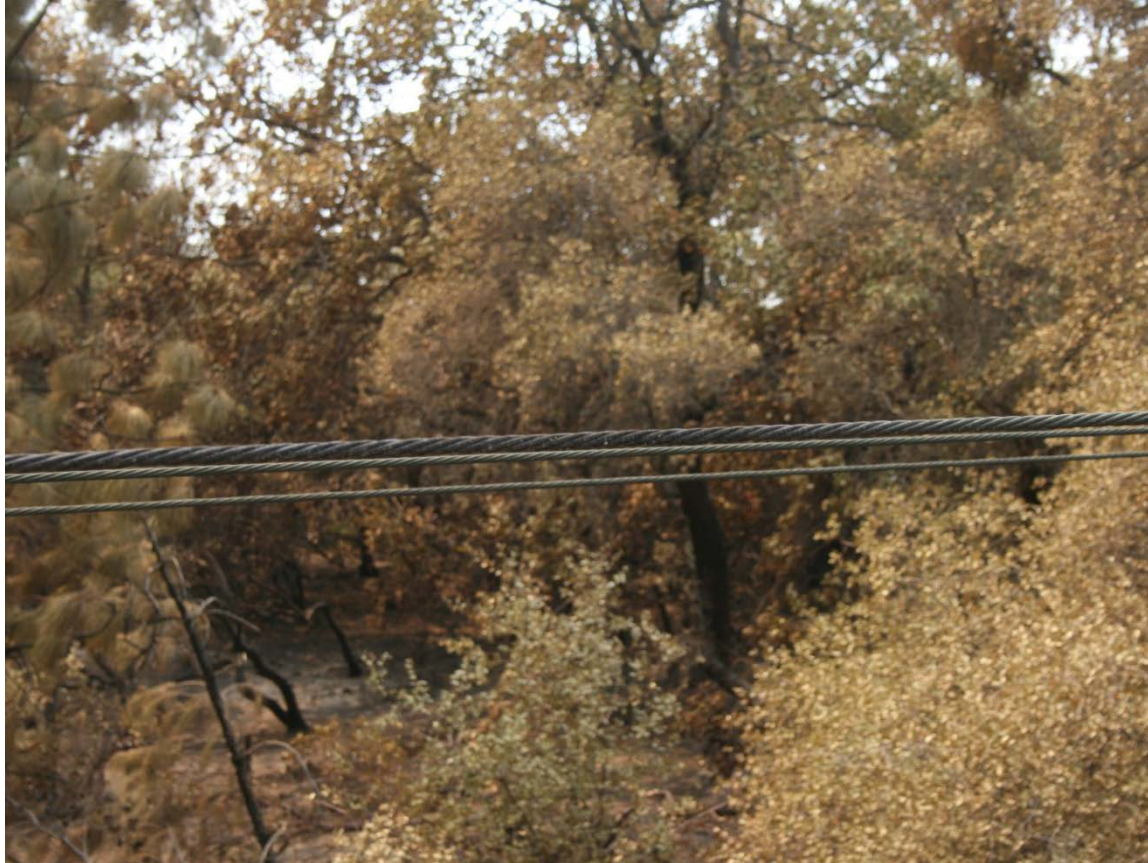
**Photo 20**

Facing south, looking at discoloration on northern most powerline conductor over the Specific Origin Area.

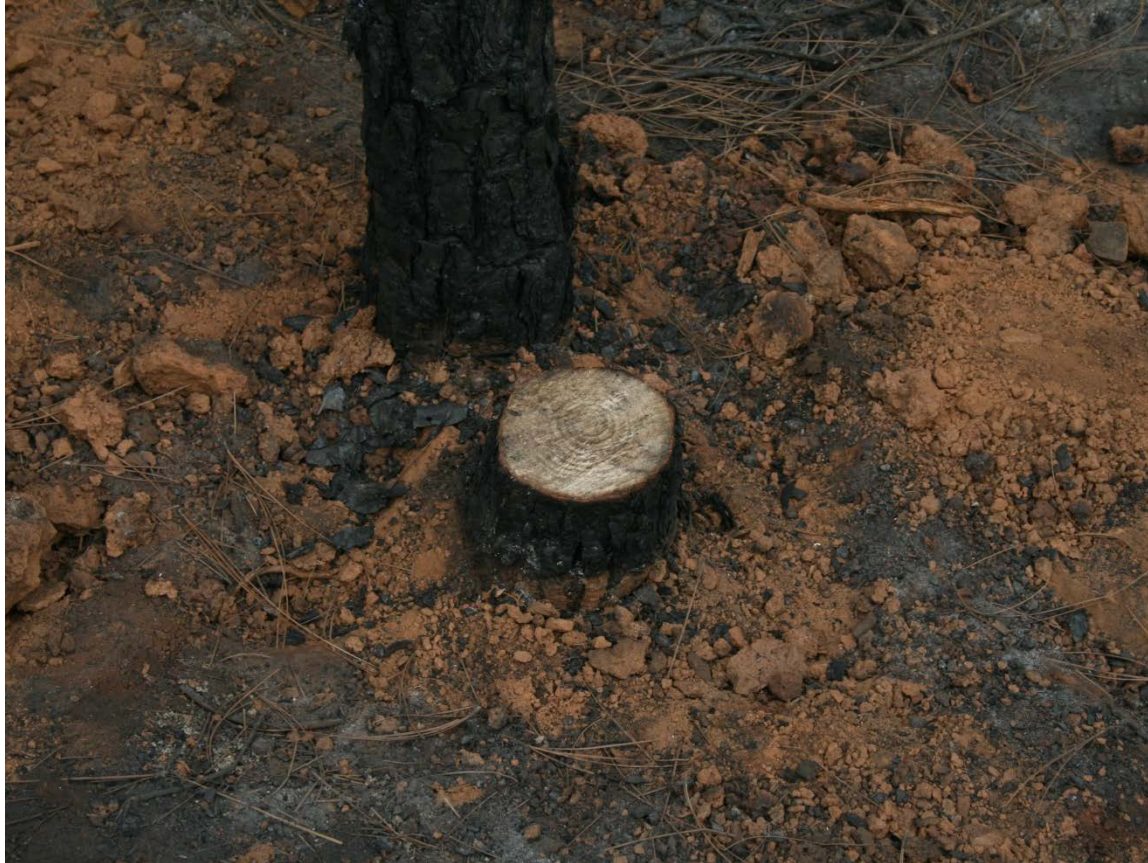
**Photo 21**

Remaining base (stump) of Evidence Item 1.

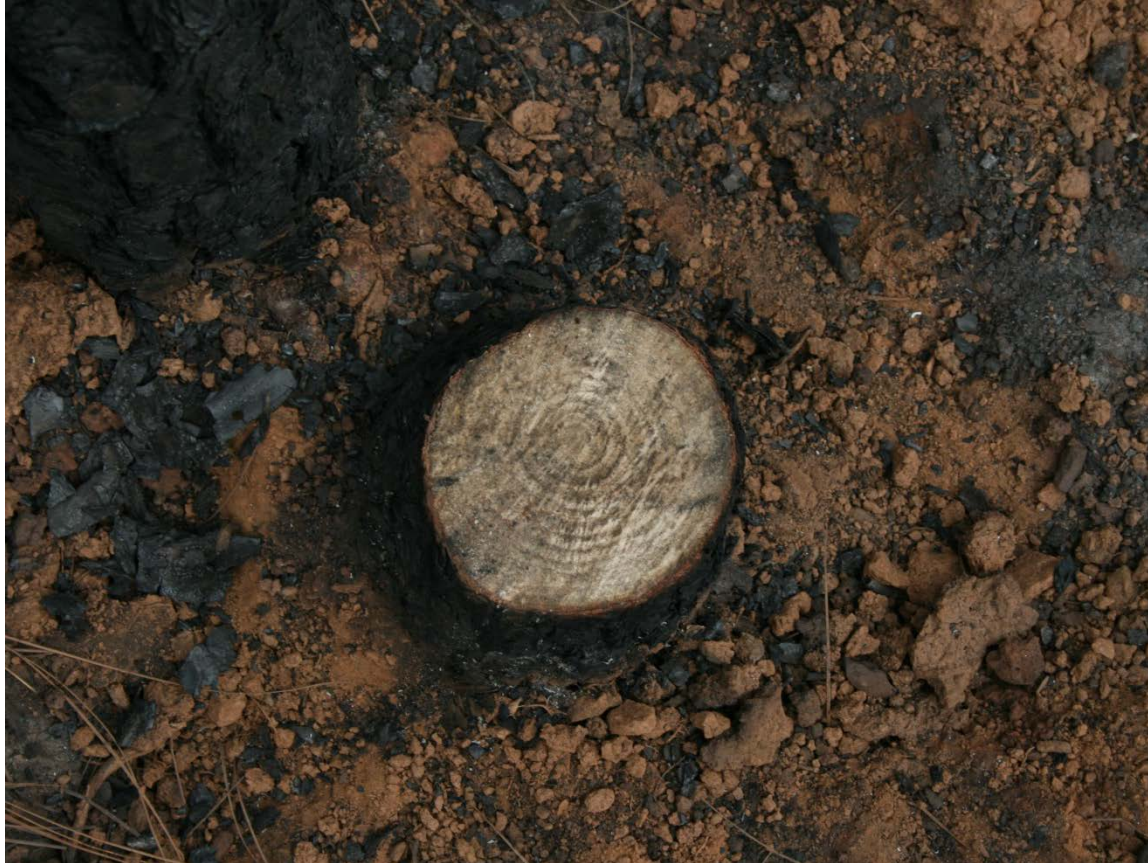
**Photo 22**

Close up of the base (stump) of Evidence Item 1.

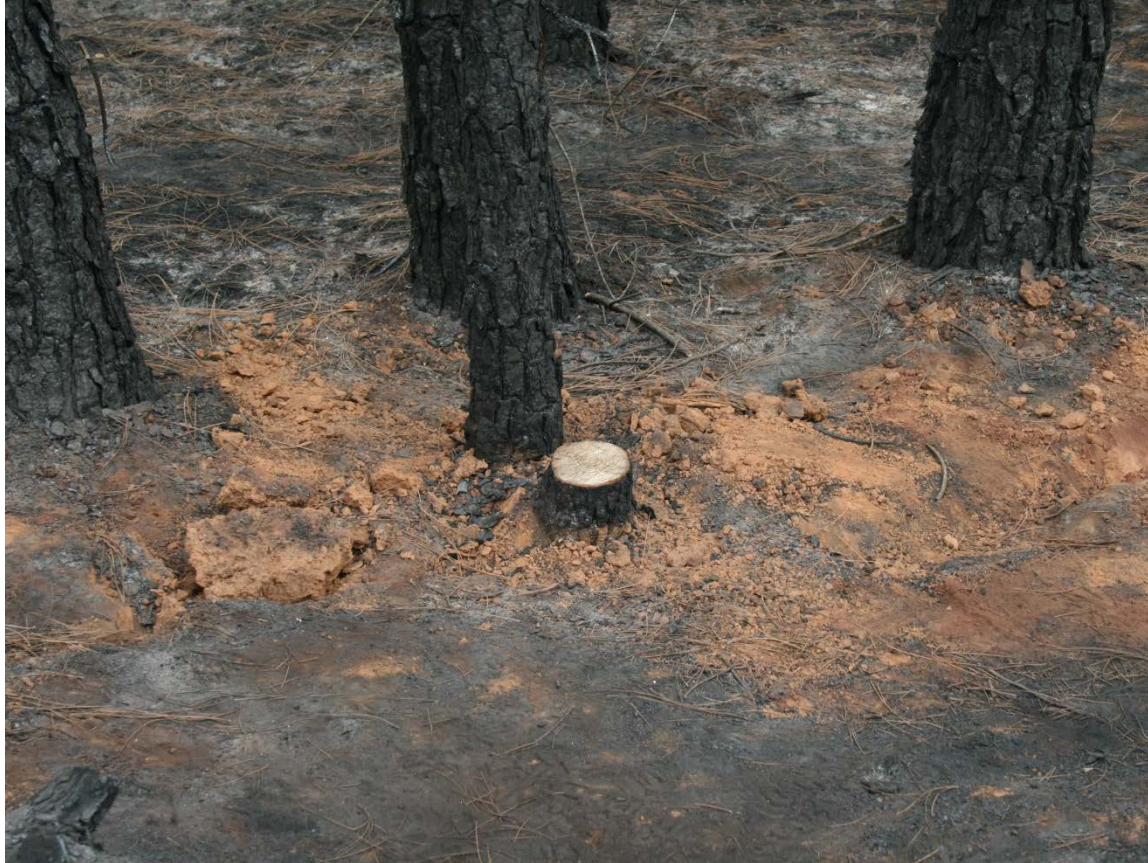
**Photo 23**

Base (stump) of Evidence Item 1.
