**Butte Incident**

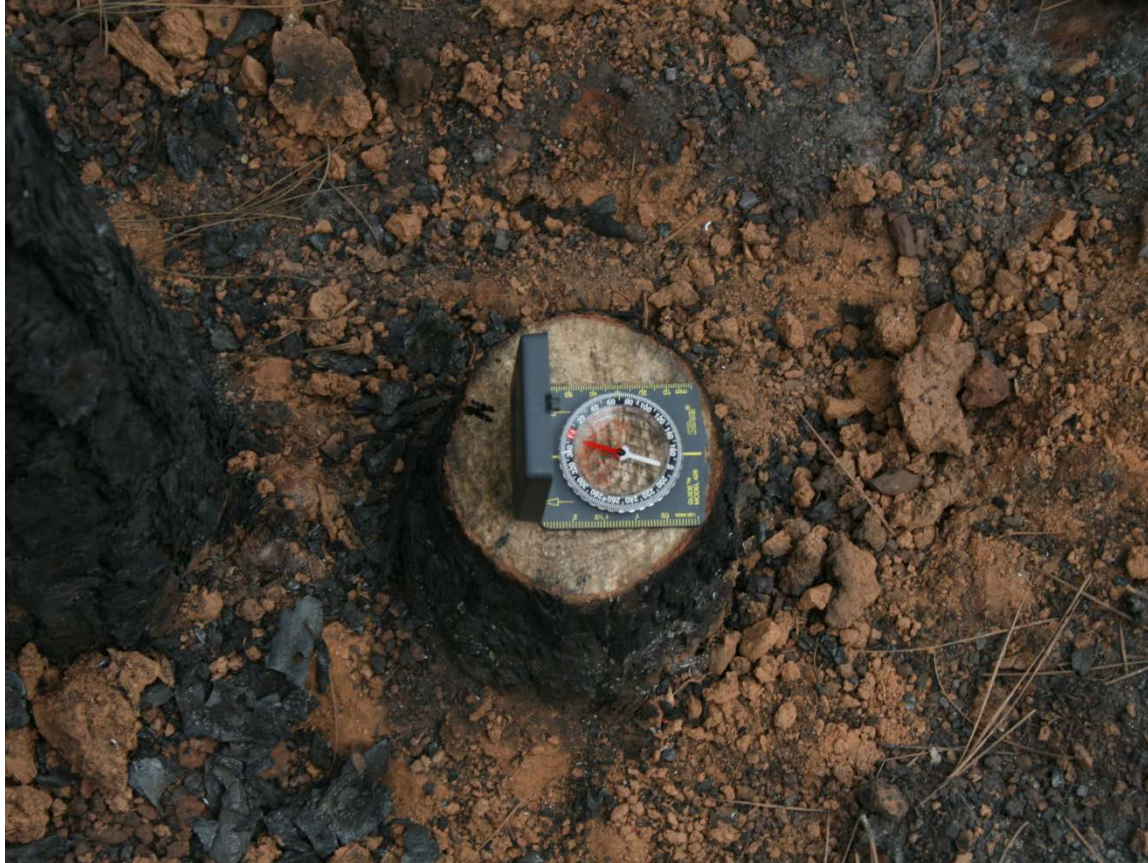
**Photo 24**

Compass was used to identify North and a black sharpie used to mark "N" and "S" on the base (stump) of Evidence Item 1.

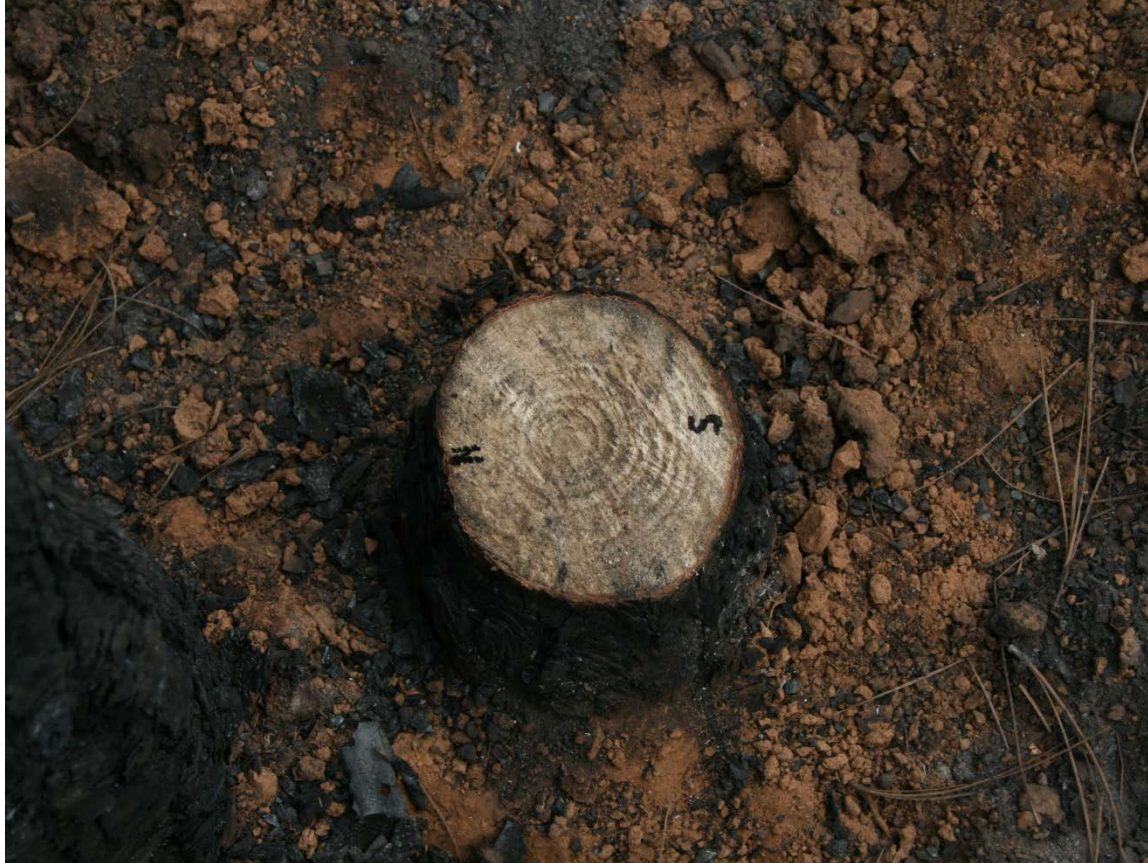
**Photo 25**

Close up of the base of Evidence Item 1 showing the North and South marked on the base.

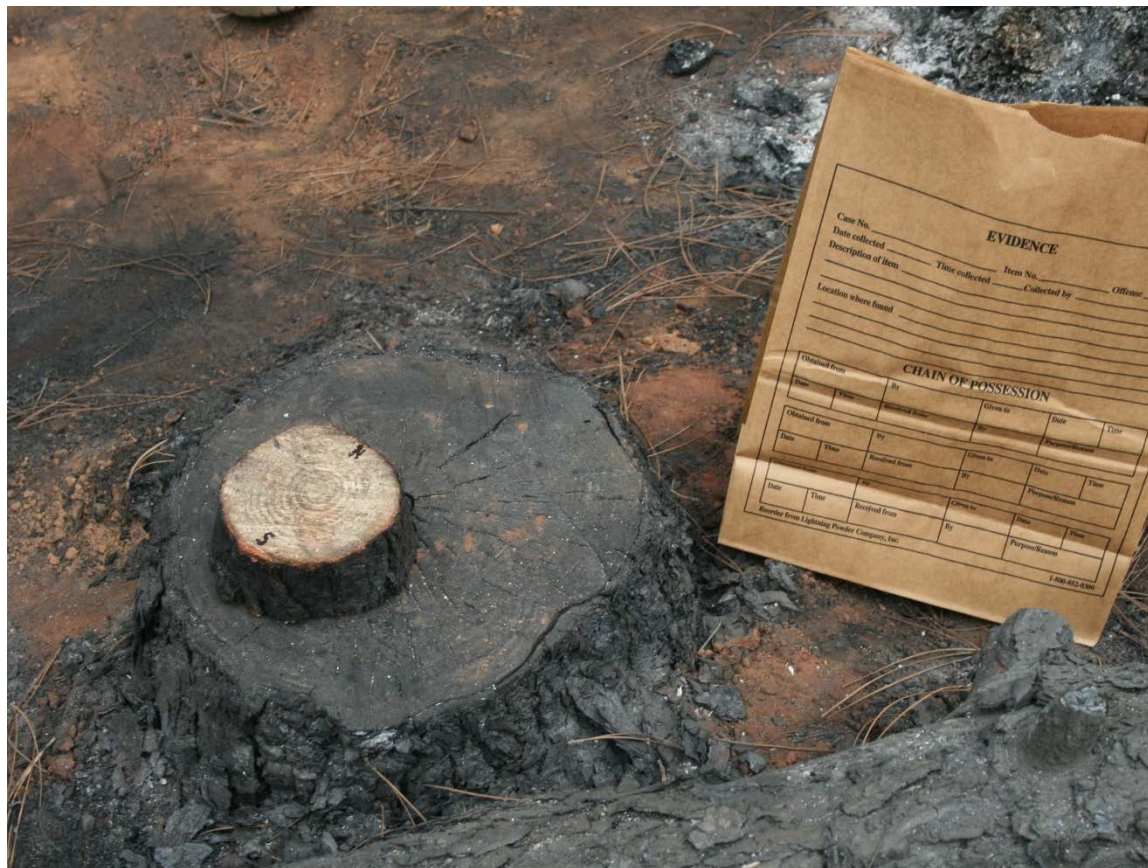
Photo 26

Evidence Item 2.

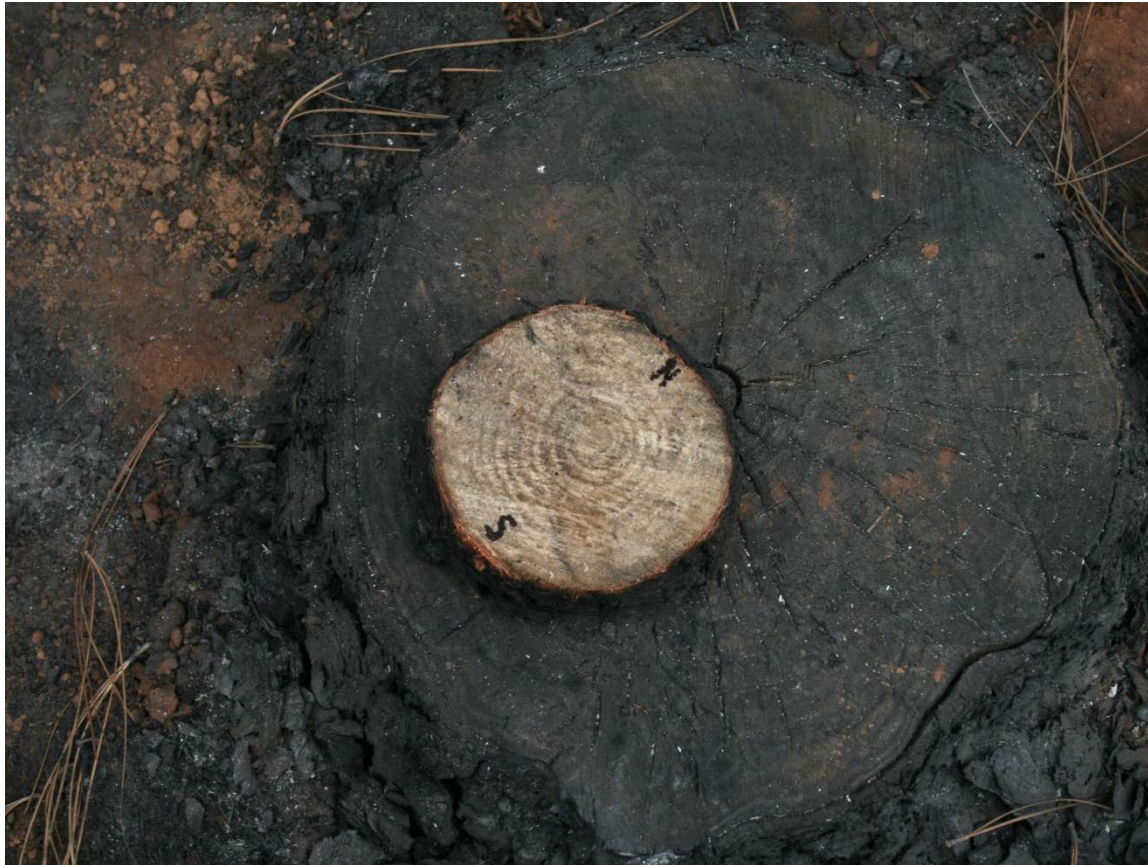
**Photo 27**

Close up of the top of Evidence Item 2.

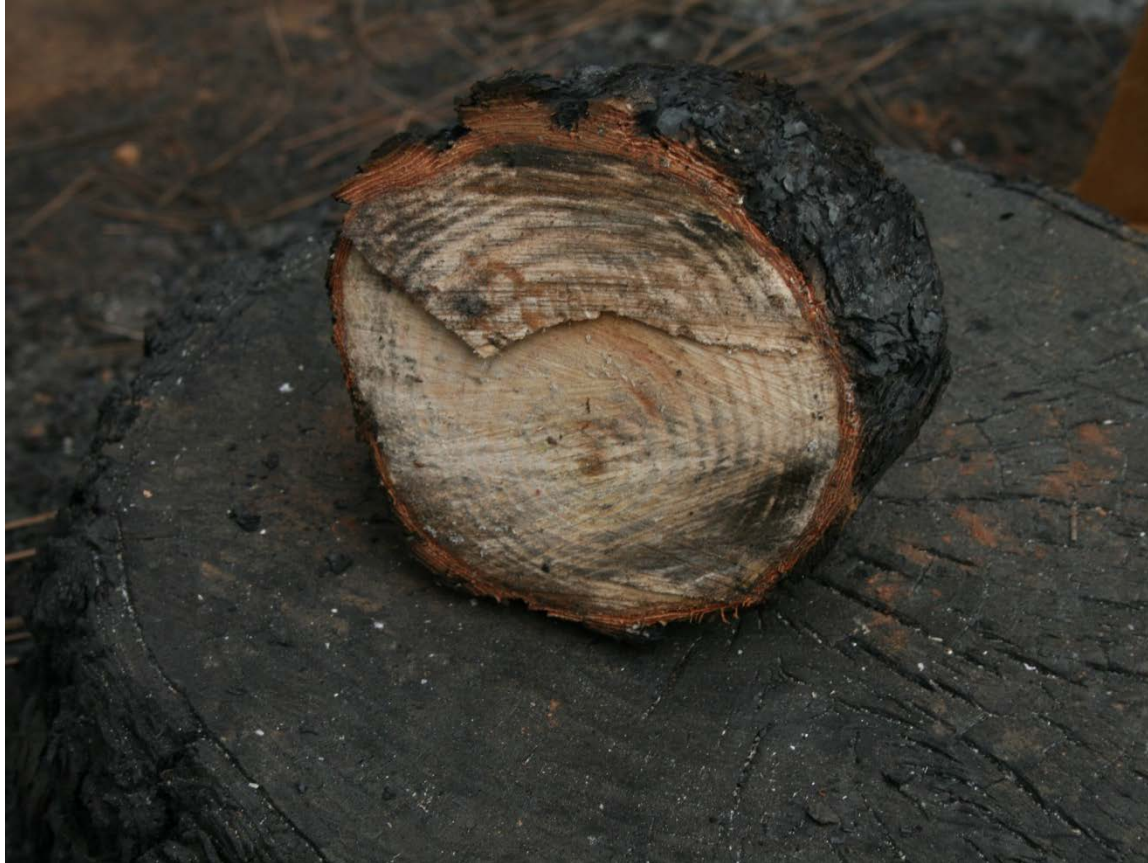
**Photo 28**

Close up of the bottom of Evidence Item 2.

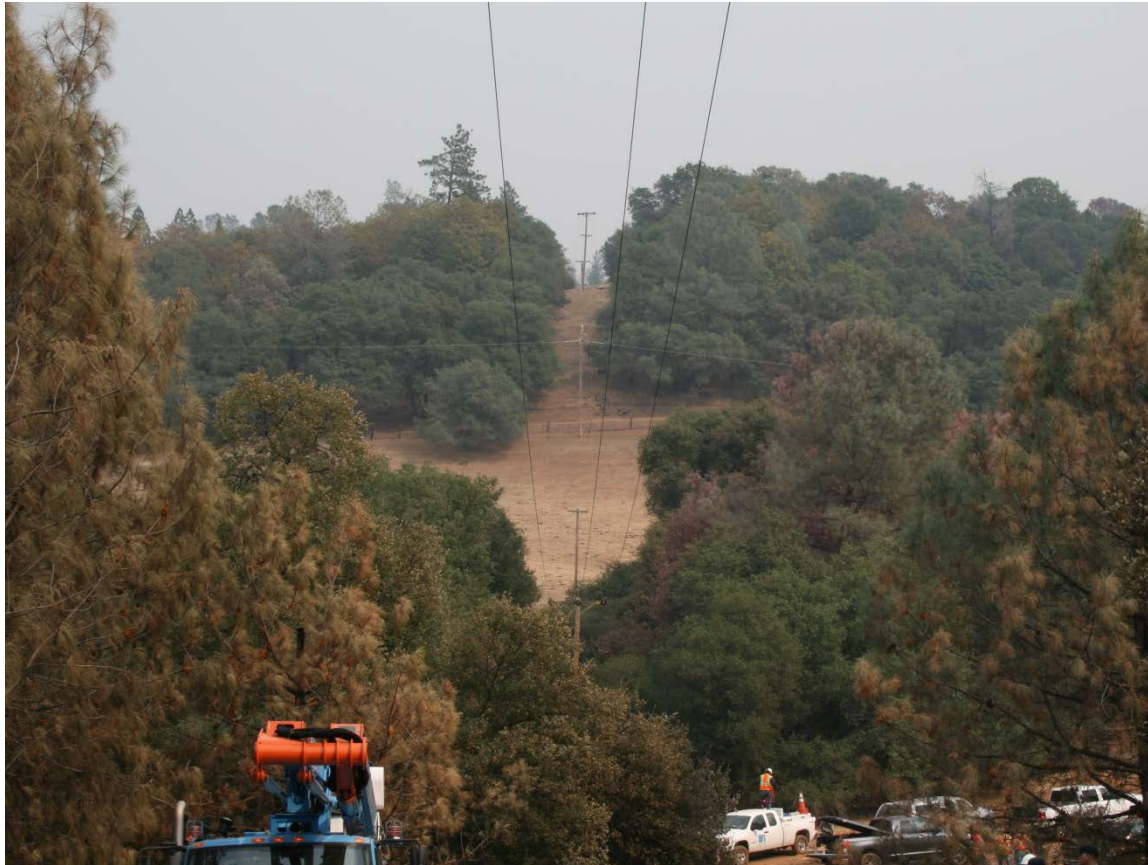
**Photo 30**

Facing east, looking at PG&E vehicle moved into the Specific Origin Area for collection of powerline conductor.

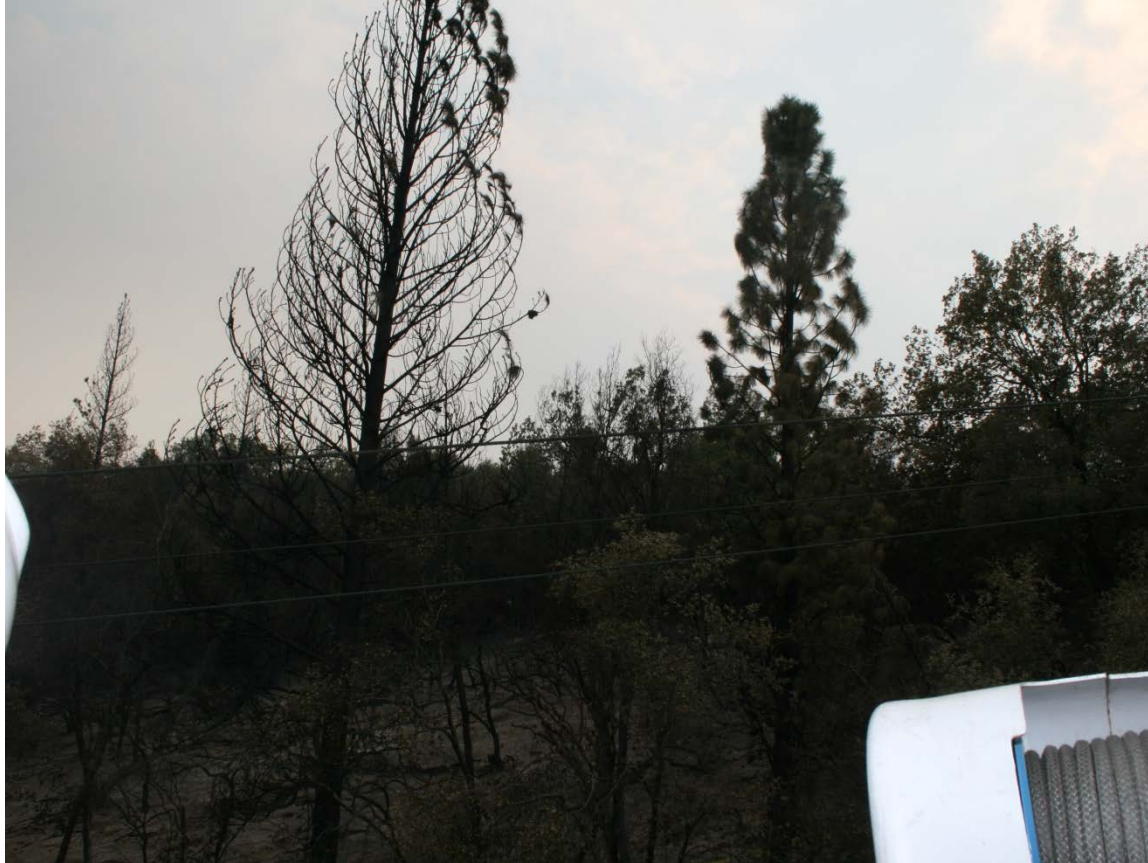
**Photo 32**

From PG&E bucket truck, facing south, looking at powerline conductors over the Specific Origin Area.

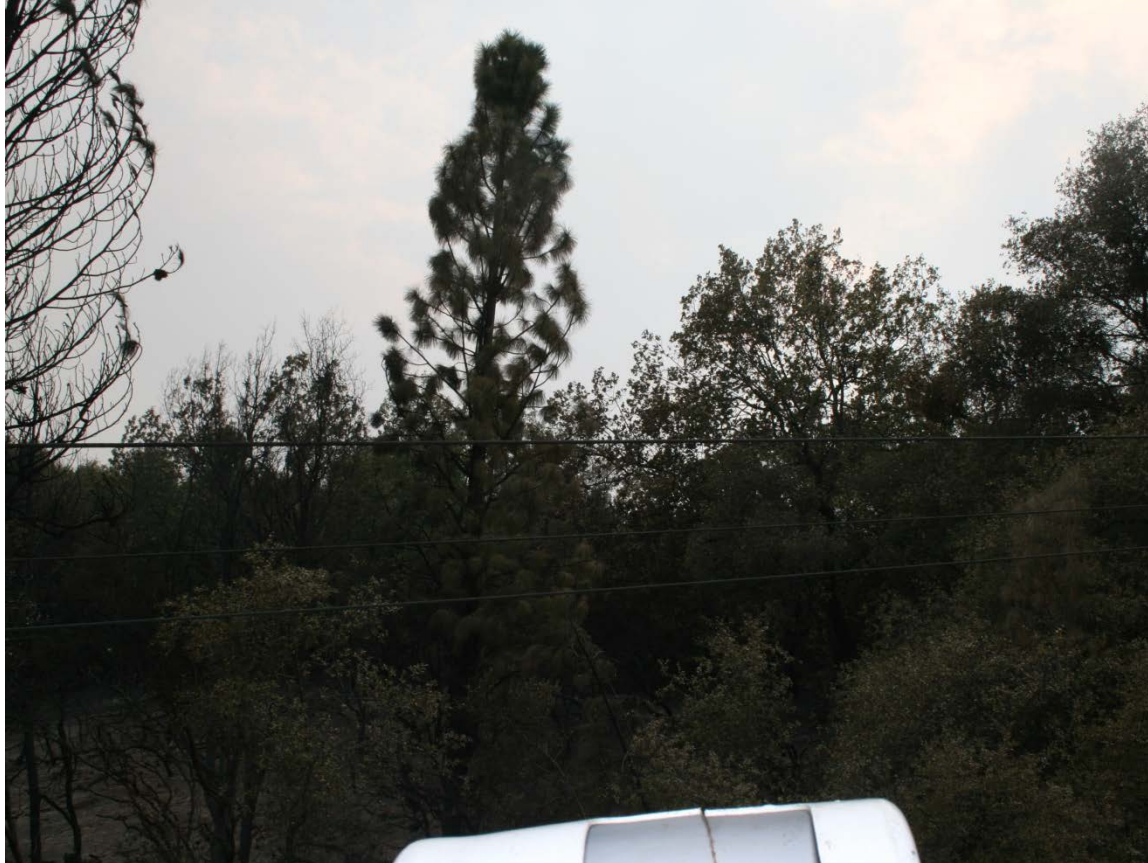
**Photo 33**

From PG&E bucket truck, facing south, looking at powerline conductors over the Specific Origin Area.

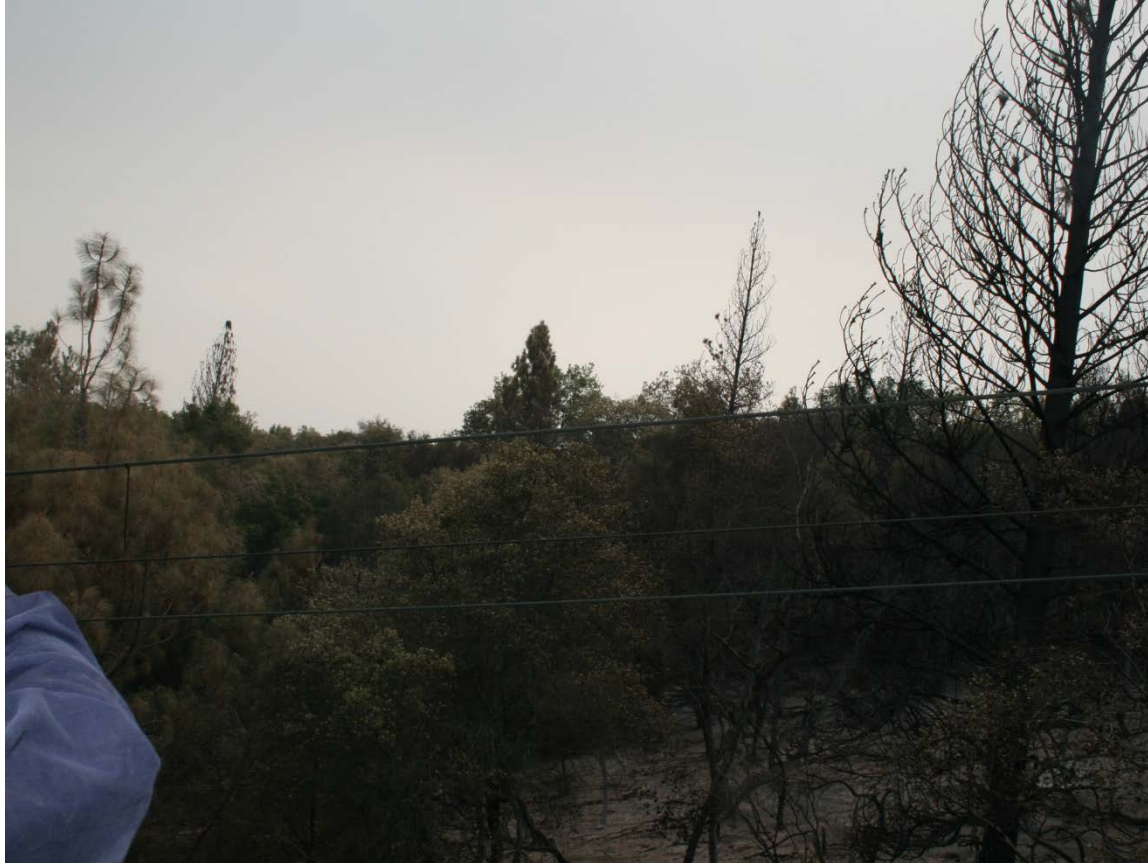
**Photo 34**

From PG&E bucket truck, facing south, looking at powerline conductors over the Specific Origin Area.

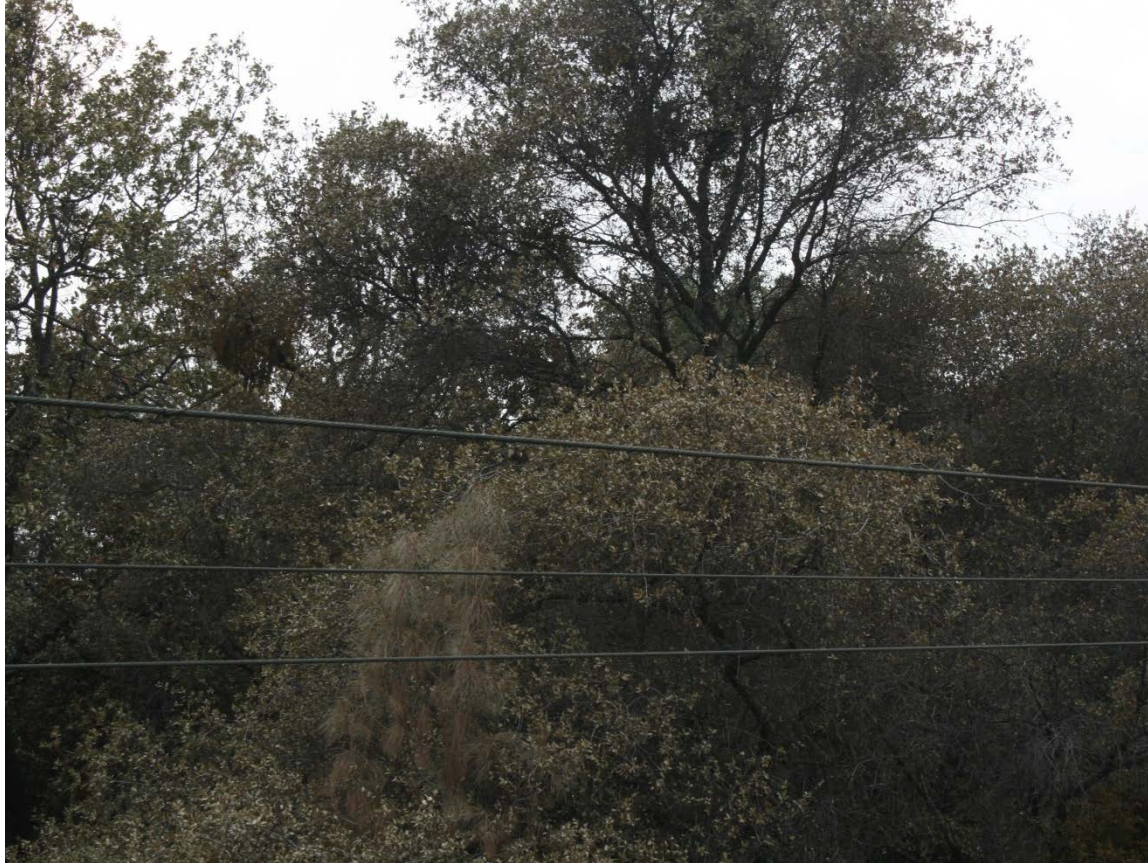
**Photo 35**

Facing southwest, looking at the start of the discoloration on the northern (closest) most conductor. (Discoloration visible on left side of photo)

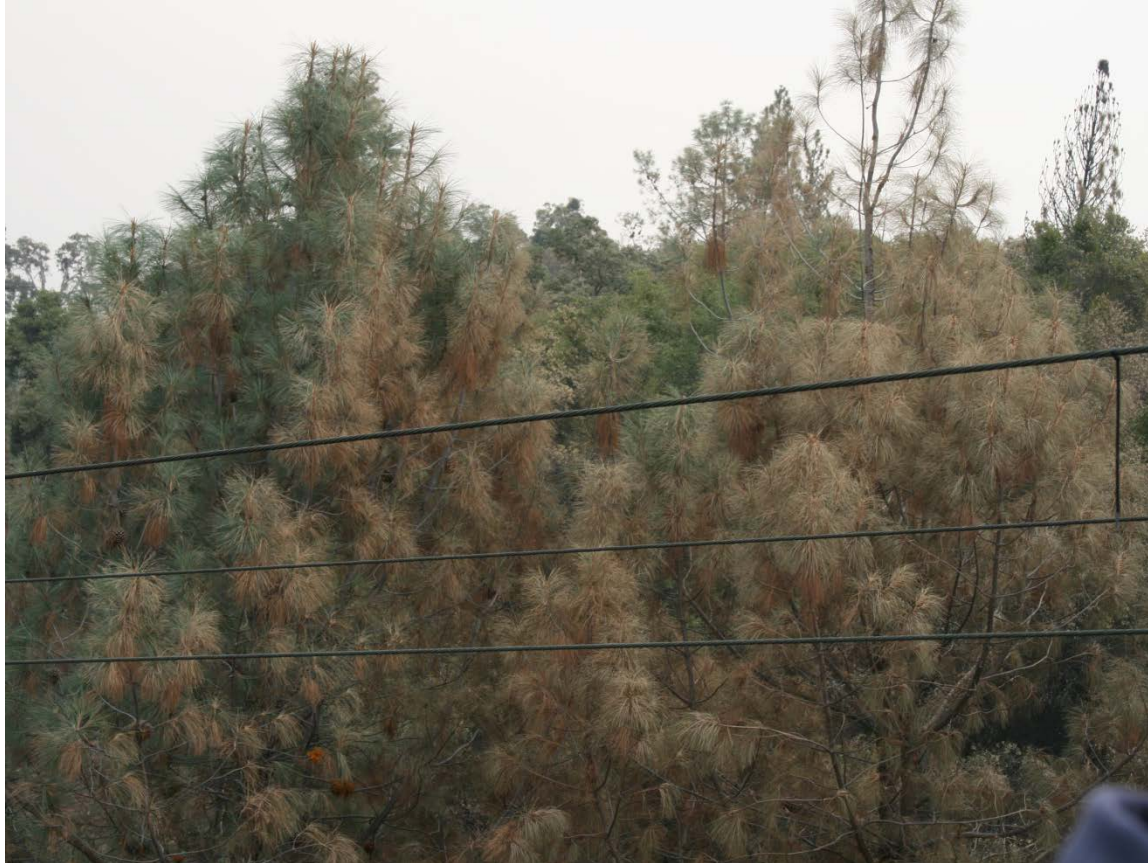
**Photo 36**

Facing southeast, view of discoloration on the northern (closest) most conductor.

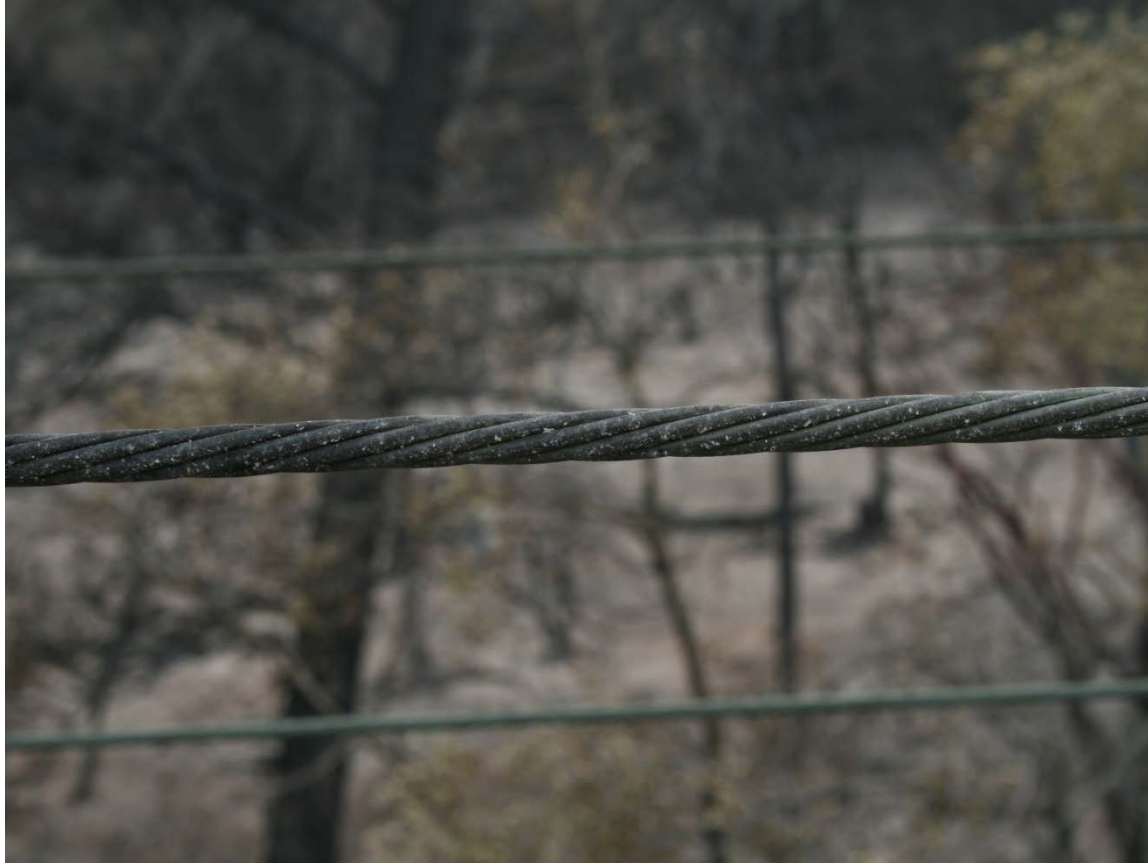
**Photo 37**

Close up of northern most powerline conductor showing discoloration on the left side of the photo.

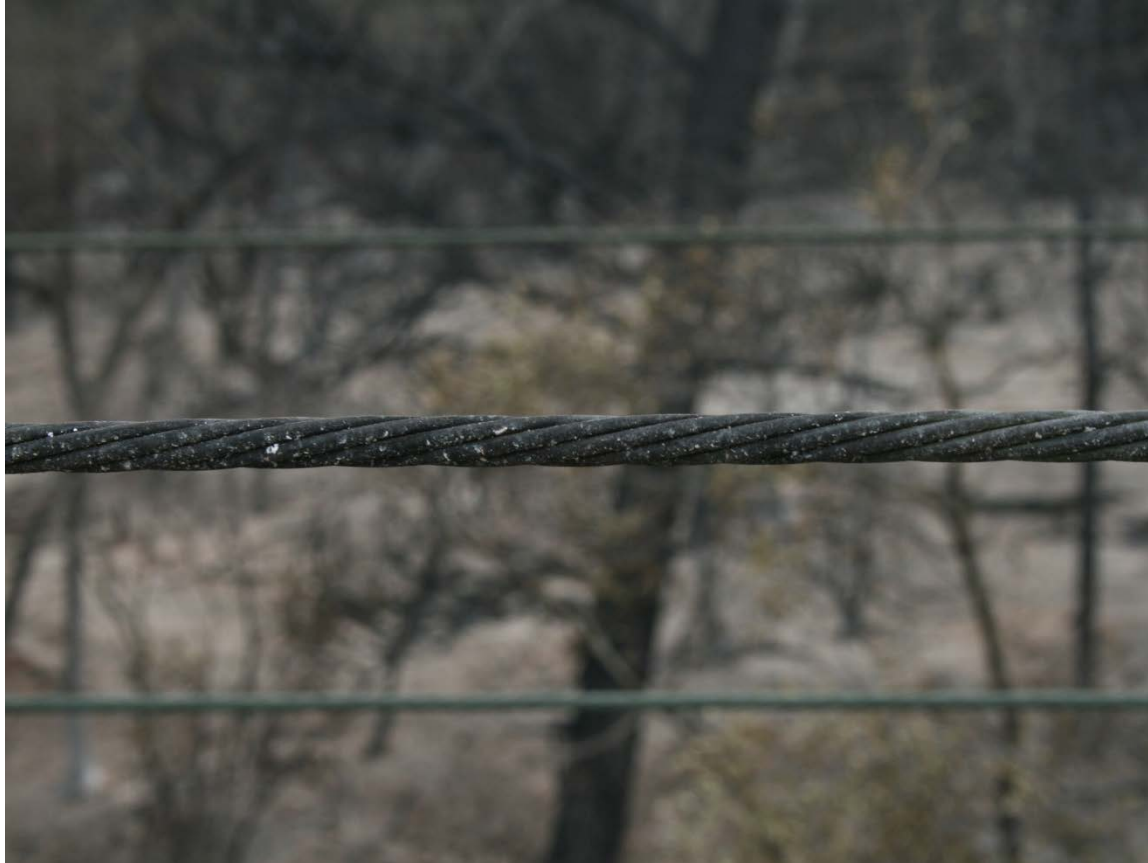
**Photo 38**

Close up of northern most powerline conductor, view of discoloration, moving east along conductor from photo 37.

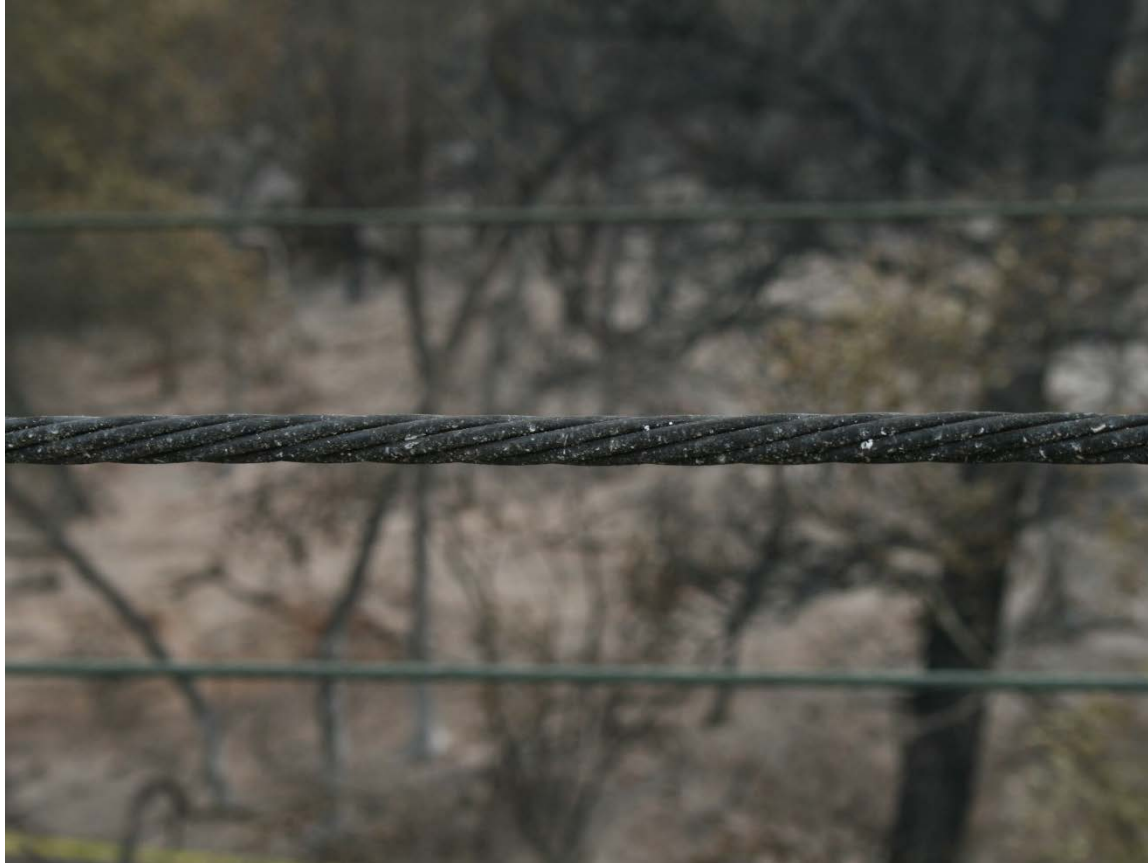
**Photo 39**

Continuing east along conductor, close up of northern most powerline conductor over the Specific Origin Area showing discoloration.

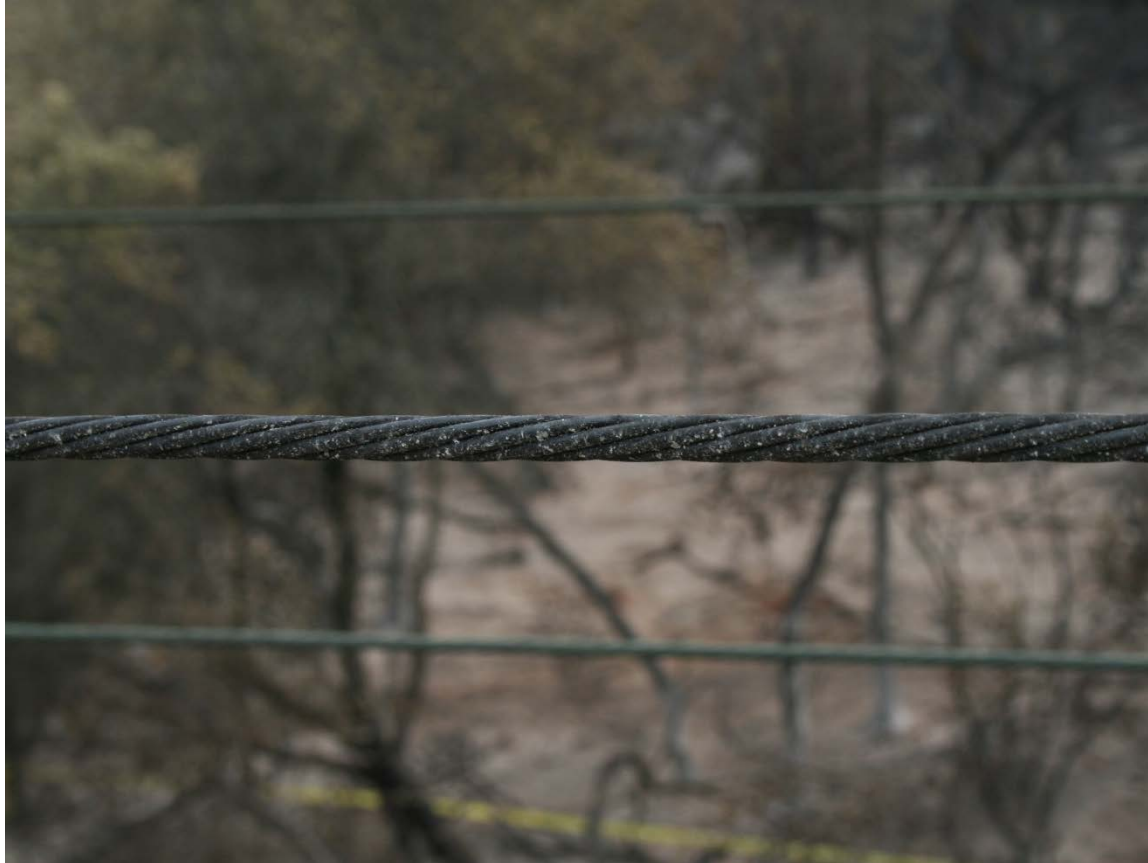
**Photo 40**

Continuing east along conductor, close up of northern most powerline conductor over the Specific Origin Area showing discoloration.

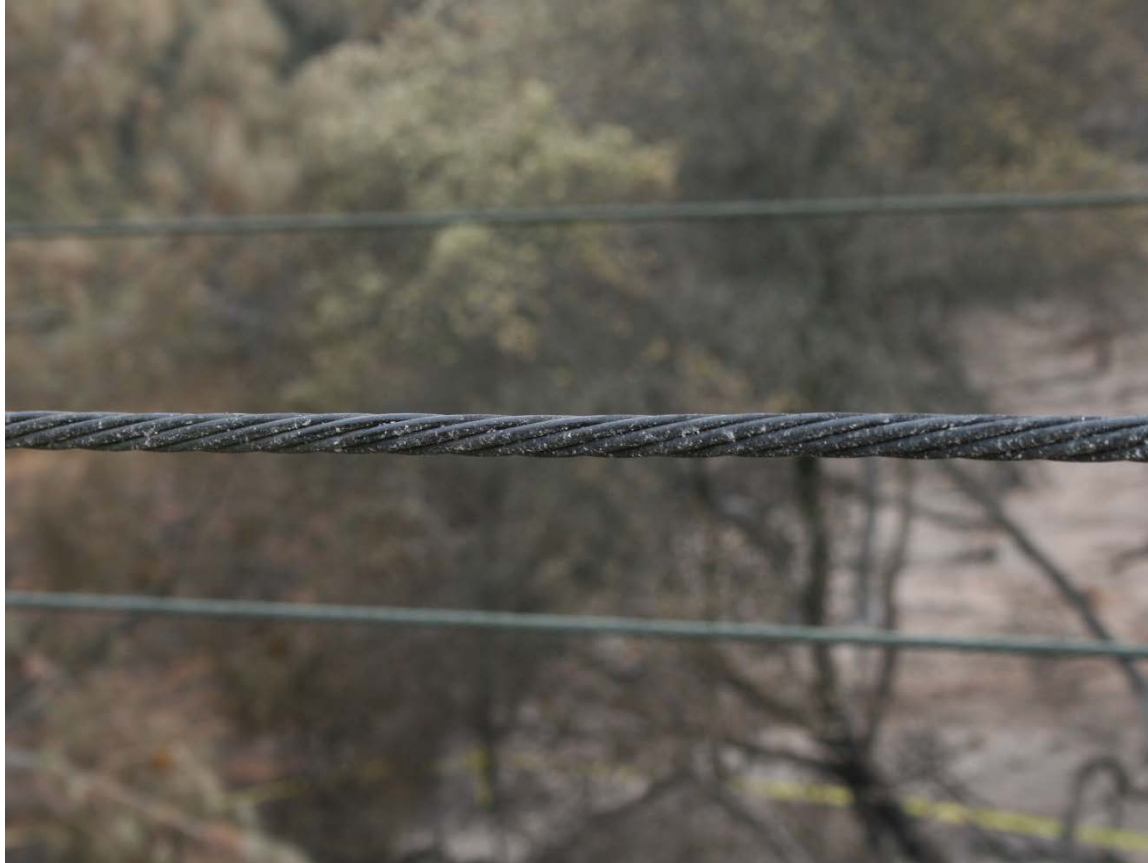
**Photo 41**

Continuing east along conductor, close up of northern most powerline conductor over the Specific Origin Area showing discoloration.

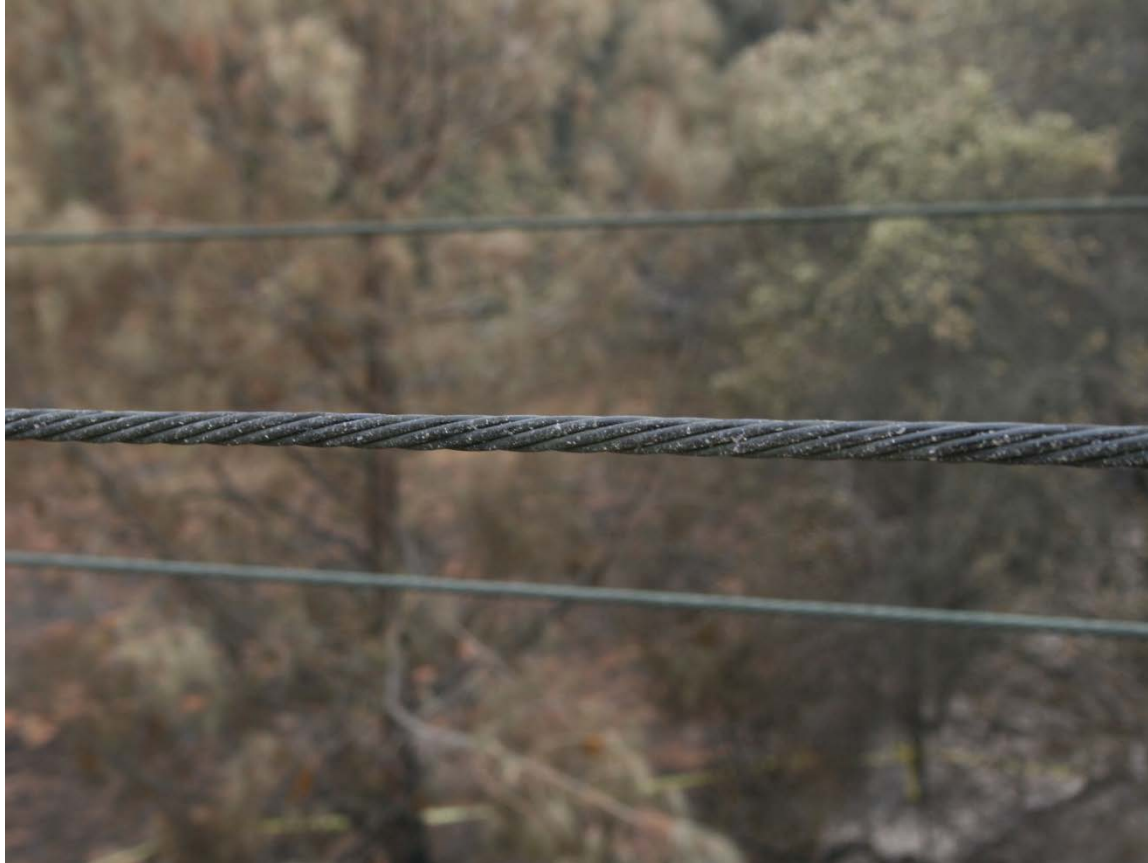
**Photo 42**

Continuing east along conductor, close up of northern most powerline conductor over the Specific Origin Area showing discoloration.

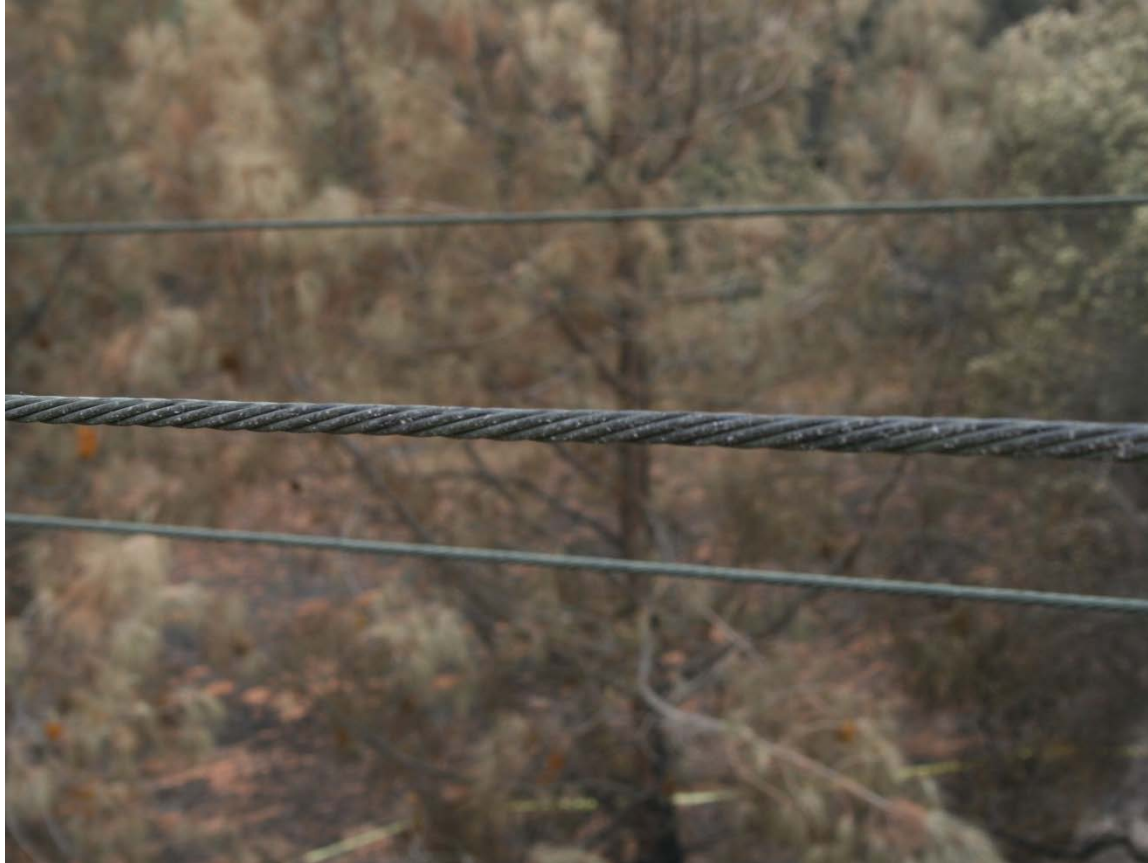
**Photo 43**

Continuing east along conductor, close up of northern most powerline conductor over the Specific Origin Area showing discoloration.

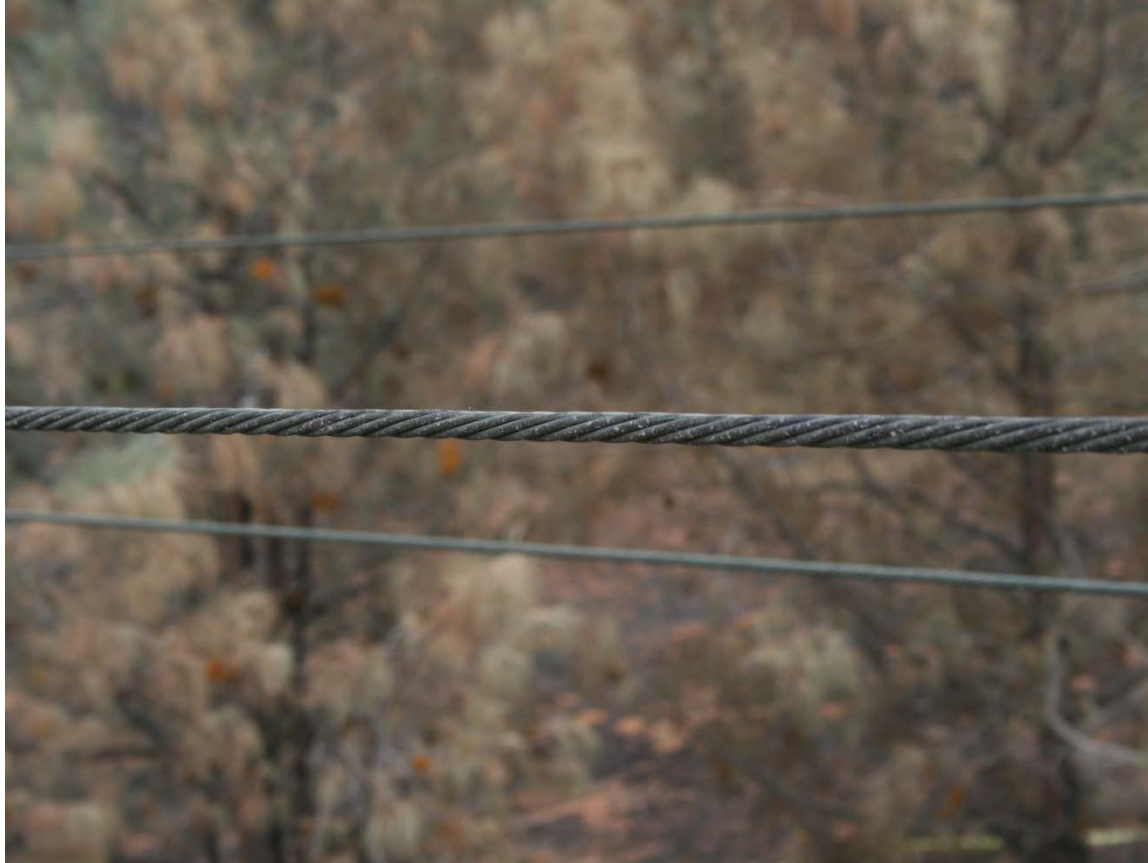
**Photo 44**

Continuing east along conductor, close up of northern most powerline conductor over the Specific Origin Area showing discoloration.

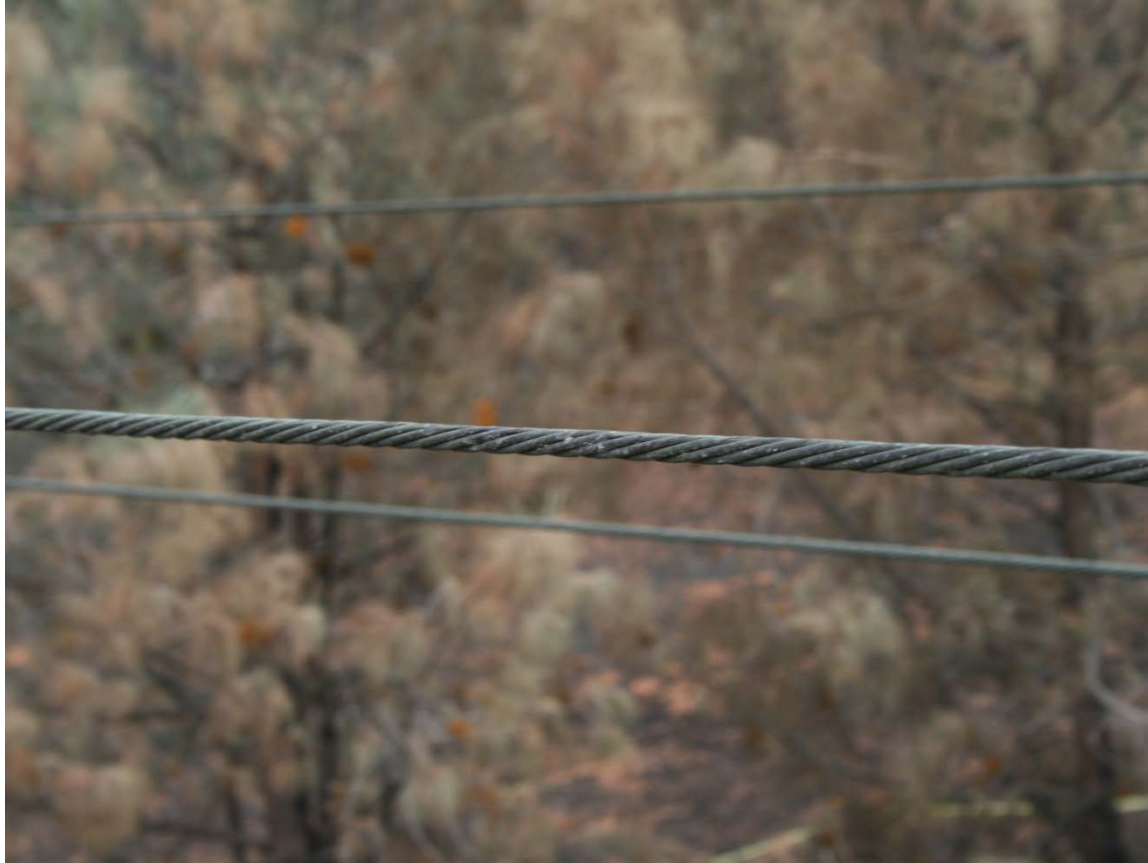
**Photo 45**

Continuing east along conductor, close up of northern most powerline conductor over the Specific Origin Area showing discoloration.

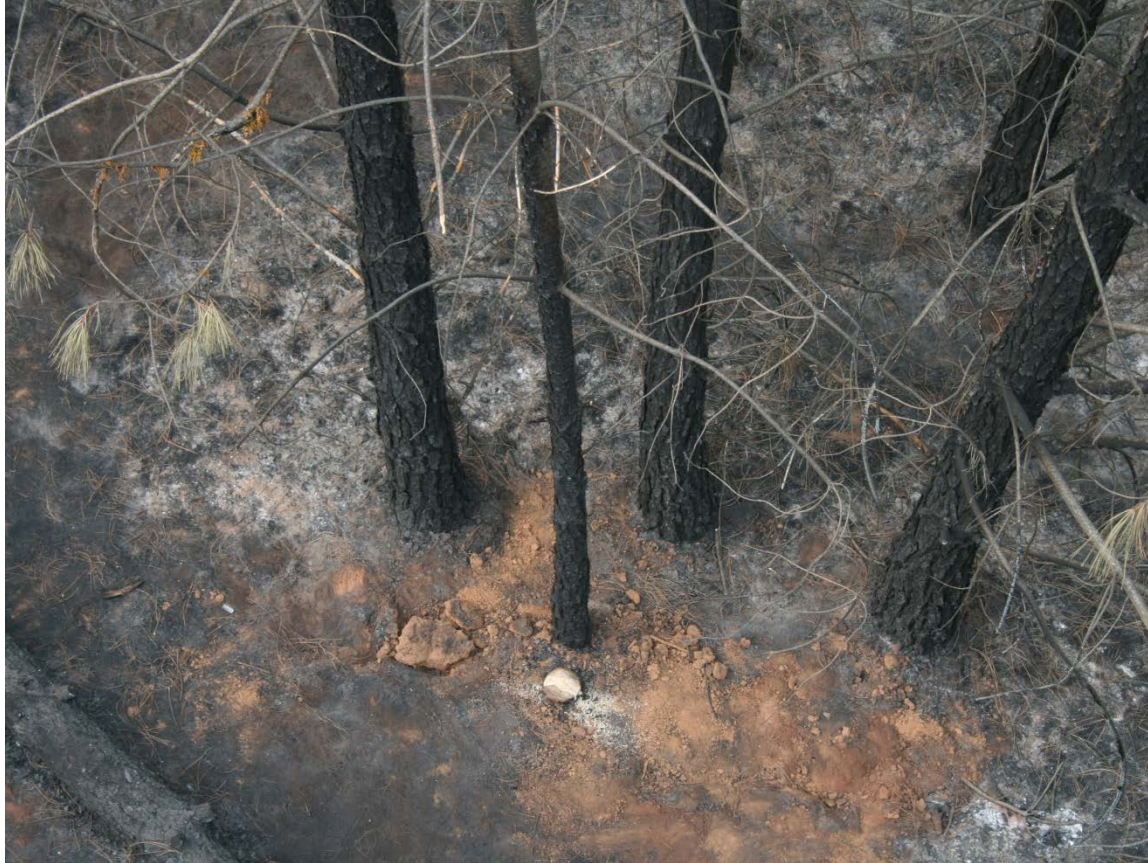
**Photo 47**

Overhead view of the remaining base (stump) of Evidence Item 1 and trees surrounding it on the north side.

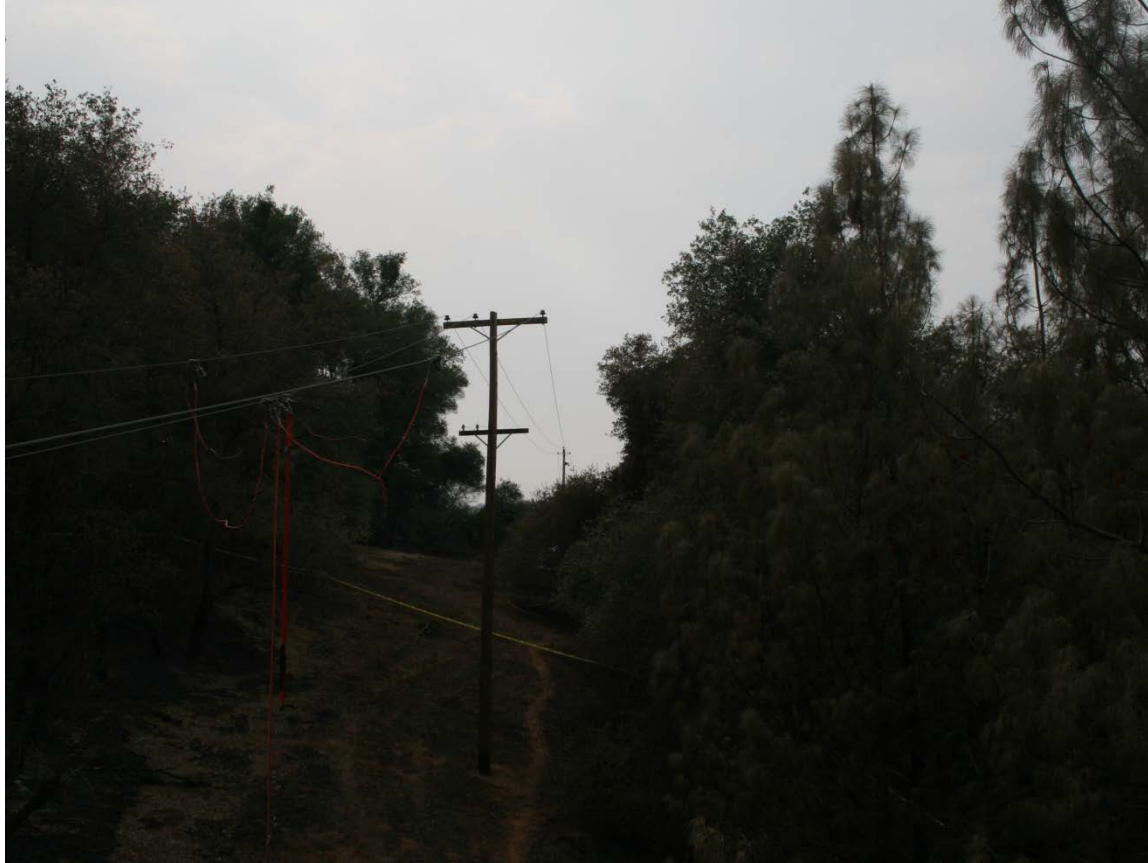
**Photo 54**

Facing west from the Specific Origin Area, view of powerlines from the PG&E bucket truck.
