**Butte Incident**

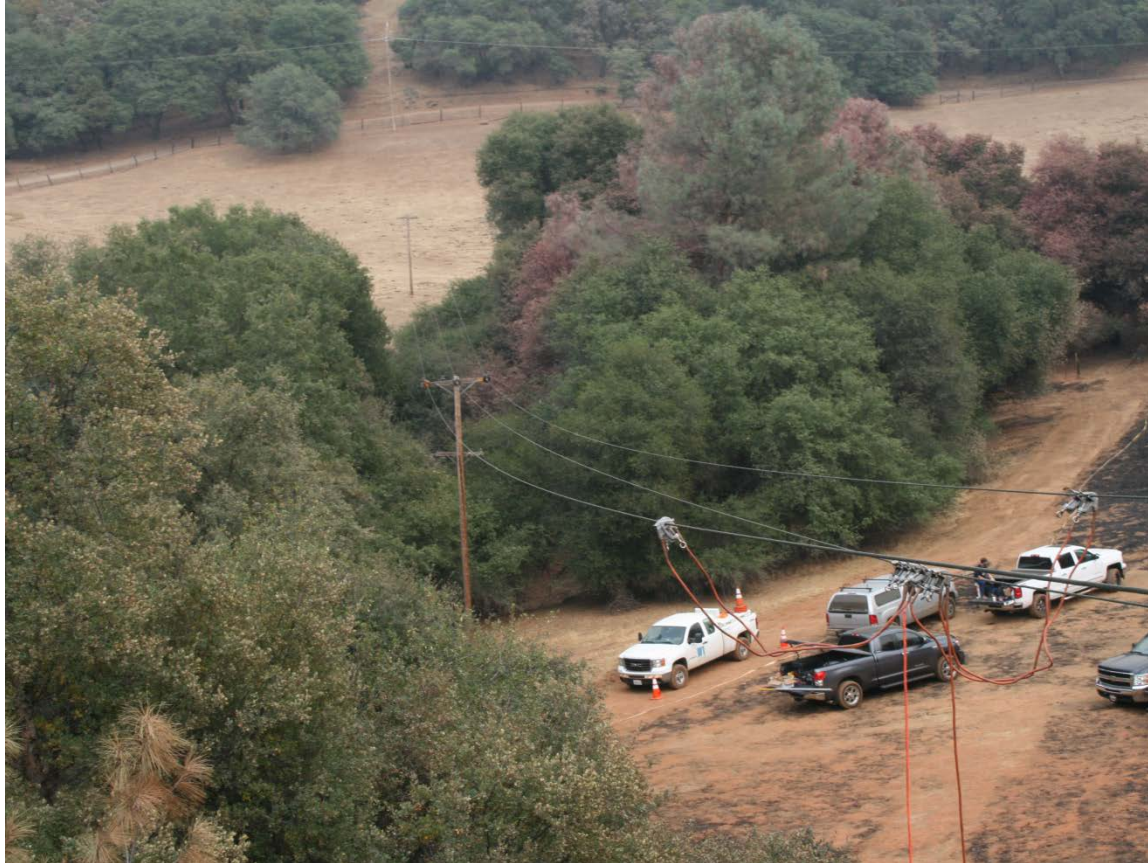
**Photo 55**

Facing east from the Specific Origin Area, view of the powerlines from the PG&E bucket truck.

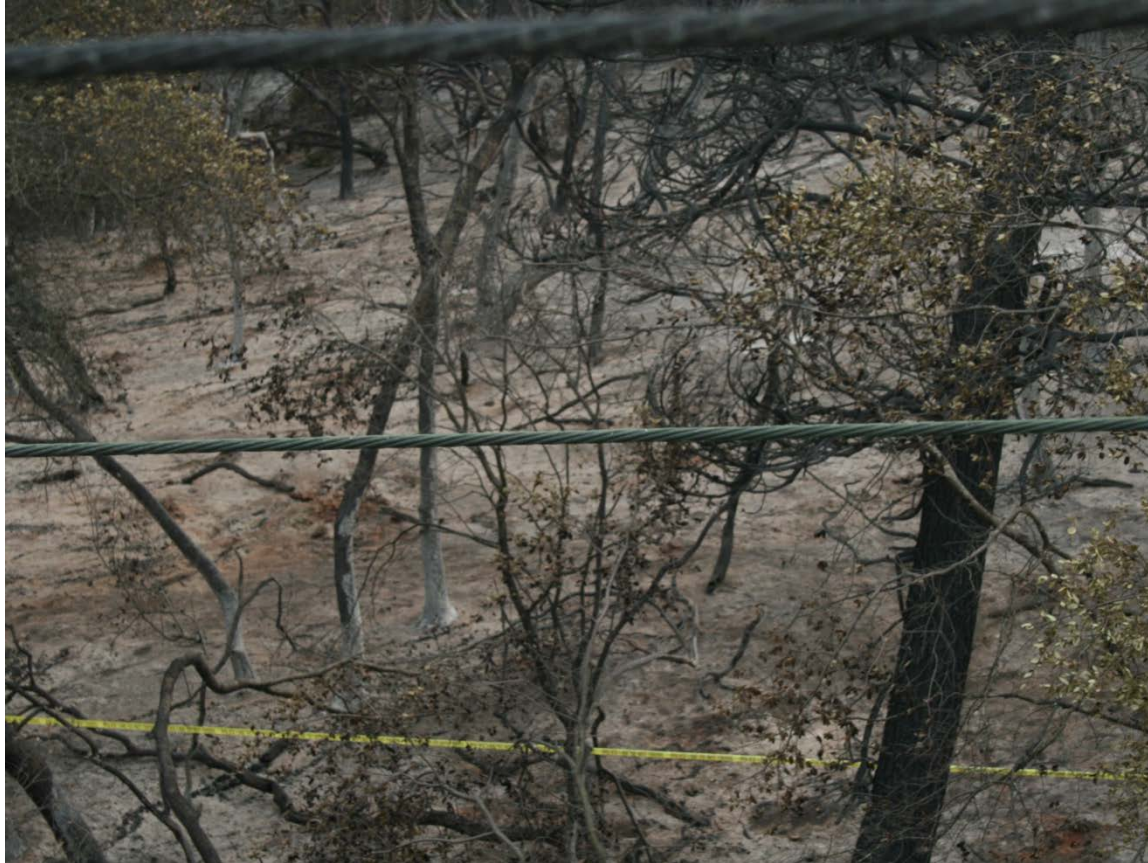
**Photo 56**

View of the center powerline conductor within the Specific Origin Area.  
No discoloration visible on the conductor.

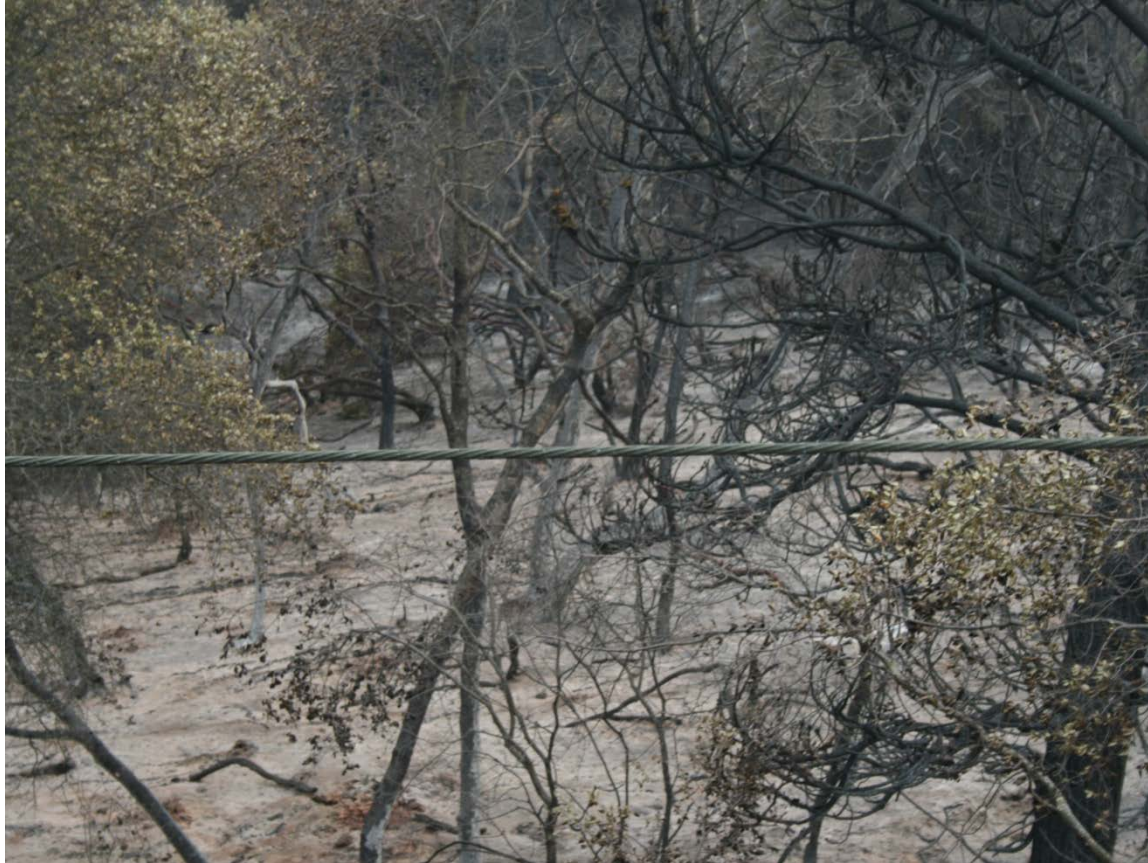
**Photo 57**

View of the southern most powerline conductor within the General Origin Area. No discoloration visible on the conductor.

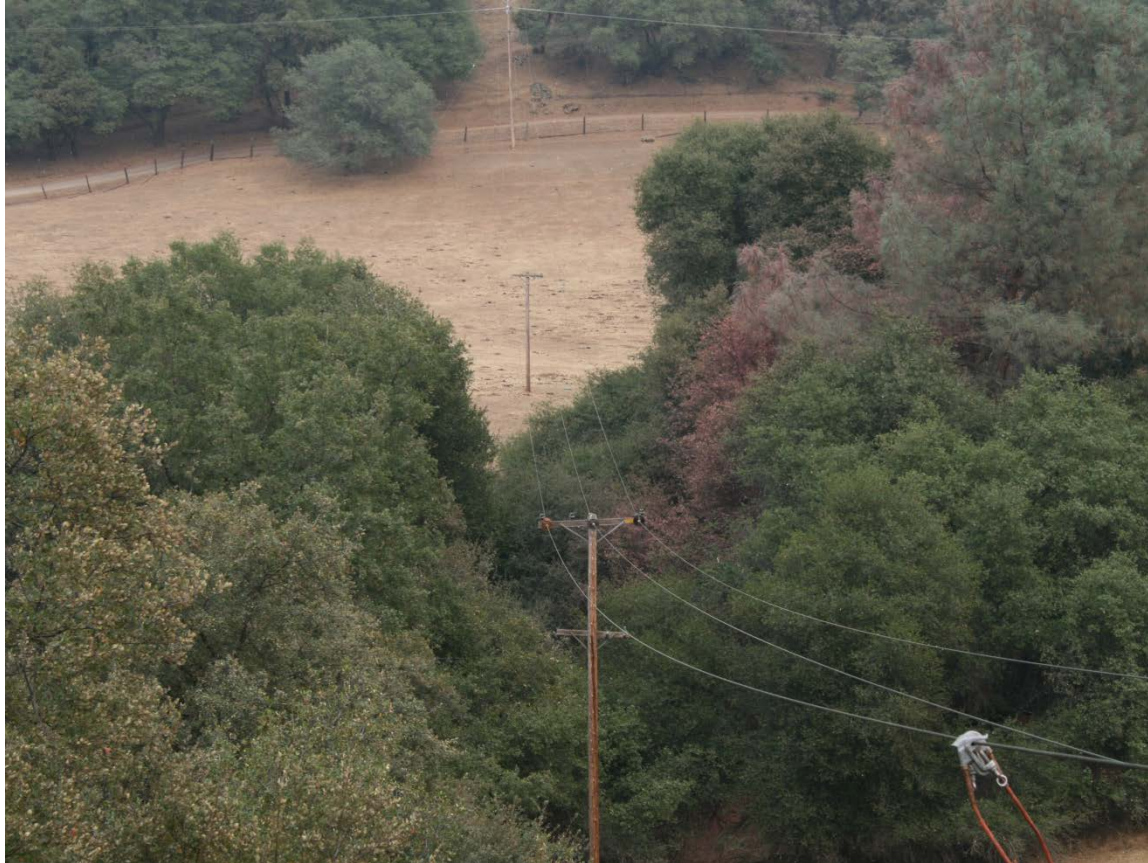
**Photo 58**

From the PG&E bucket truck, facing east, view of the powerlines from the Specific Origin Area towards Charamuga Ranch Road.

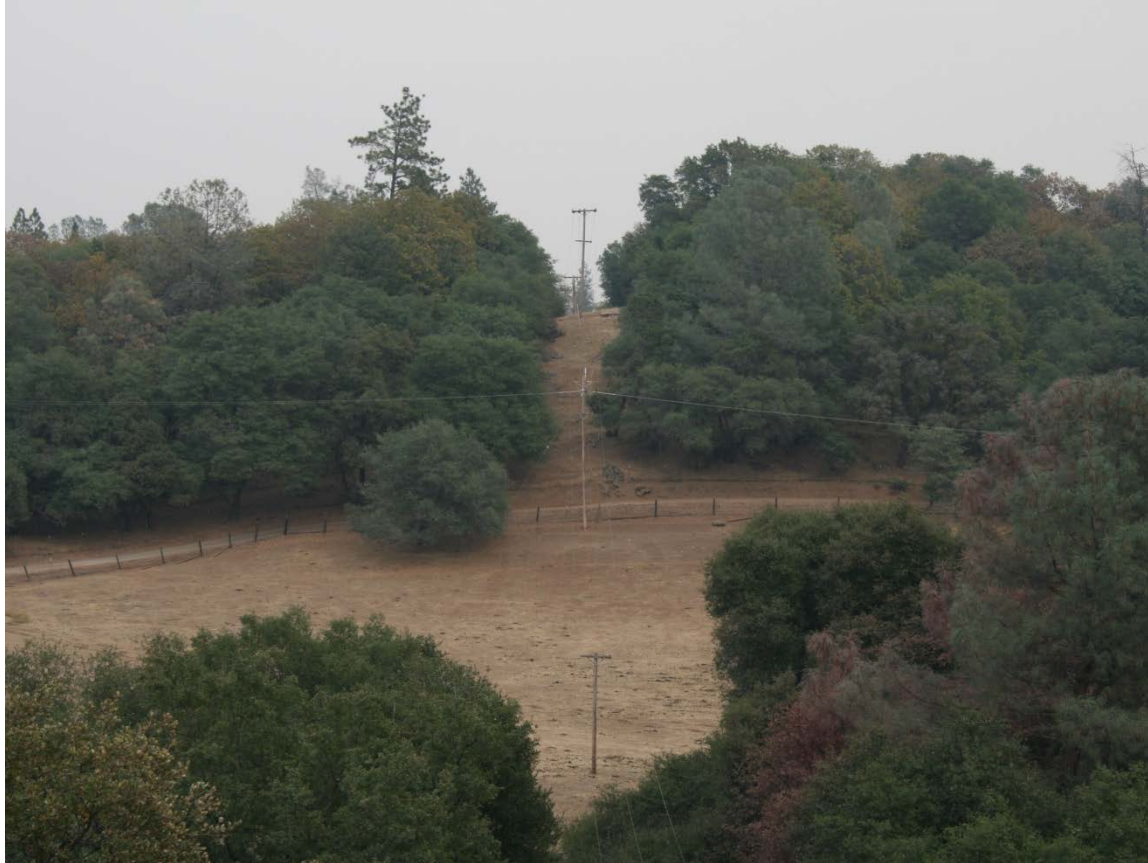
**Photo 59**

View of powerlines continuing east across Charamuga Ranch Road.

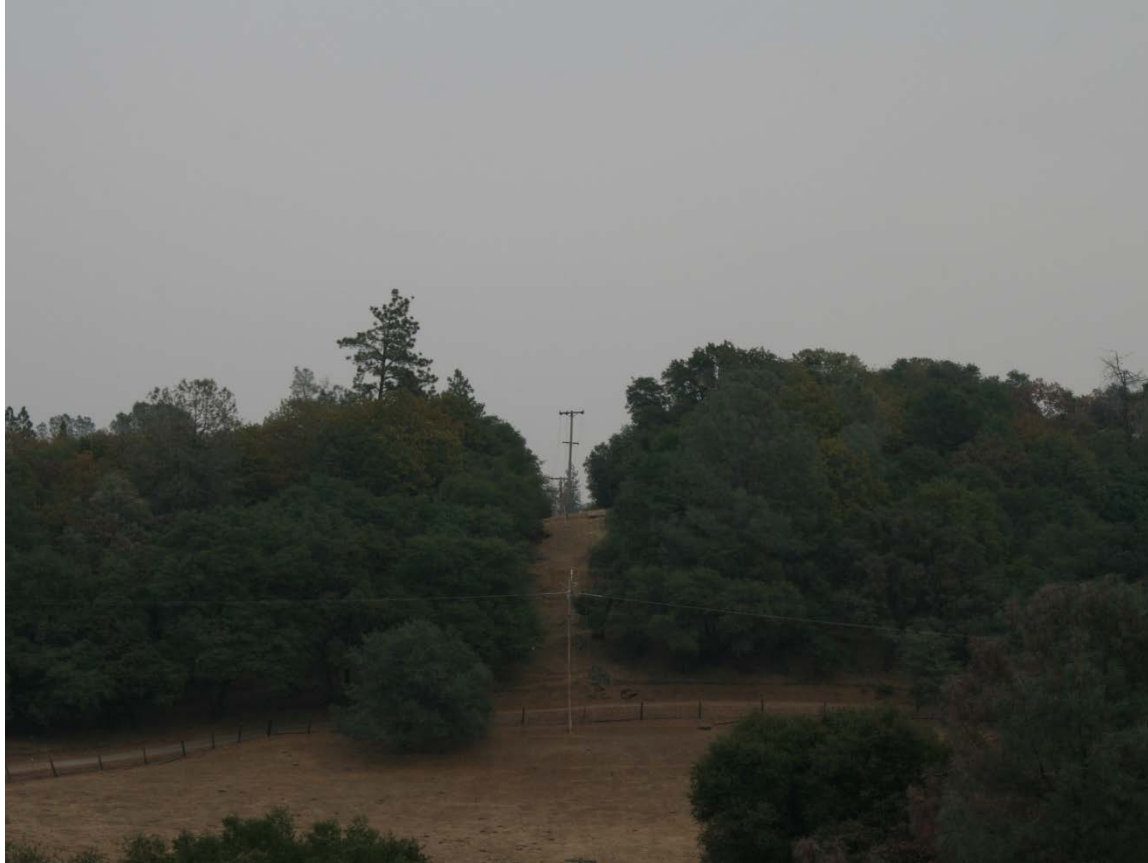
**Photo 60**

View of powerlines continuing east across Charamuga Ranch Road.

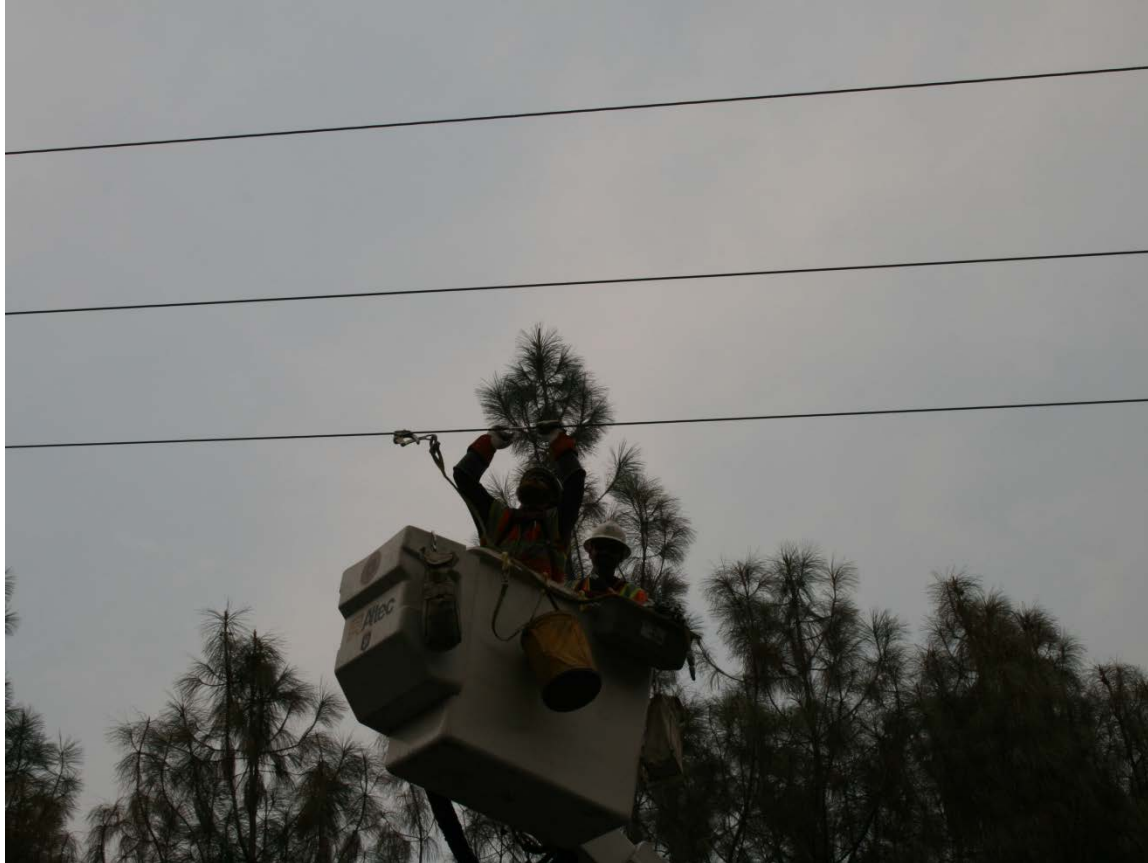
**Photo 61**

PG&E crew removing section of northern most powerline conductor over the SOA, Evidence Item #3.

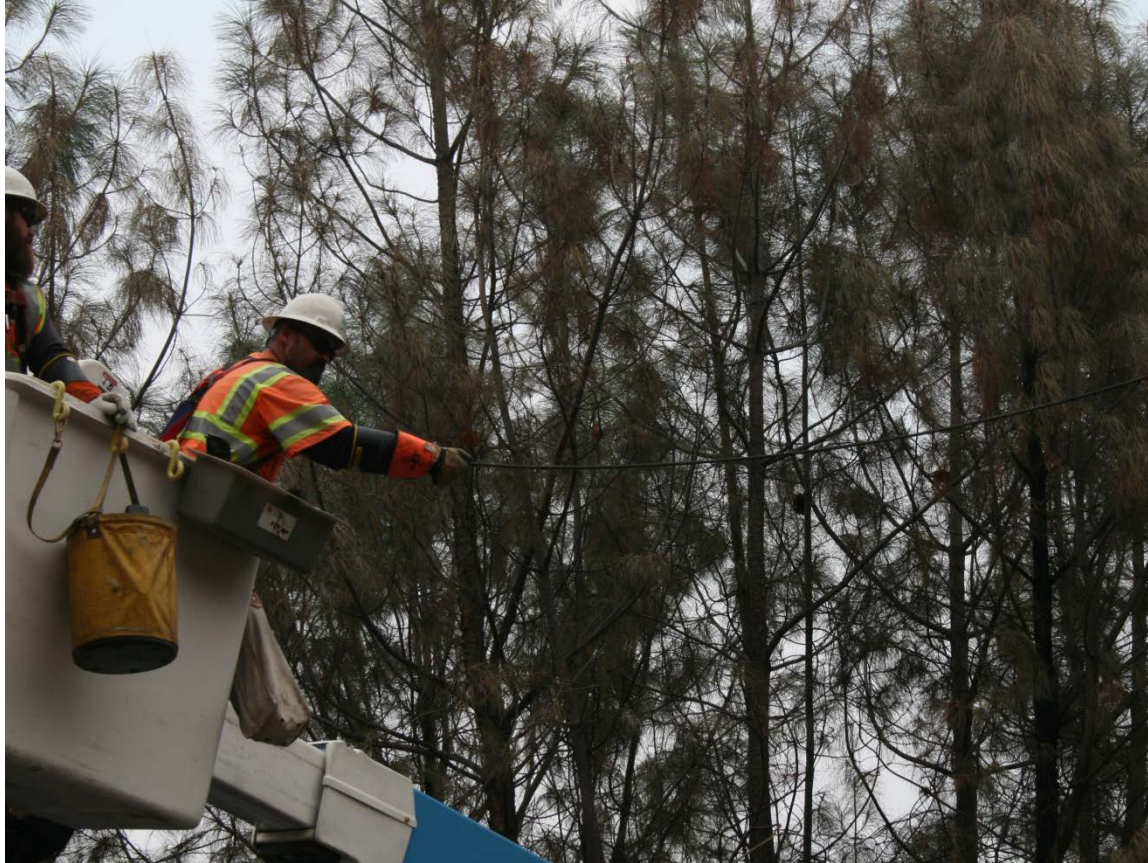
**Photo 62**

PG&E crew removing section of northern most powerline conductor over the SOA, Evidence Item #3.

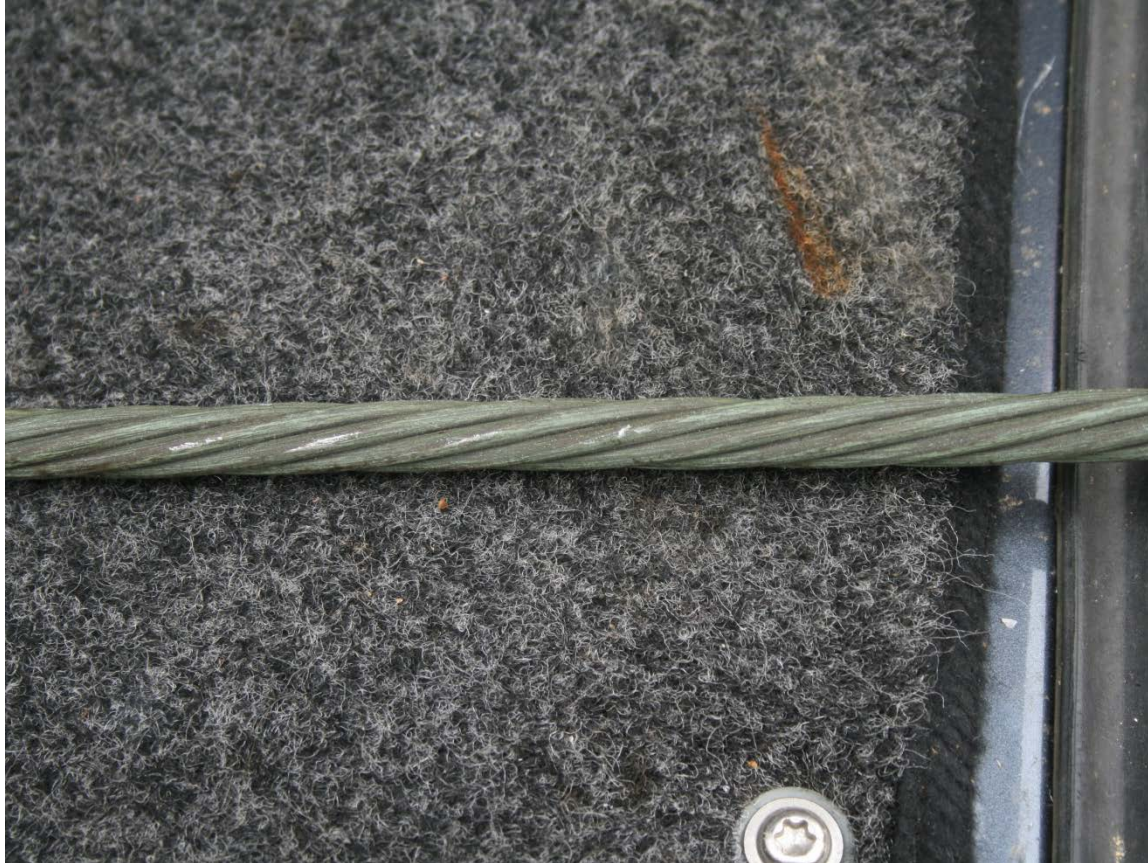
**Photo 63**

Close up of powerline conductor (Evidence Item 3). Series of photos starting from west end of item moving east.

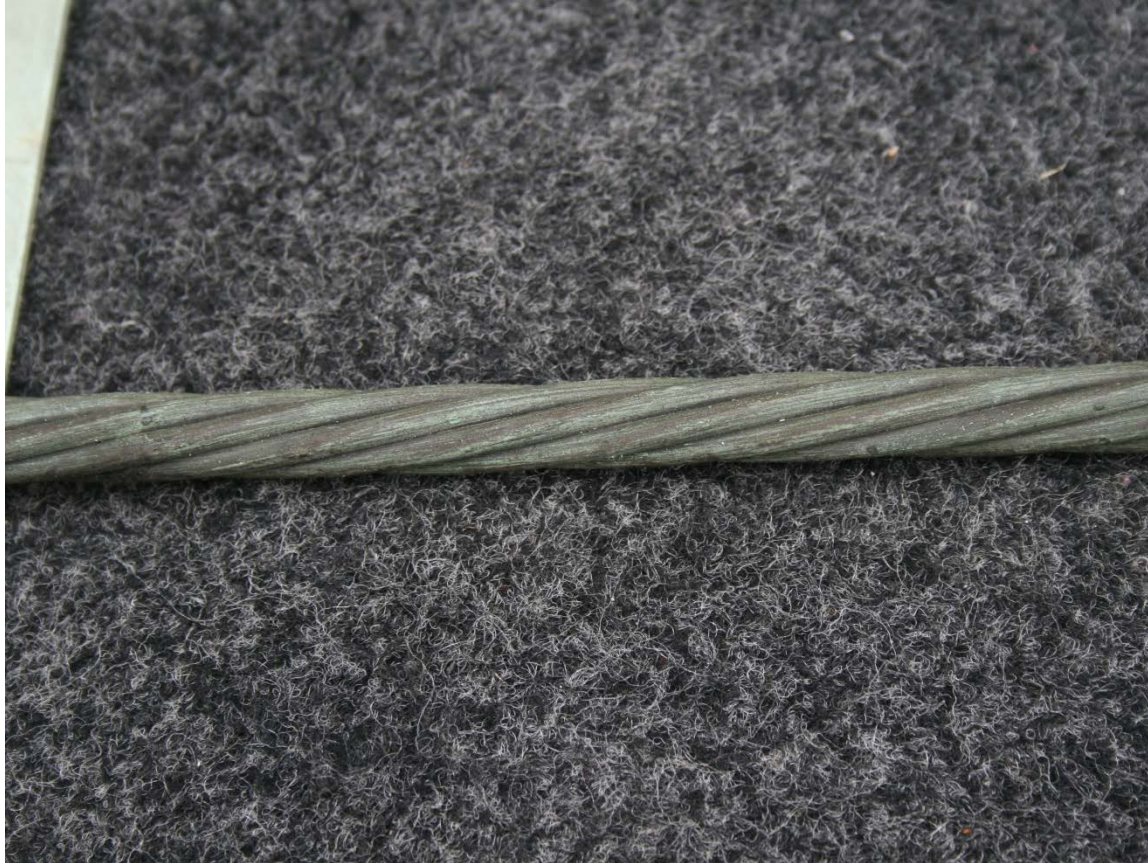
**Photo 64**

Close up of powerline conductor (Evidence Item 3). Series of photos starting from west end of item moving east.

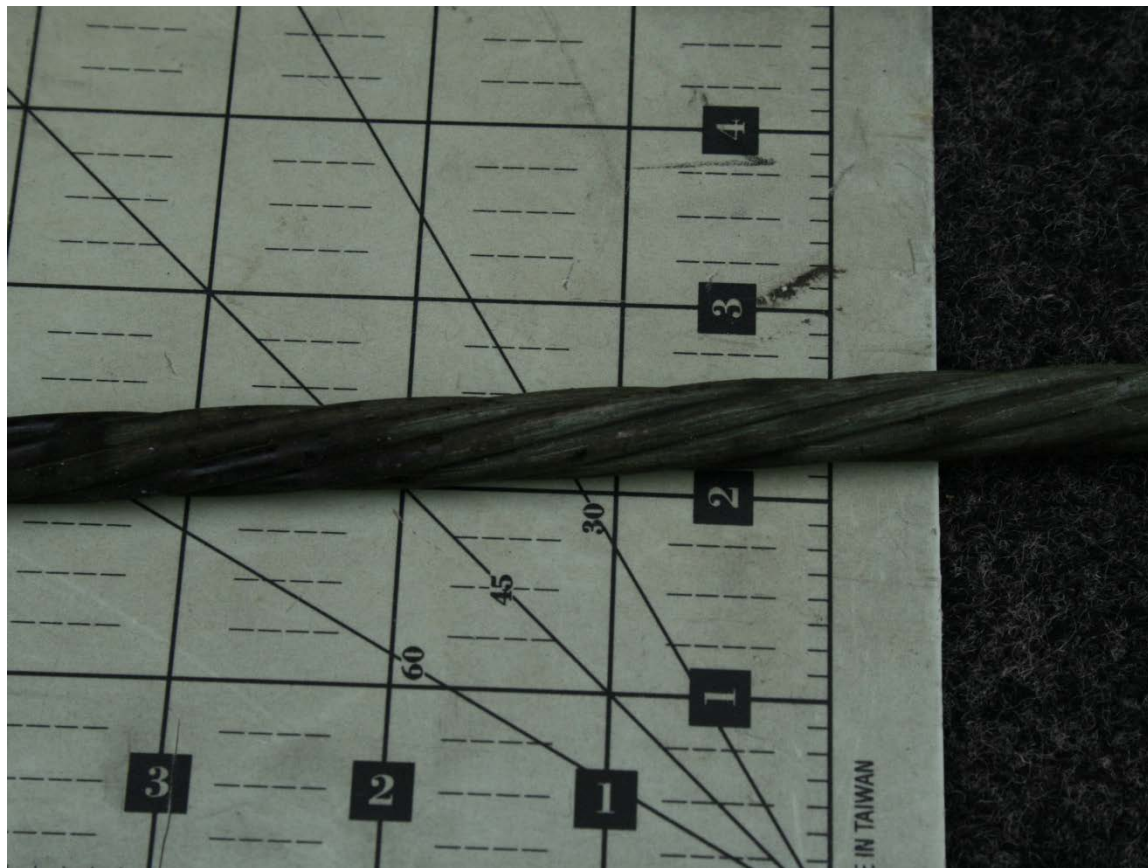
**Photo 65**

Close up of powerline conductor (Evidence Item 3). Series of photos starting from west end of item moving east. Discoloration visible on conductor.

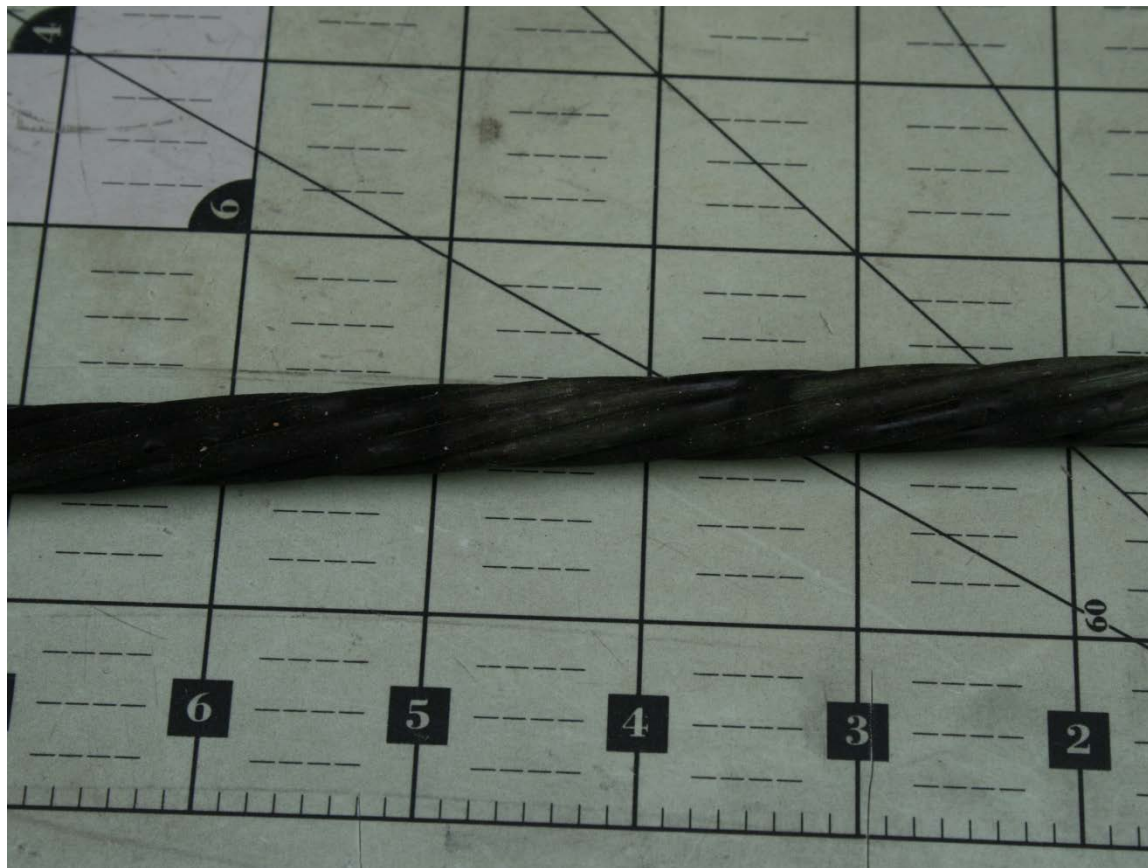
**Photo 66**

Close up of powerline conductor (Evidence Item 3). Series of photos starting from west end of item moving east. Discoloration visible on conductor.

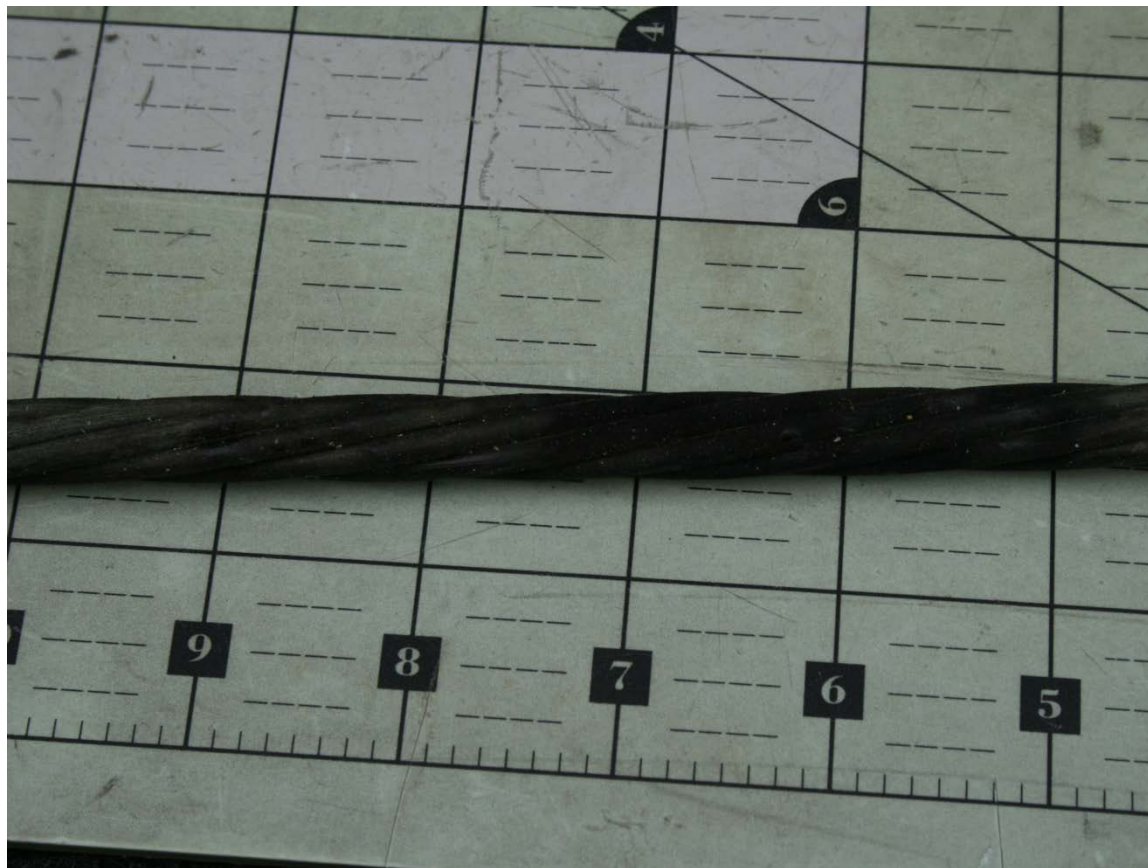
**Photo 67**

Close up of powerline conductor (Evidence Item 3). Series of photos starting from west end of item moving east. Discoloration visible on conductor.

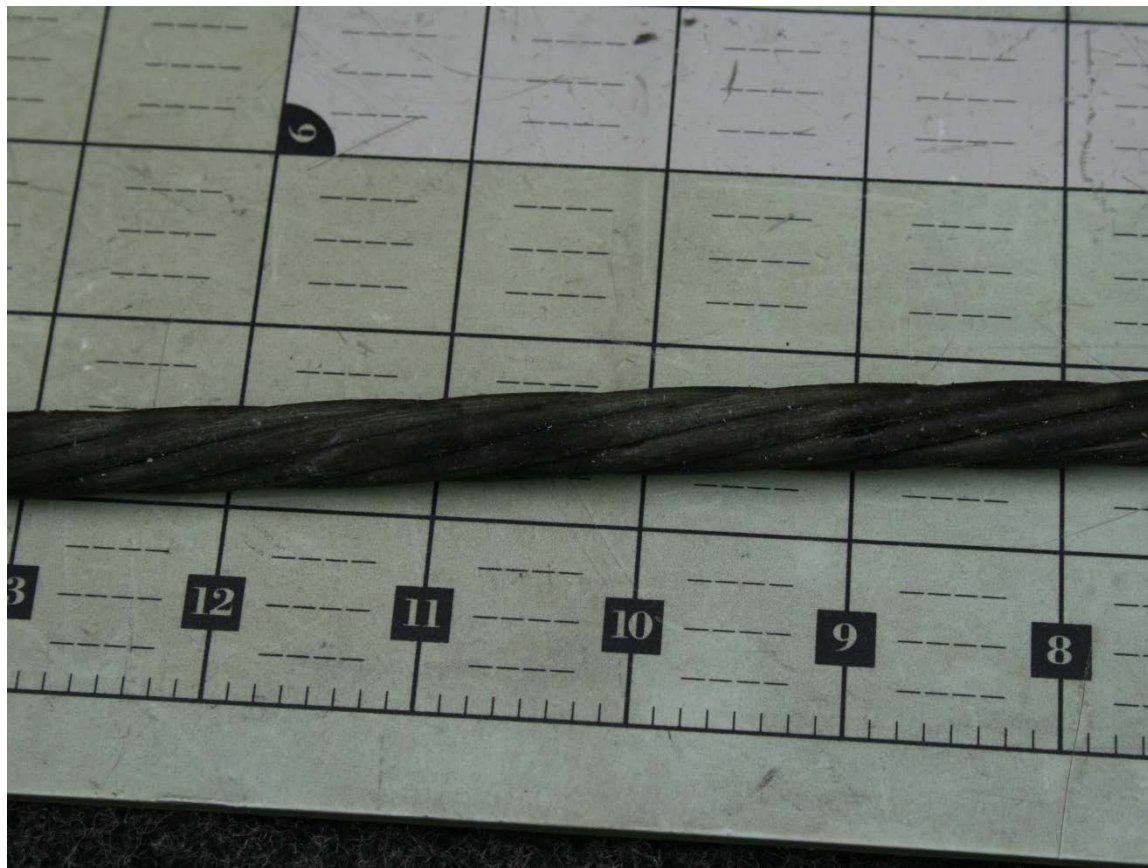
**Photo 68**

Close up of powerline conductor (Evidence Item 3). Series of photos starting from west end of item moving east. Discoloration visible on conductor.

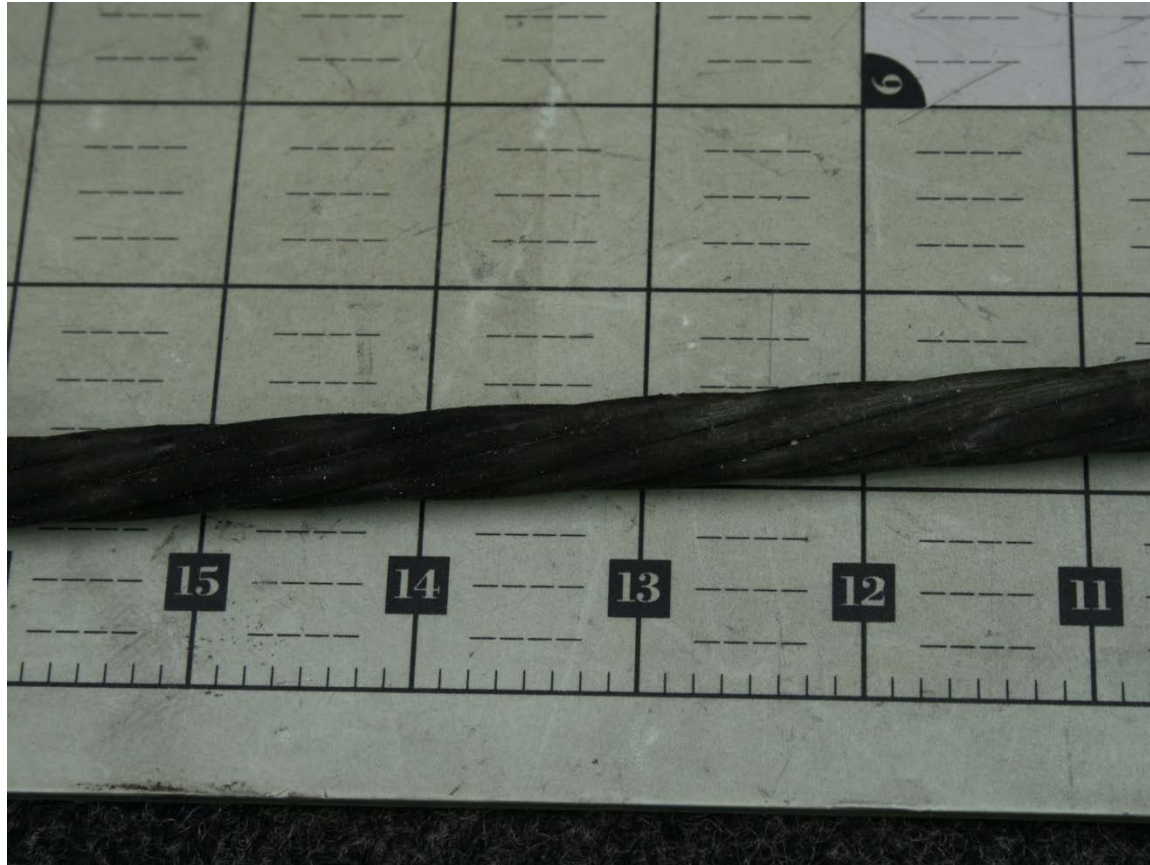
**Photo 69**

Close up of powerline conductor (Evidence Item 3). Series of photos starting from west end of item moving east. Discoloration visible on conductor.

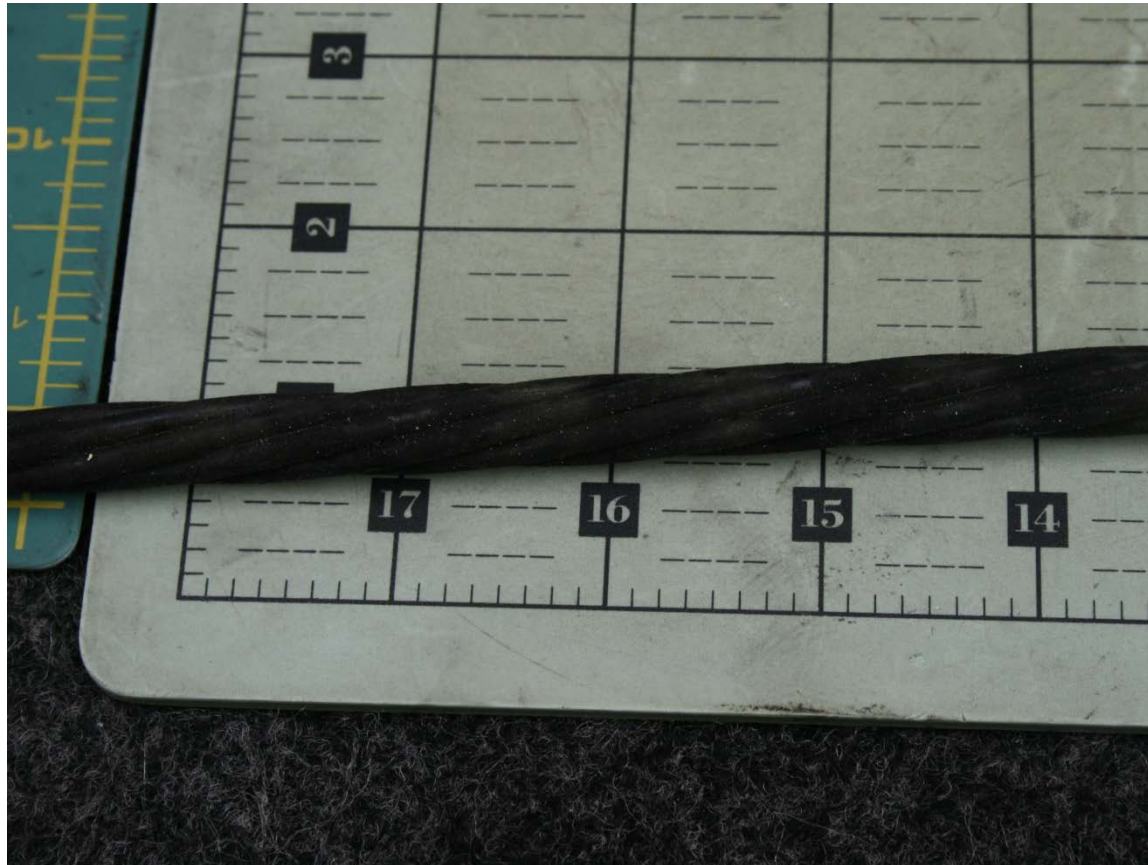
**Photo 70**

Close up of powerline conductor (Evidence Item 3). Series of photos starting from west end of item moving east. Discoloration visible on conductor.

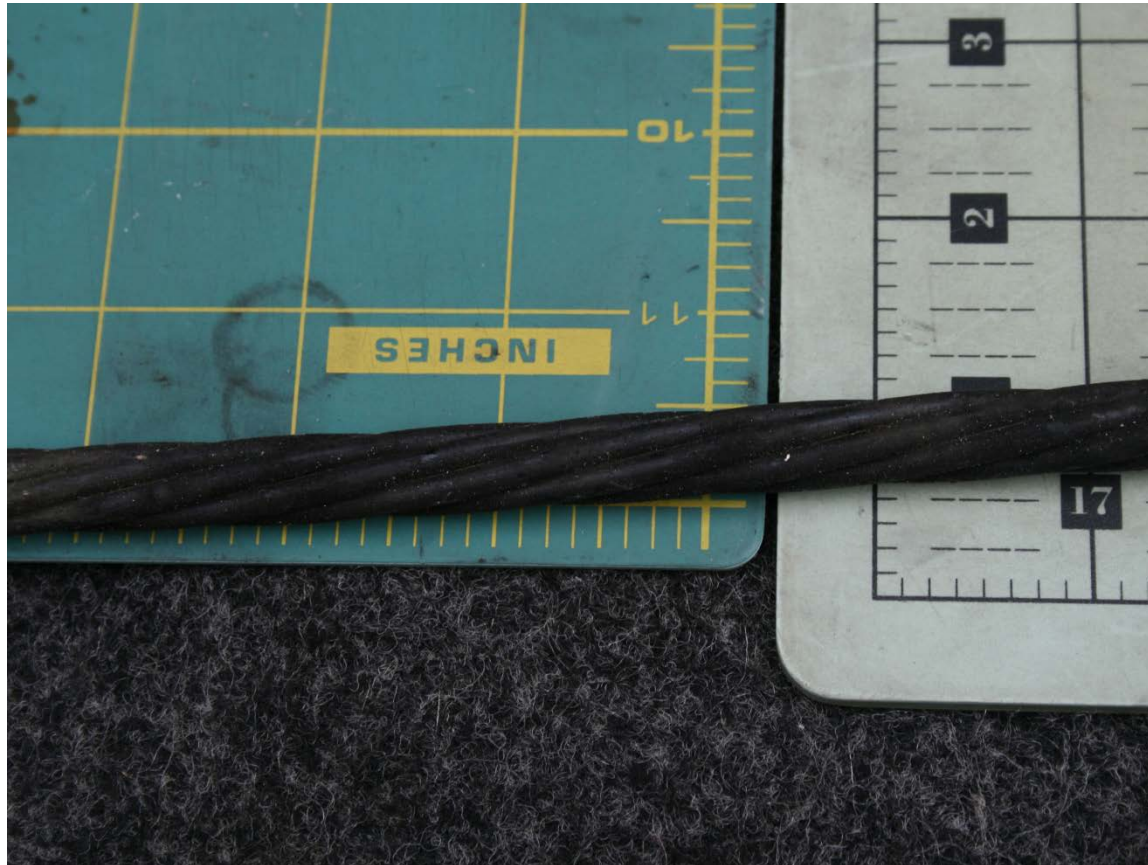
**Photo 71**

Close up of powerline conductor (Evidence Item 3). Series of photos starting from west end of item moving east. Discoloration visible on conductor.

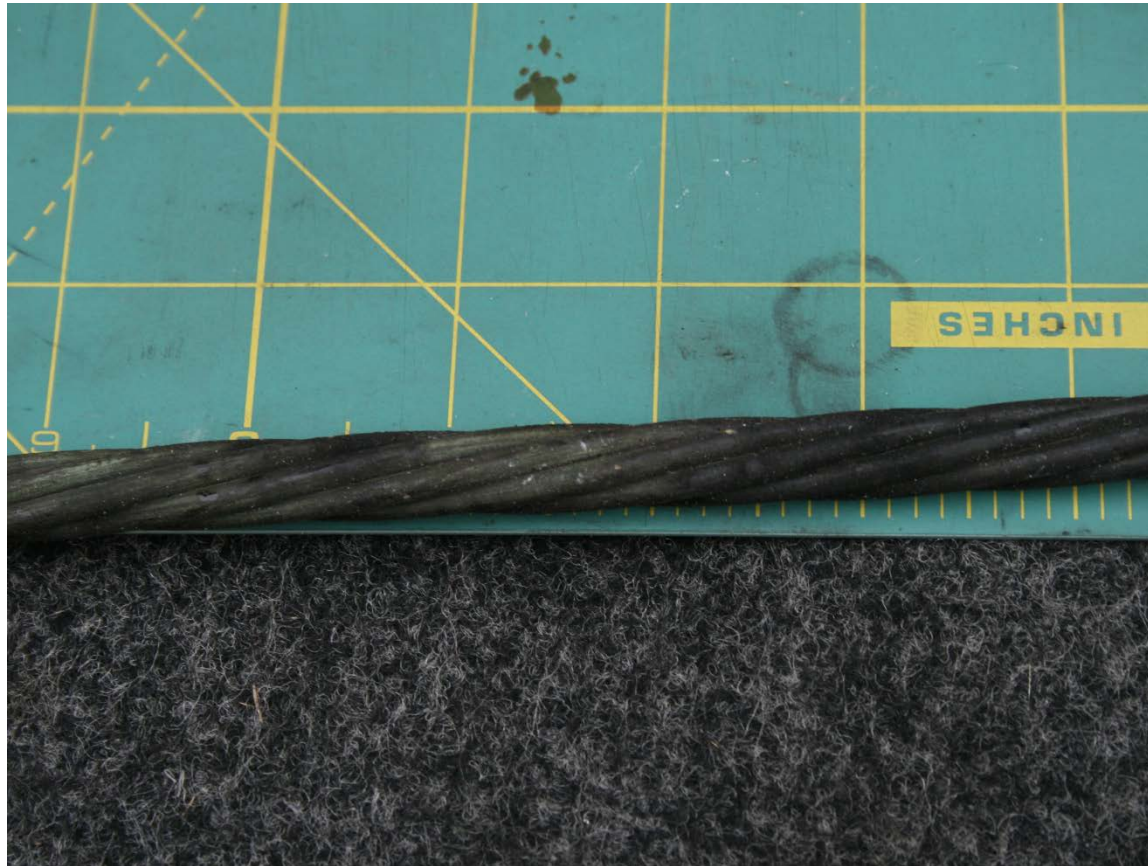
**Photo 72**

Close up of powerline conductor (Evidence Item 3). Series of photos starting from west end of item moving east. Discoloration visible on conductor.

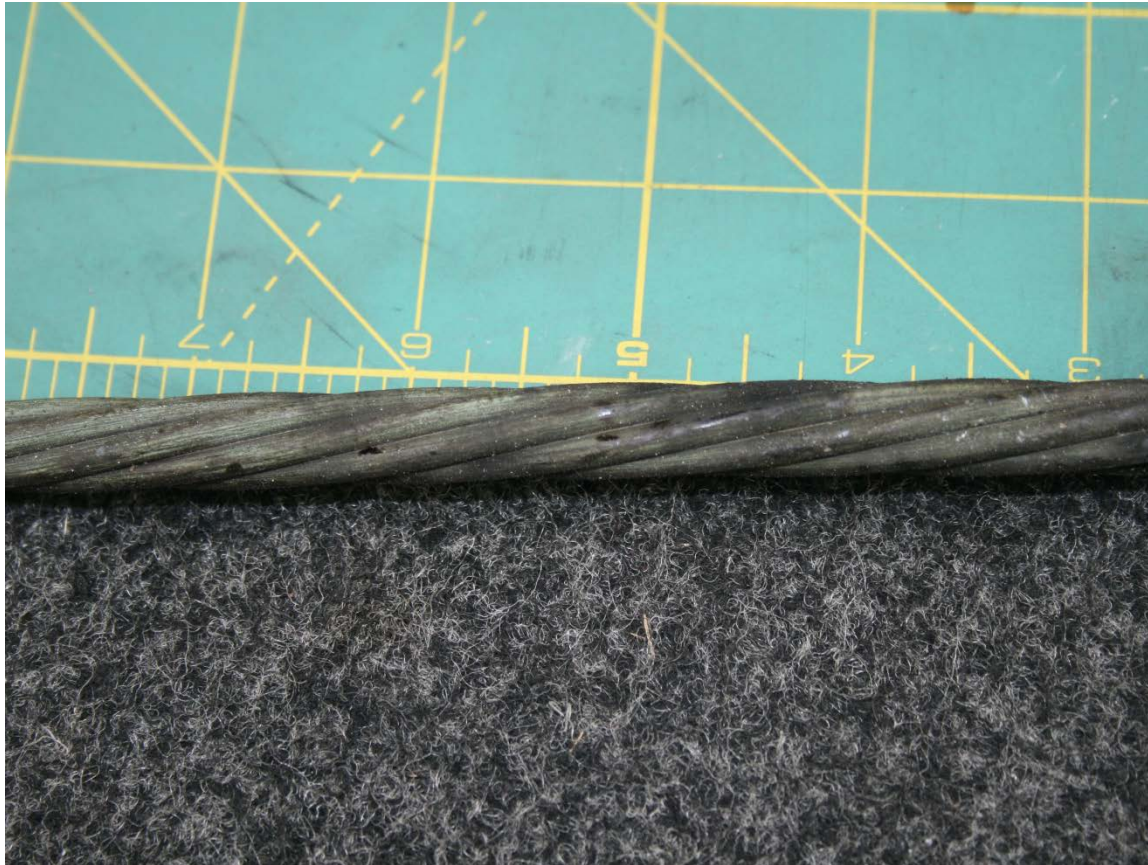
**Photo 73**

Close up of powerline conductor (Evidence Item 3). Series of photos starting from west end of item moving east. Discoloration visible on conductor.

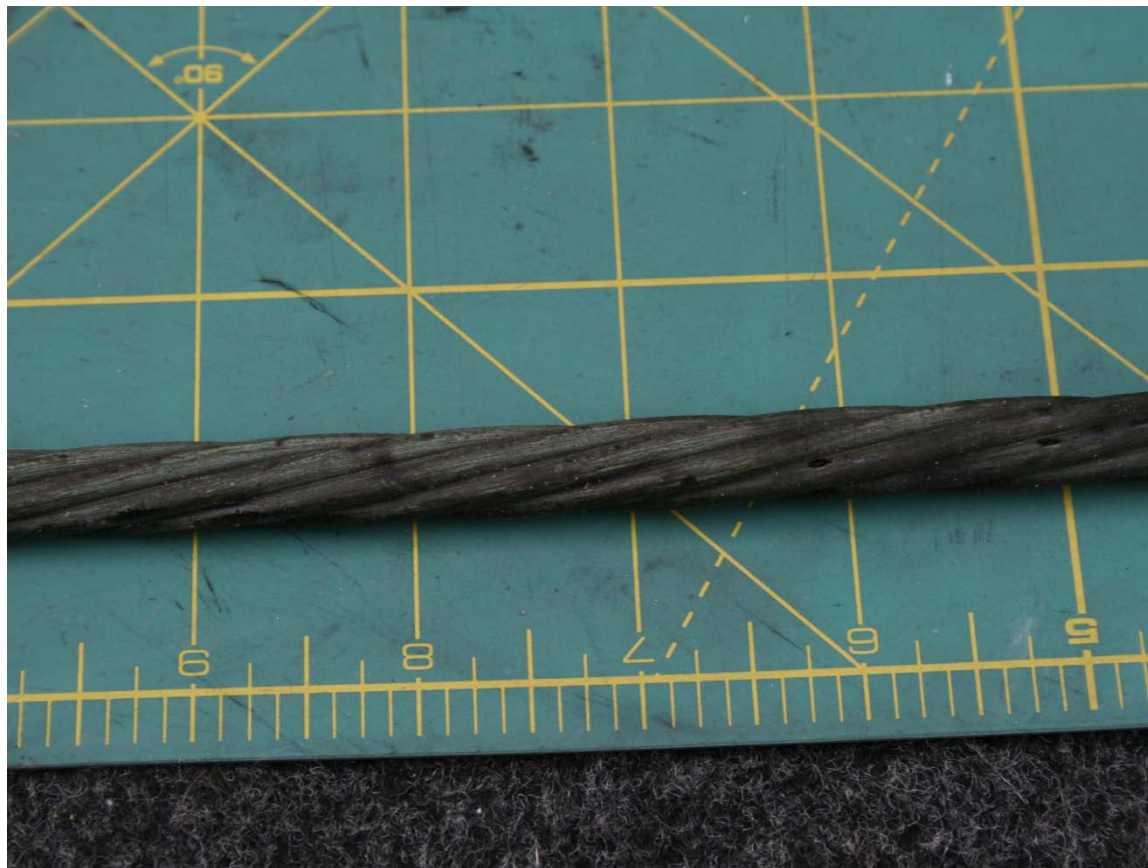
**Photo 74**

Close up of powerline conductor (Evidence Item 3). Series of photos starting from west end of item moving east. Discoloration visible on conductor.

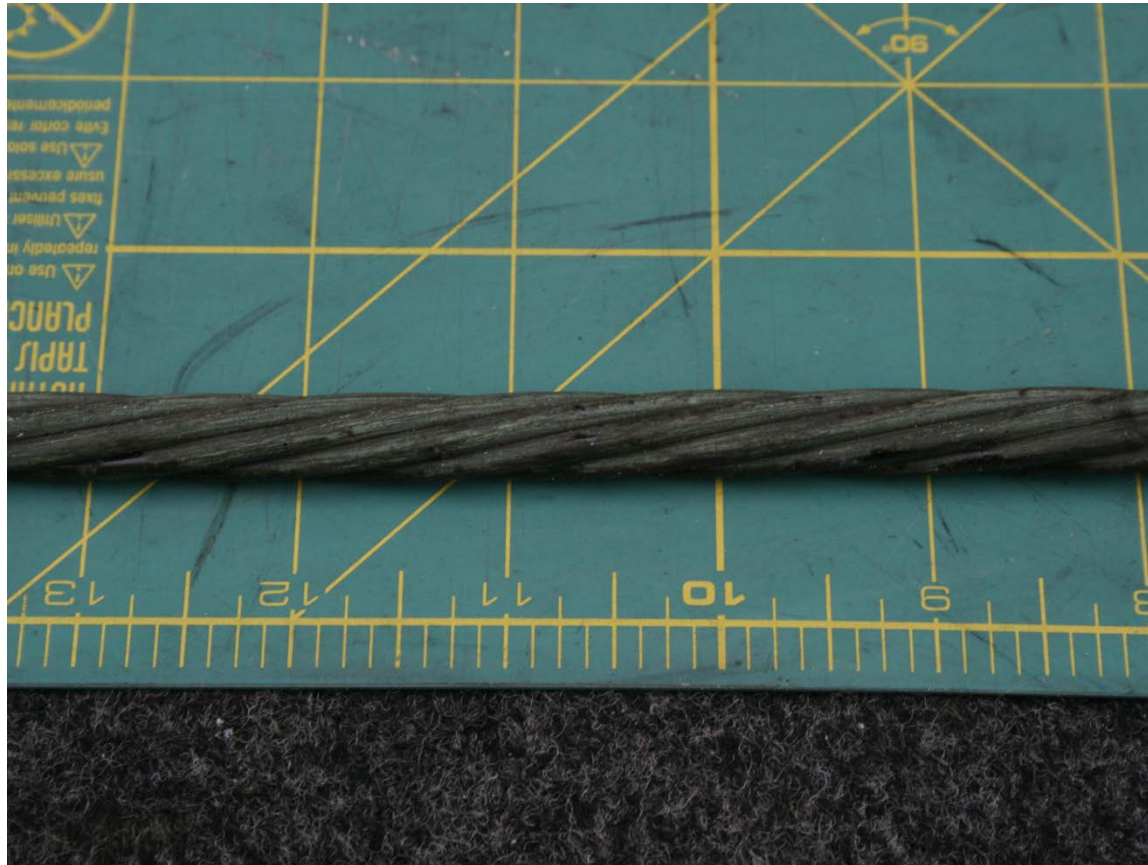
**Photo 75**

Close up of powerline conductor (Evidence Item 3). Series of photos starting from west end of item moving east. Discoloration visible on conductor.

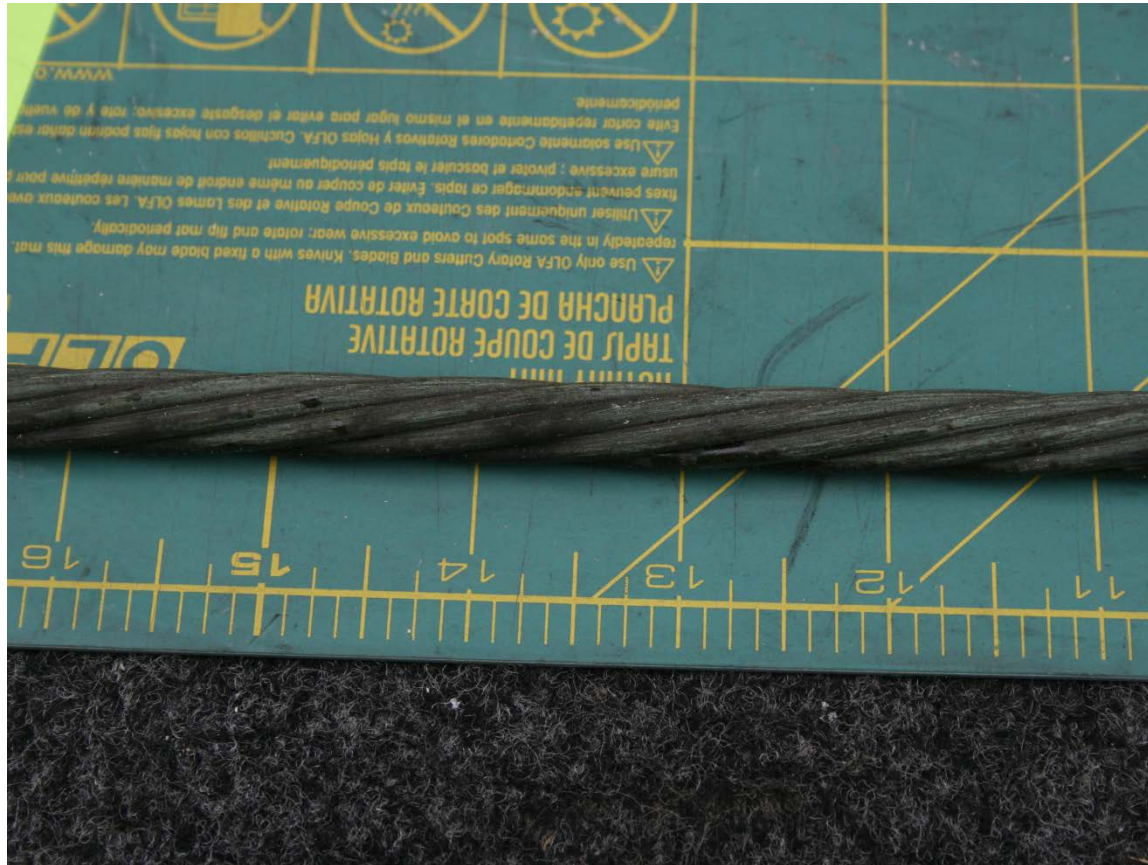
**Photo 76**

Close up of powerline conductor (Evidence Item 3). Series of photos starting from west end of item moving east. Discoloration visible on conductor.
