**Butte Incident**

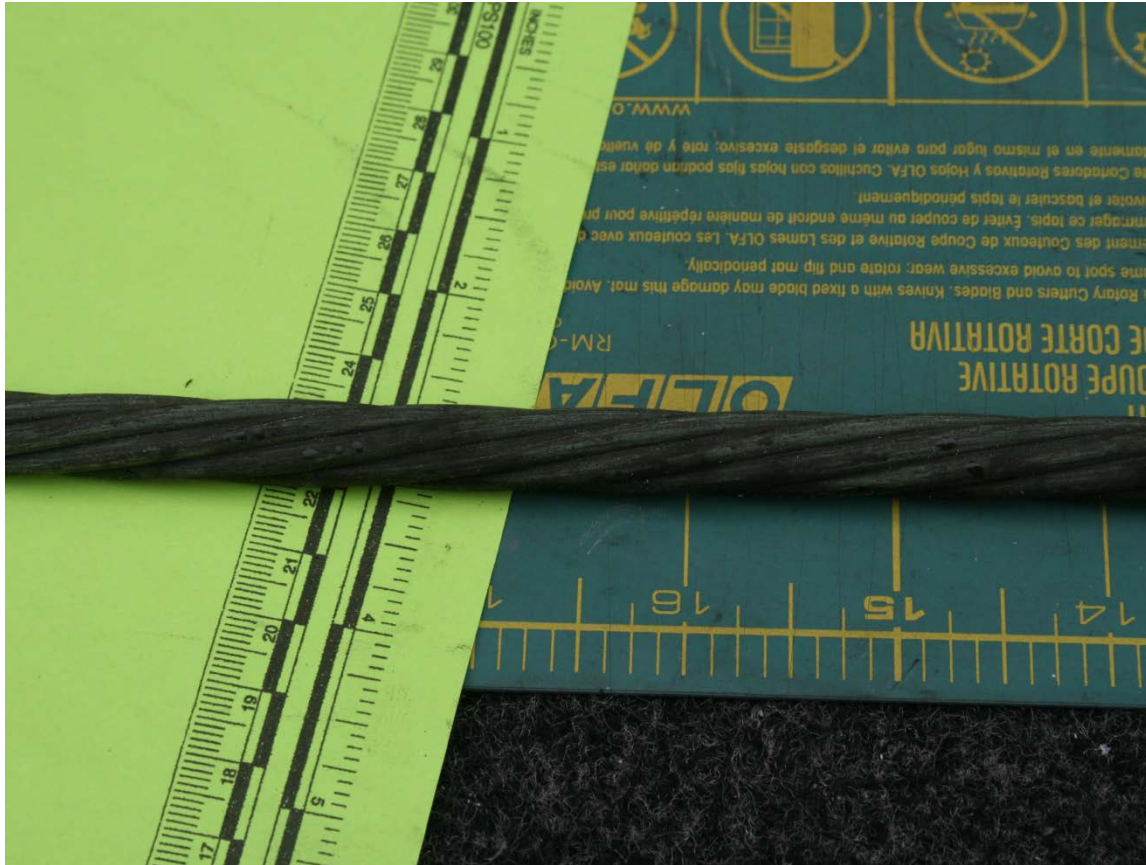
**Photo 77**

Close up of powerline conductor (Evidence Item 3). Series of photos starting from west end of item moving east. Discoloration visible on conductor.

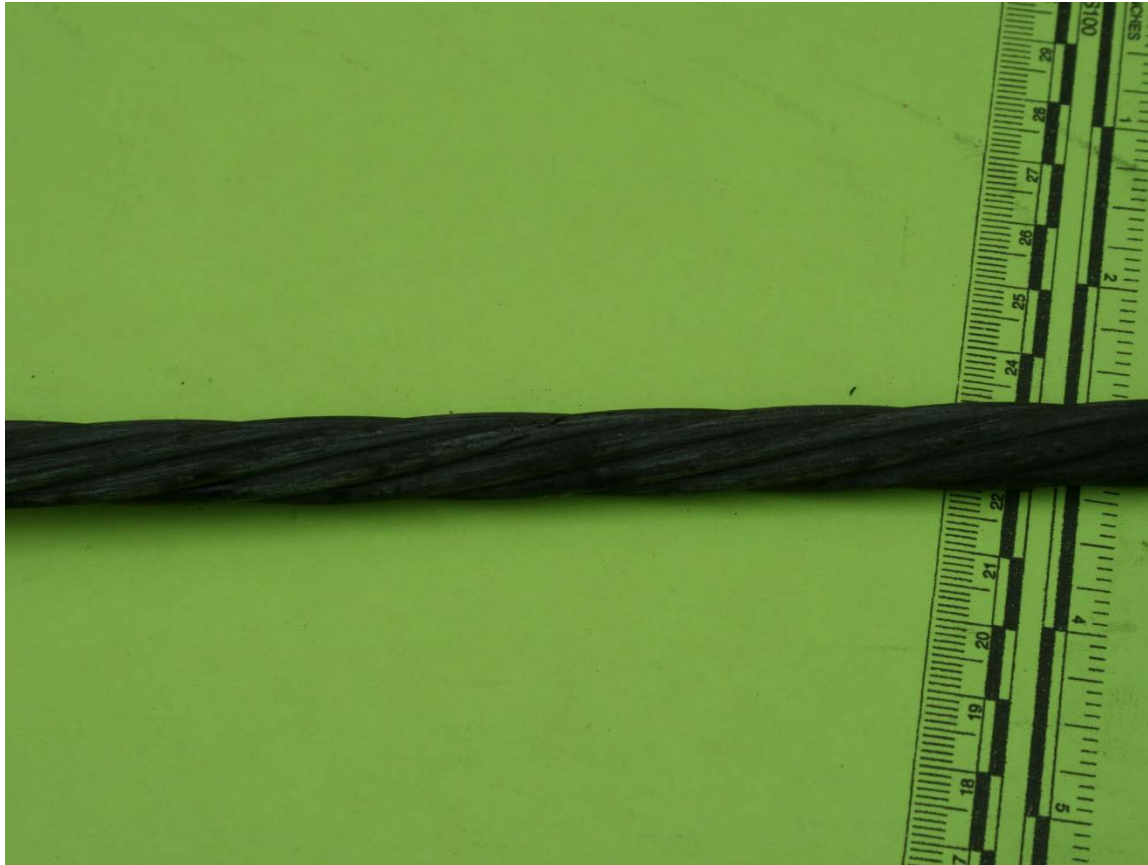
**Photo 78**

Close up of powerline conductor (Evidence Item 3). Series of photos starting from west end of item moving east. Discoloration visible on conductor.

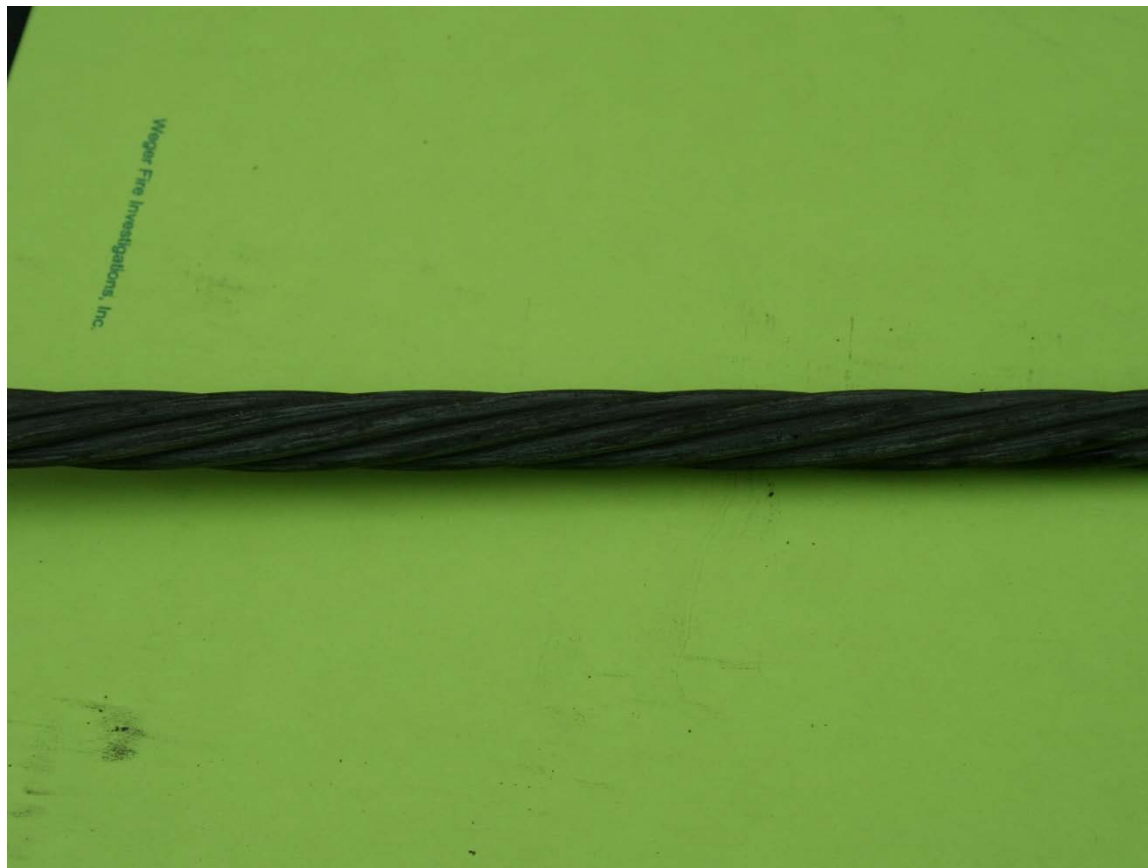
**Photo 79**

Close up of powerline conductor (Evidence Item 3). Series of photos starting from west end of item moving east. Discoloration visible on conductor.

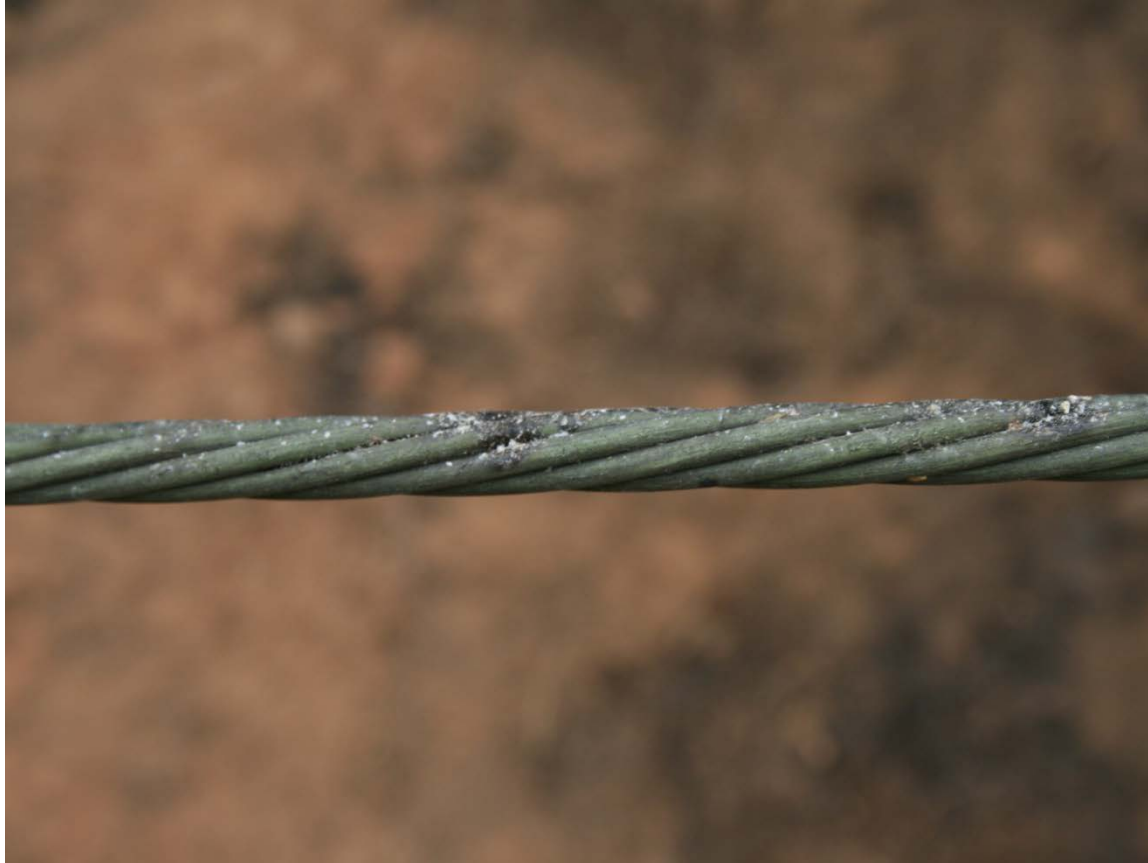
**Photo 81**

Close up of powerline conductor (Evidence Item 3). Series of photos starting from west end of item moving east. Discoloration visible on conductor.

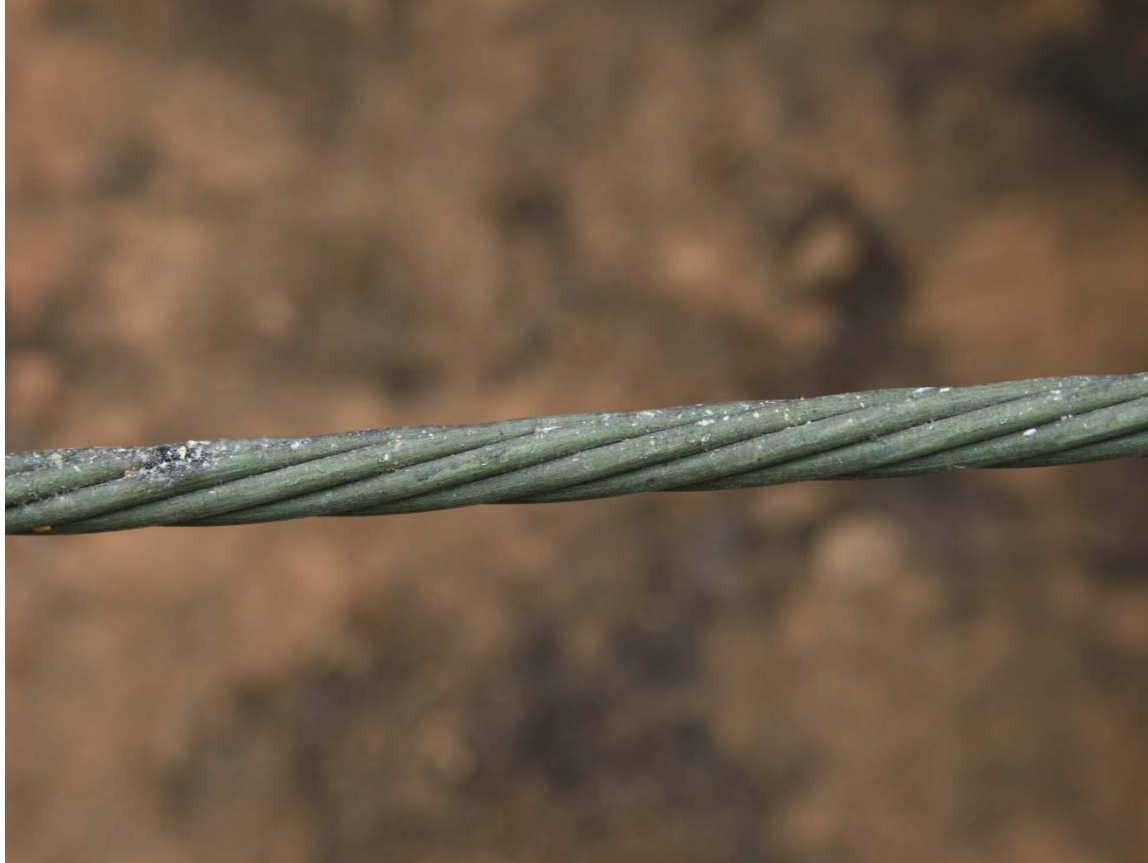
**Photo 82**

Close up of powerline conductor (Evidence Item 3). Series of photos starting from west end of item moving east. Discoloration visible on conductor.

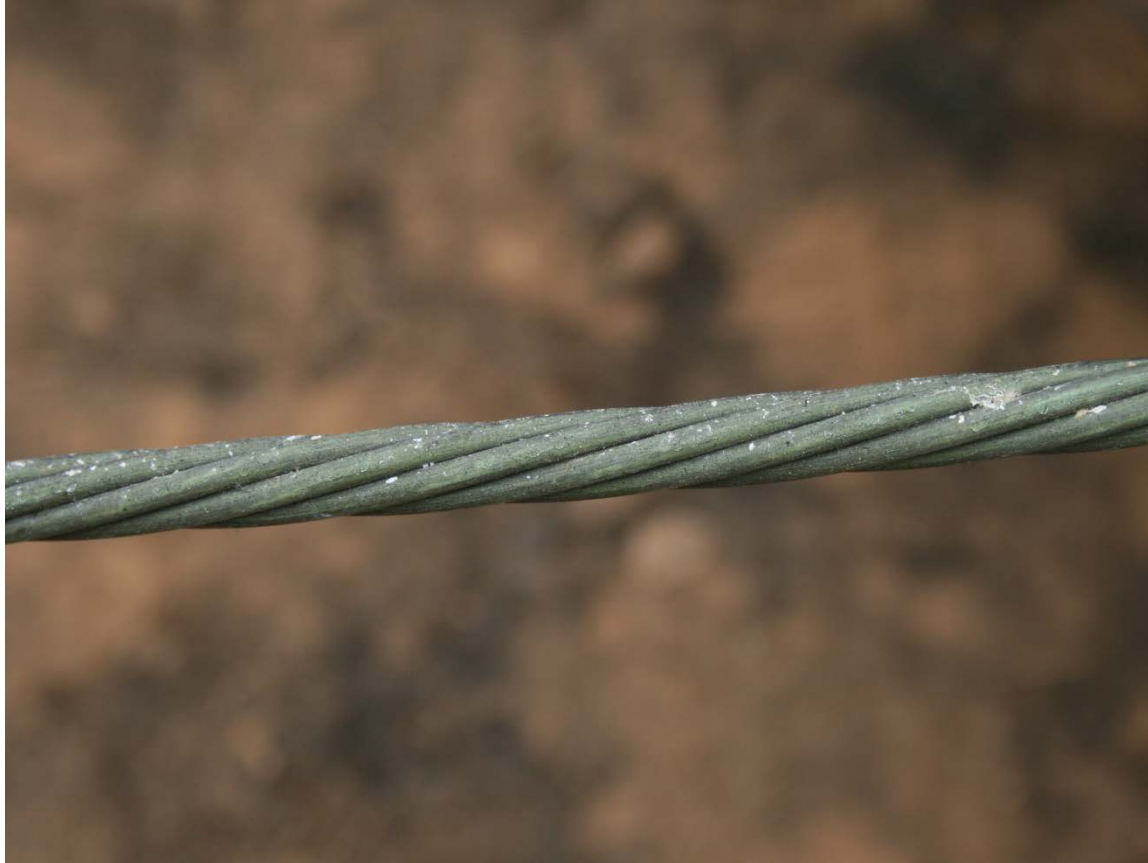
**Photo 83**

Close up of powerline conductor (Evidence Item 3). Series of photos starting from west end of item moving east.

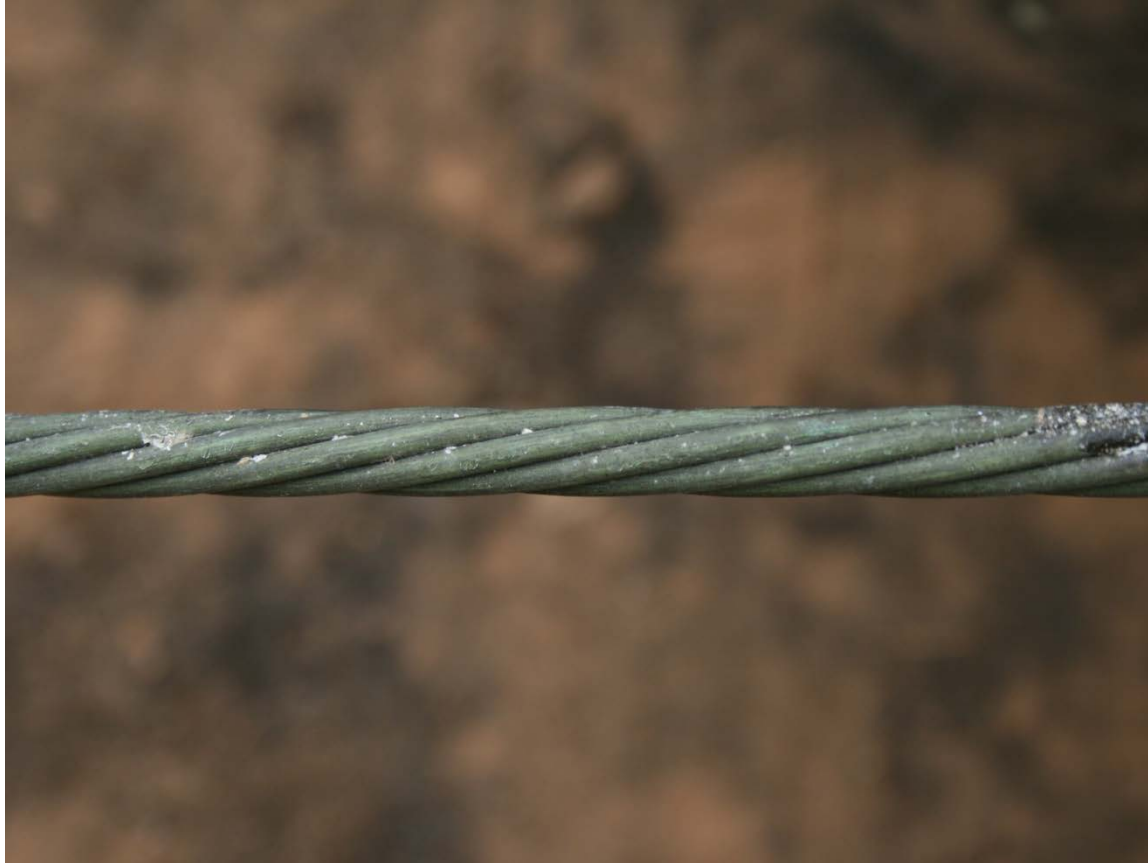
**Photo 84**

Close up of powerline conductor (Evidence Item 3). Series of photos starting from west end of item moving east. Discoloration visible on conductor.

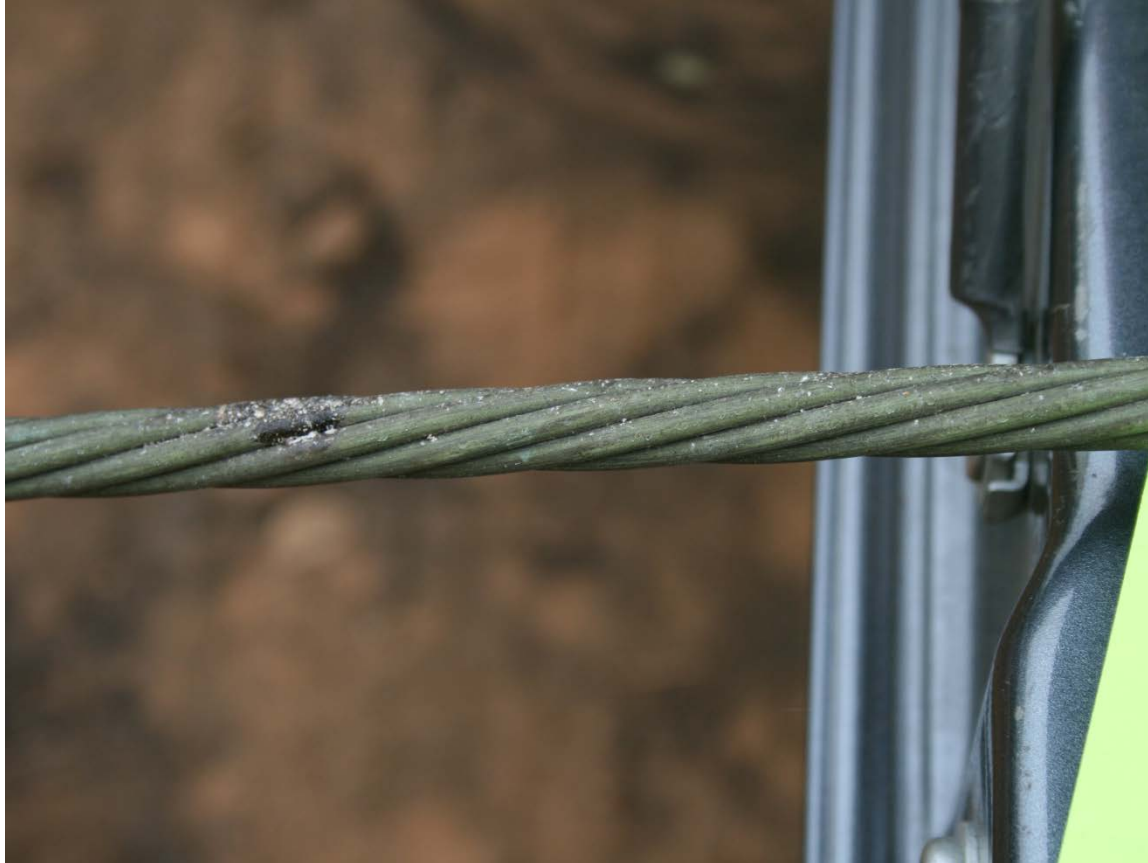
**Photo 85**

Close up of powerline conductor (Evidence Item 3). Series of photos starting from east end of item to the west after conductor was rolled to view other side. Close up of discoloration visible on the conductor.

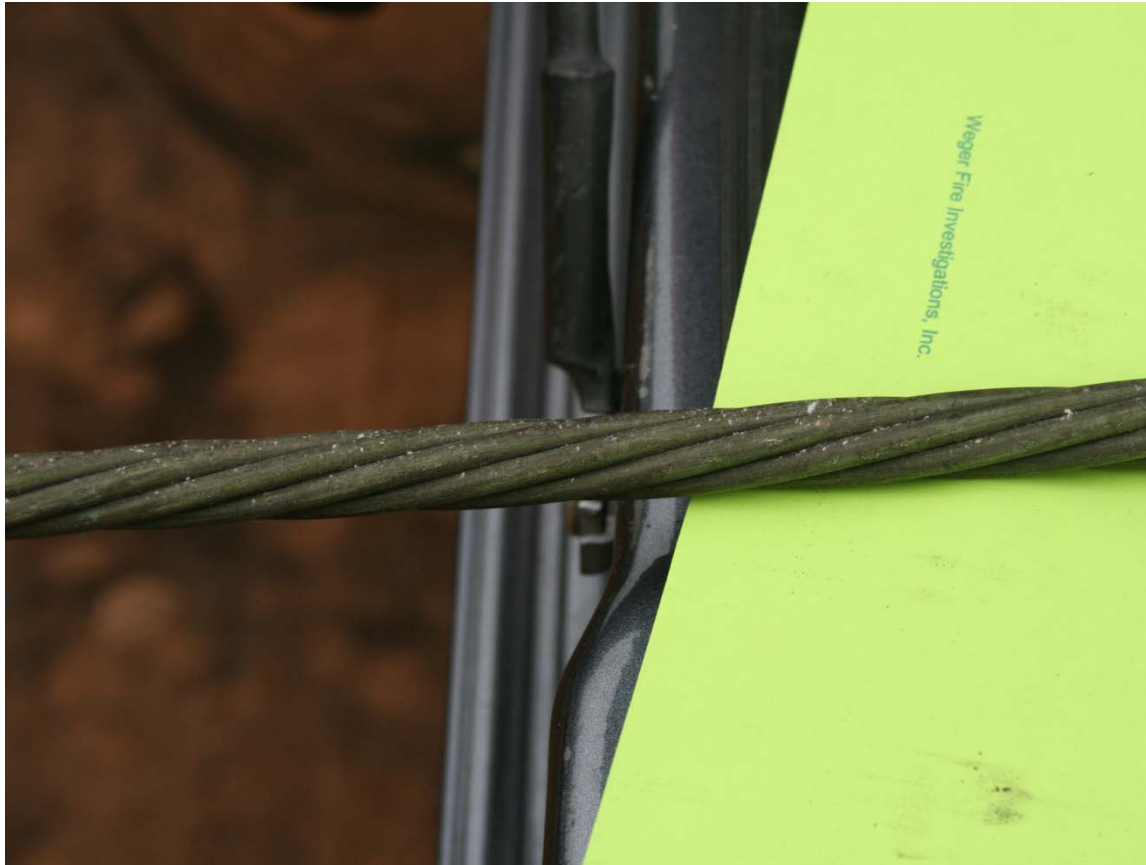
**Photo 86**

Close up of powerline conductor (Evidence Item 3). Series of photos starting from east end of item to the west after conductor was rolled to view other side. Close up of discoloration visible on the conductor.

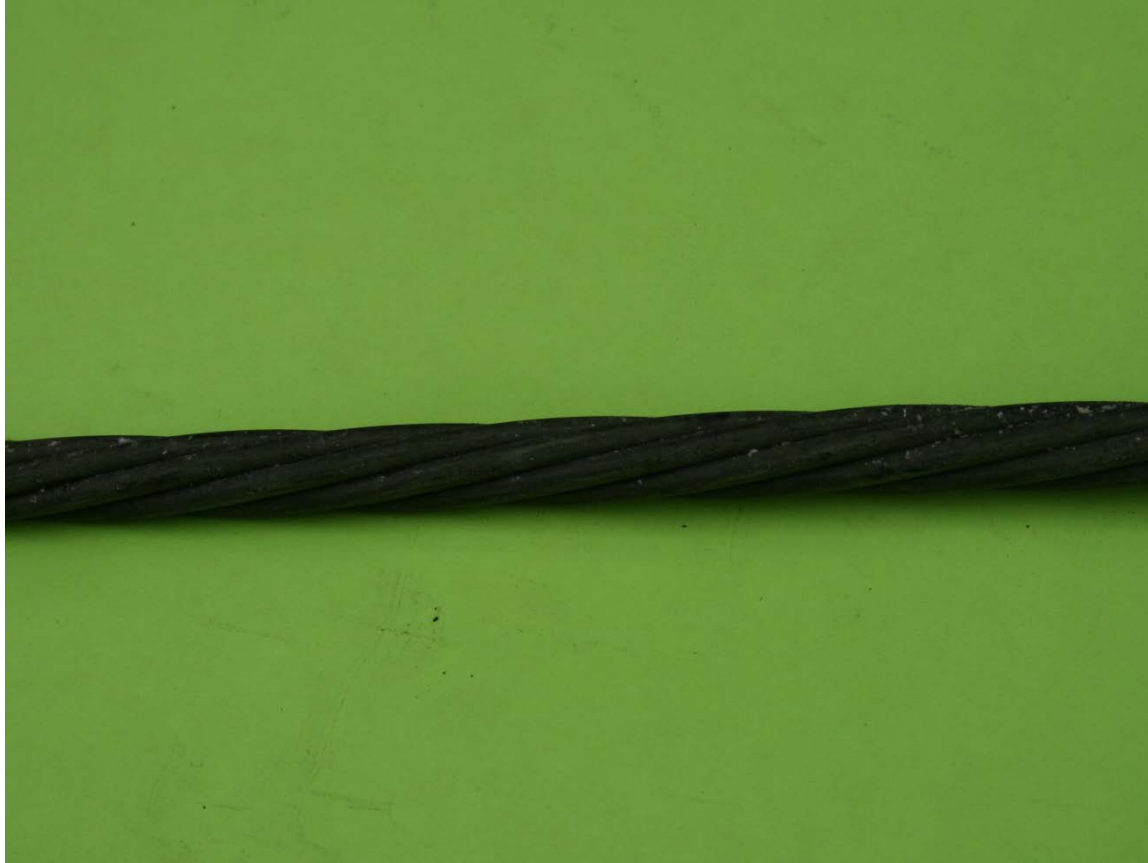
**Photo 88**

Close up of powerline conductor (Evidence Item 3). Series of photos starting from east end of item to the west after conductor was rolled to view other side. Close up of discoloration visible on the conductor.

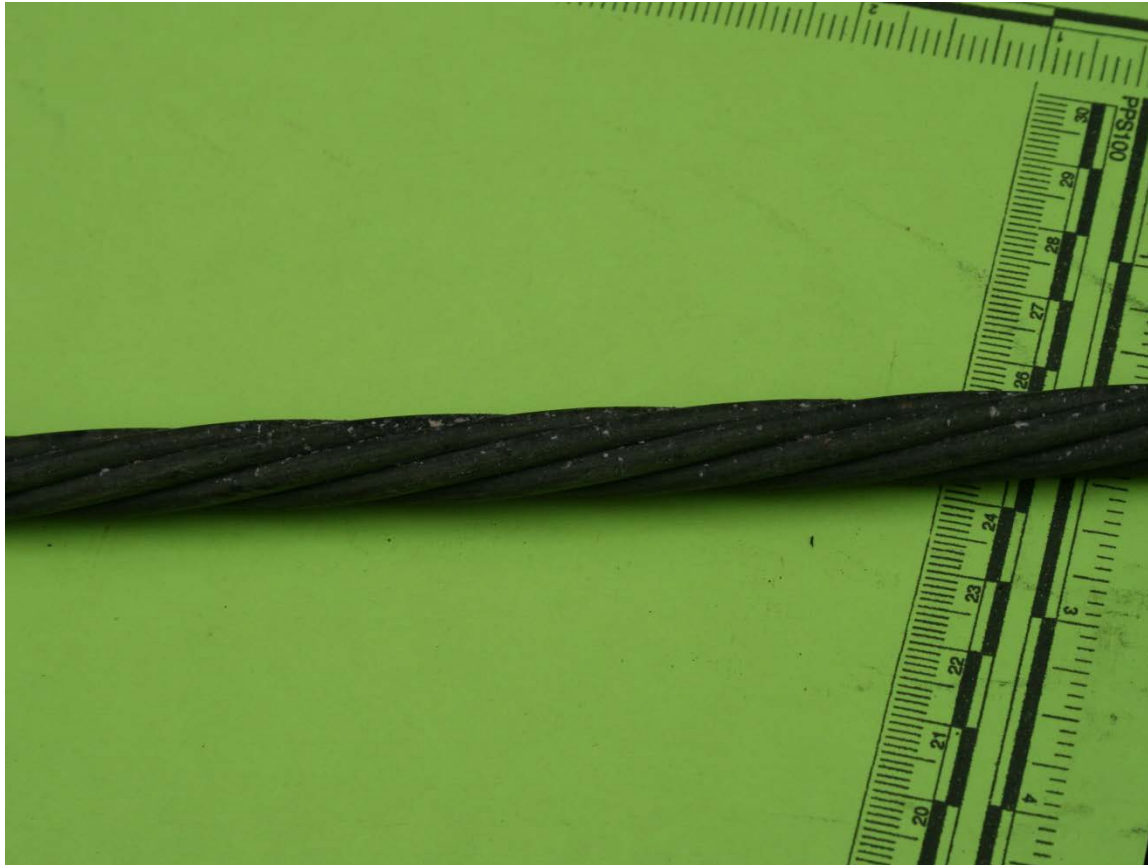
**Photo 89**

Close up of powerline conductor (Evidence Item 3). Series of photos starting from east end of item to the west after conductor was rolled to view other side. Close up of discoloration visible on the conductor.

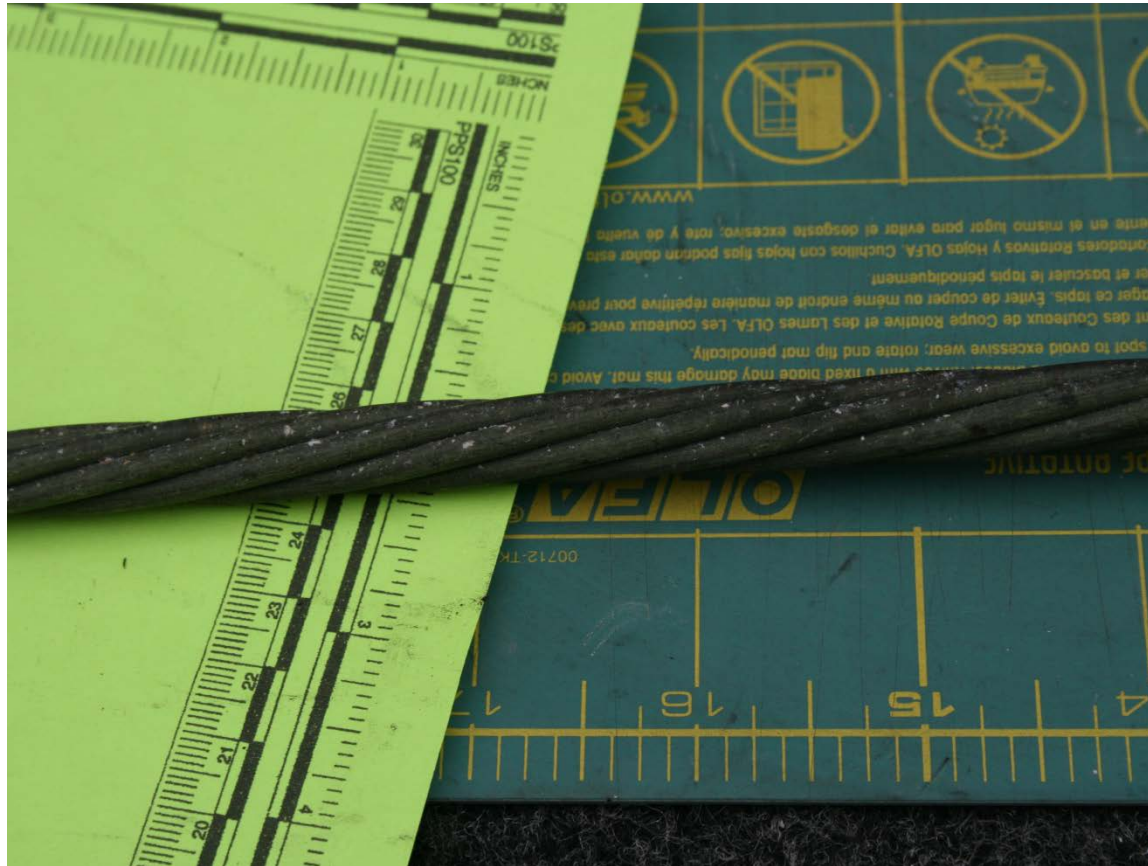
**Photo 90**

Close up of powerline conductor (Evidence Item 3). Series of photos starting from east end of item to the west after conductor was rolled to view other side. Close up of discoloration visible on the conductor.

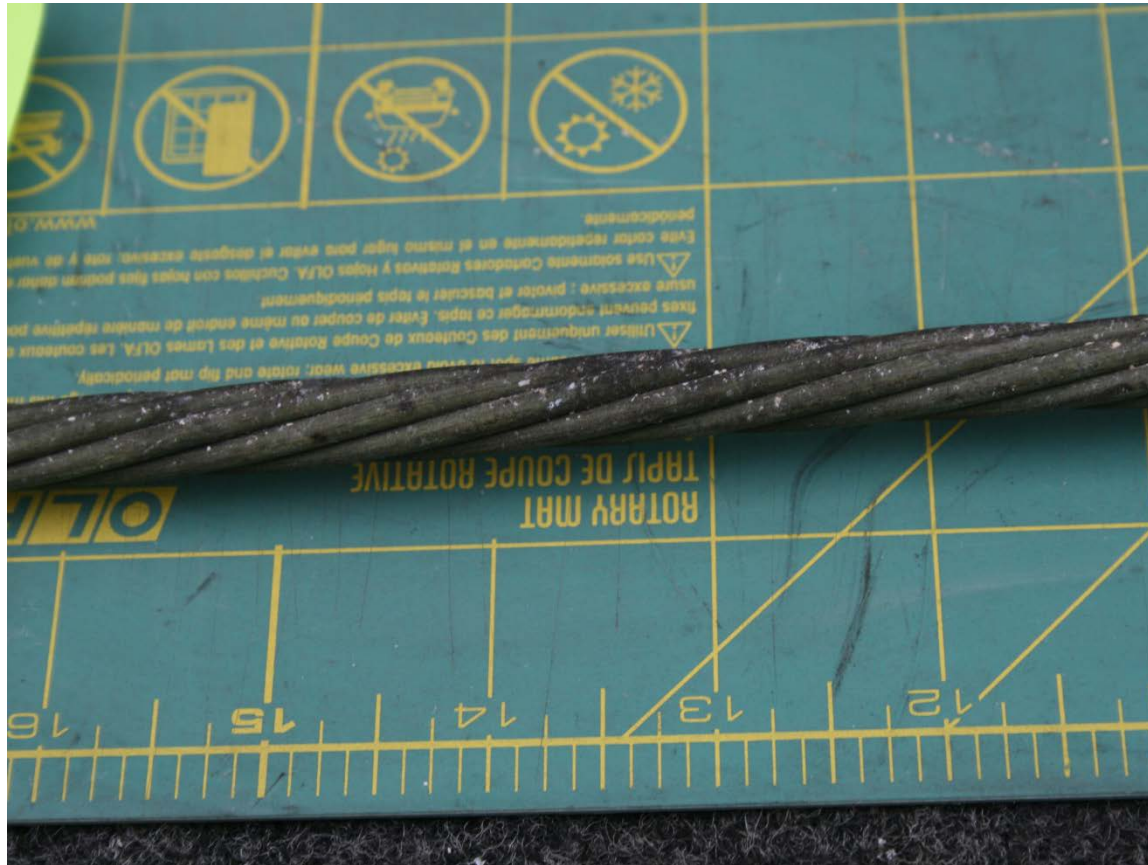
**Photo 91**

Close up of powerline conductor (Evidence Item 3). Series of photos starting from east end of item to the west after conductor was rolled to view other side. Close up of discoloration visible on the conductor.

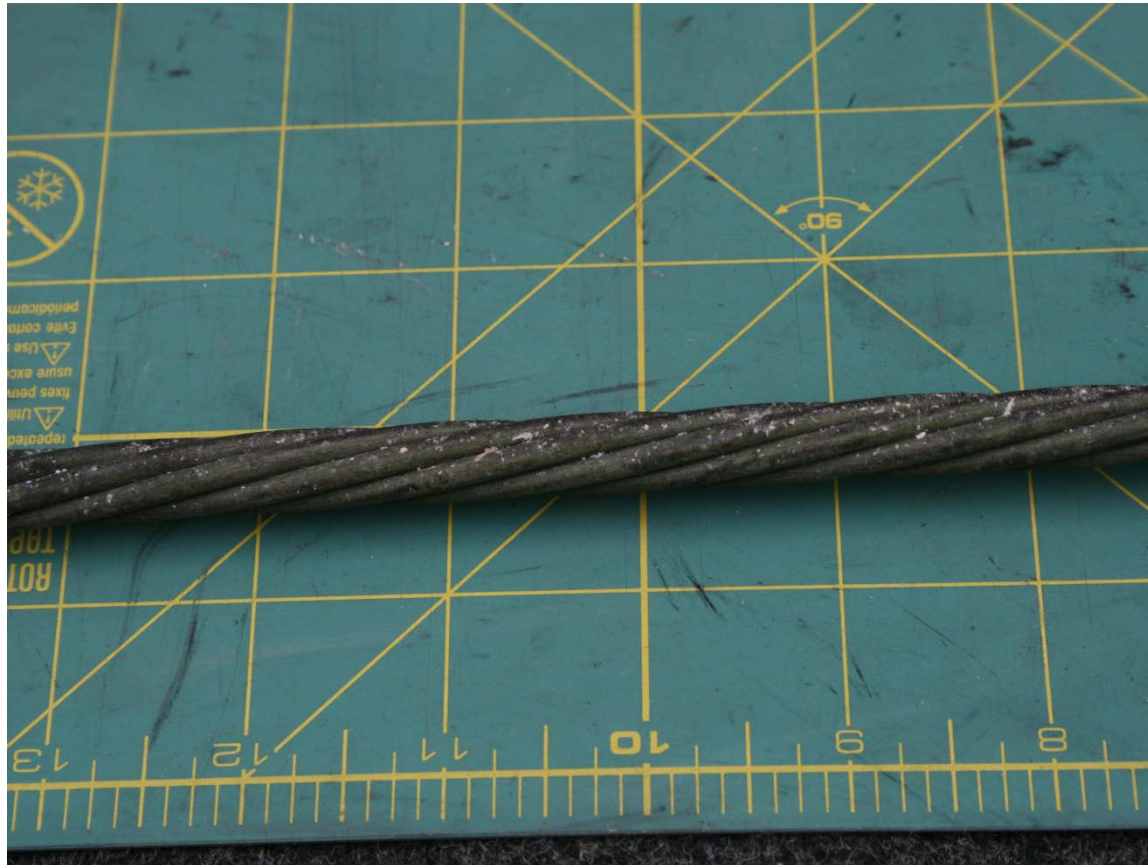
**Photo 92**

Close up of powerline conductor (Evidence Item 3). Series of photos starting from east end of item to the west after conductor was rolled to view other side. Close up of discoloration visible on the conductor.

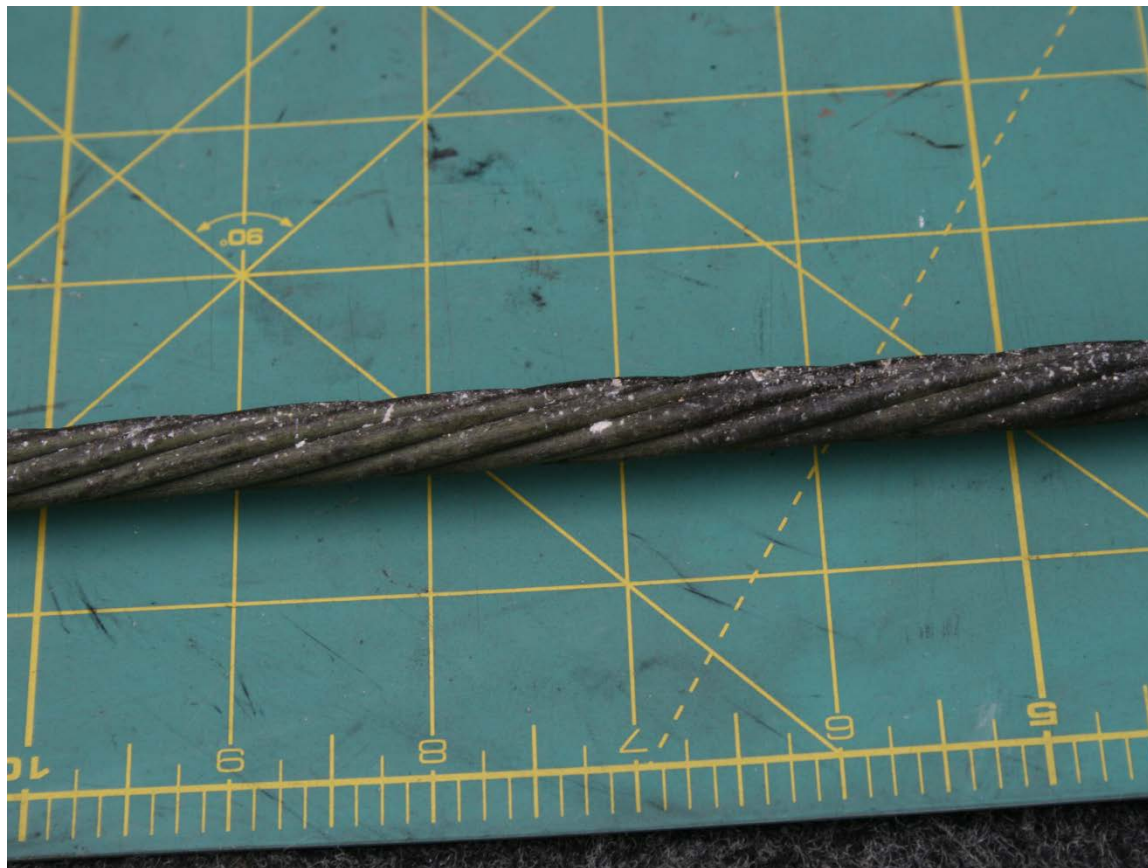
**Photo 93**

Close up of powerline conductor (Evidence Item 3). Series of photos starting from east end of item to the west after conductor was rolled to view other side. Close up of discoloration visible on the conductor.

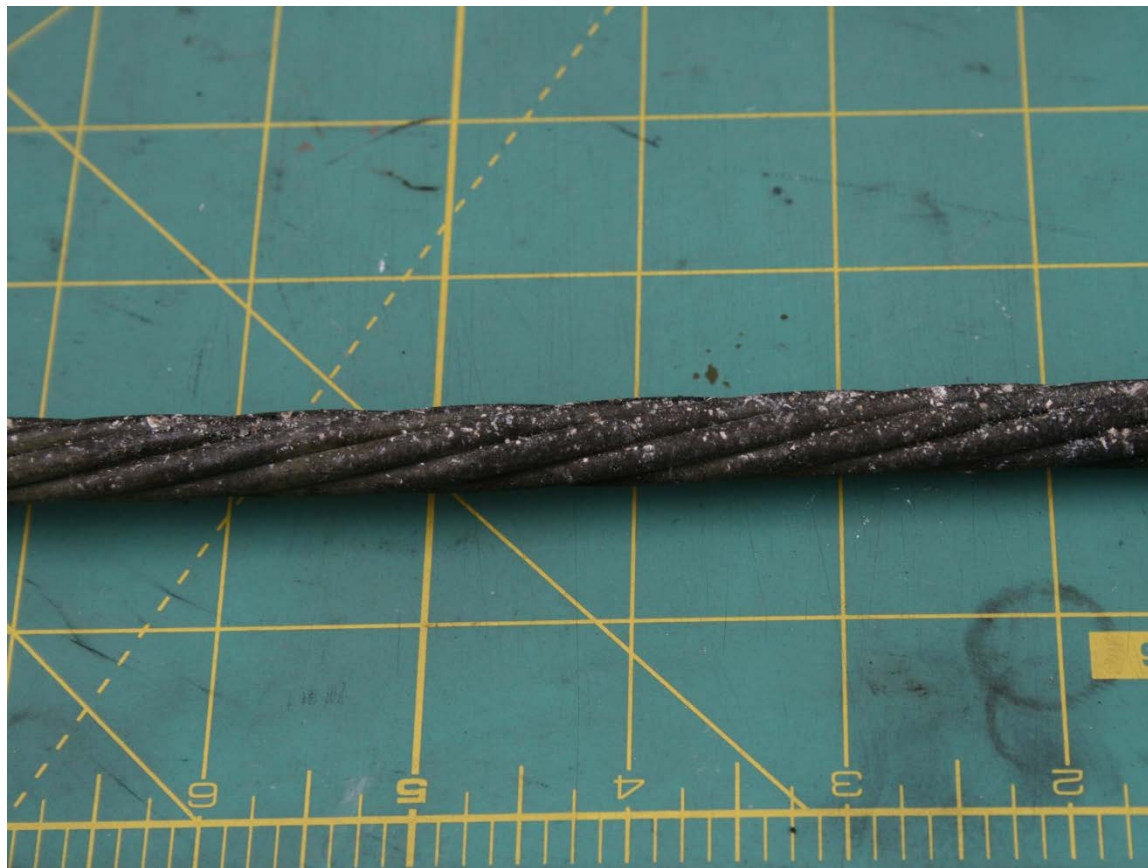
**Photo 94**

Close up of powerline conductor (Evidence Item 3). Series of photos starting from east end of item to the west after conductor was rolled to view other side. Close up of discoloration visible on the conductor.

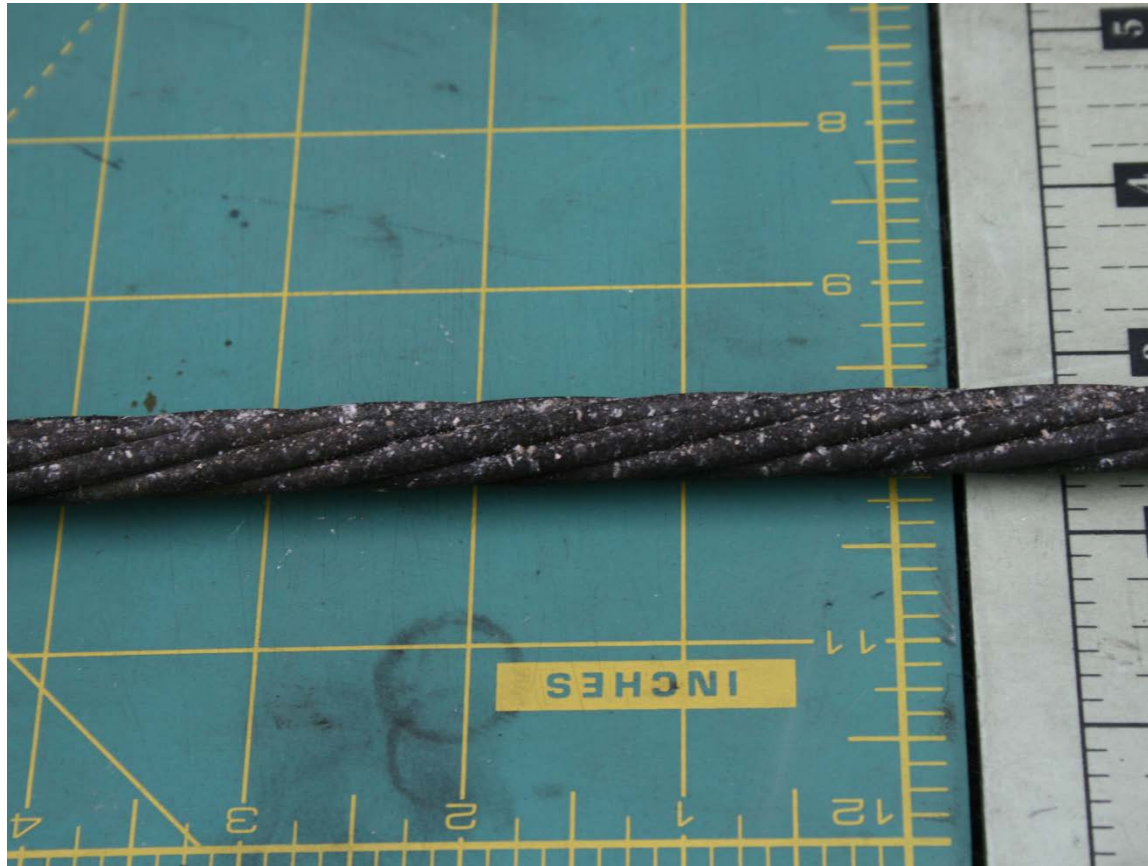
**Photo 95**

Close up of powerline conductor (Evidence Item 3). Series of photos starting from east end of item to the west after conductor was rolled to view other side. Close up of discoloration visible on the conductor.

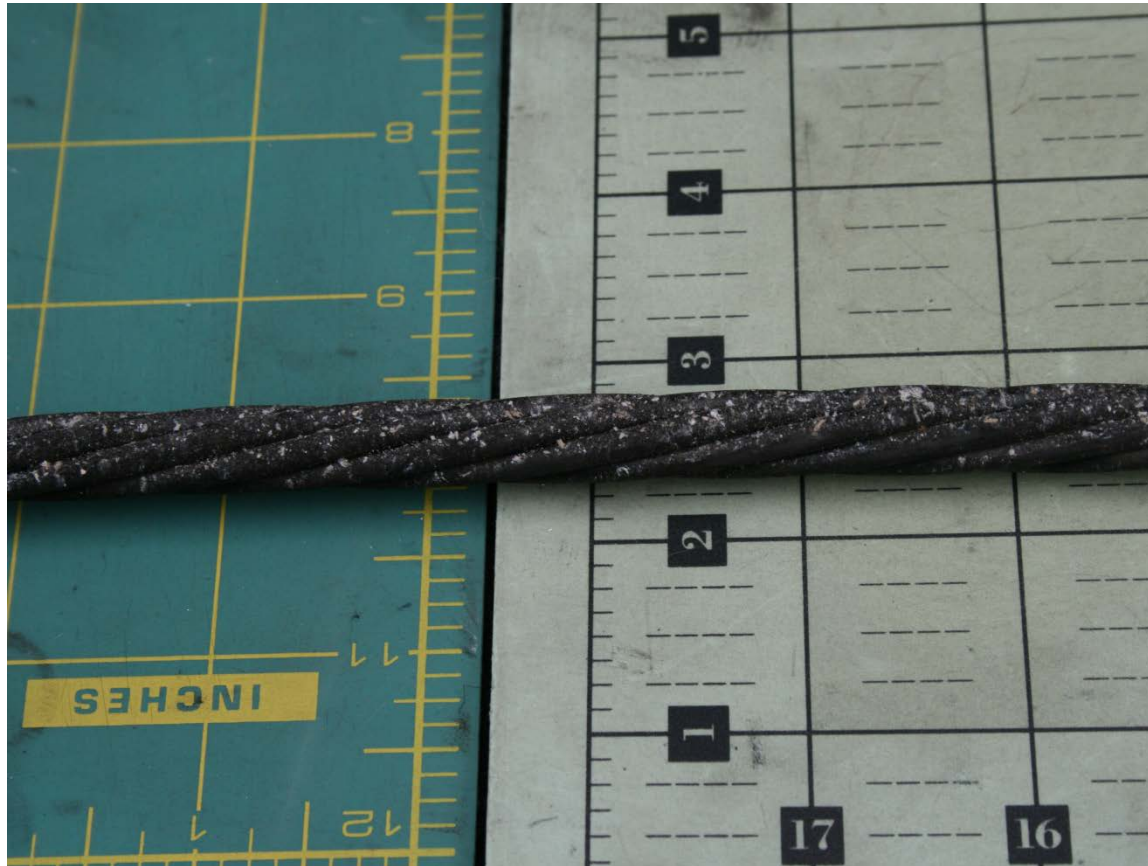
**Photo 96**

Close up of powerline conductor (Evidence Item 3). Series of photos starting from east end of item to the west after conductor was rolled to view other side. Close up of discoloration visible on the conductor.

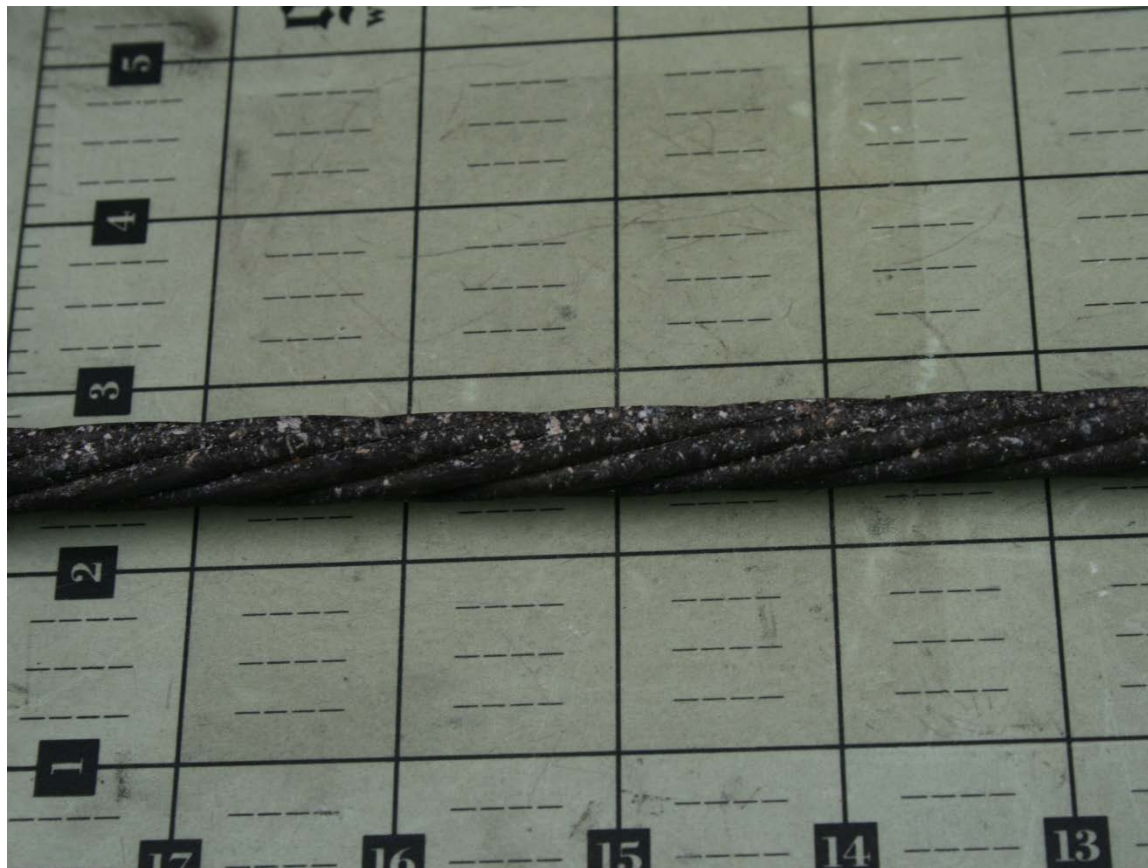
**Photo 97**

Close up of powerline conductor (Evidence Item 3). Series of photos starting from east end of item to the west after conductor was rolled to view other side. Close up of discoloration visible on the conductor.

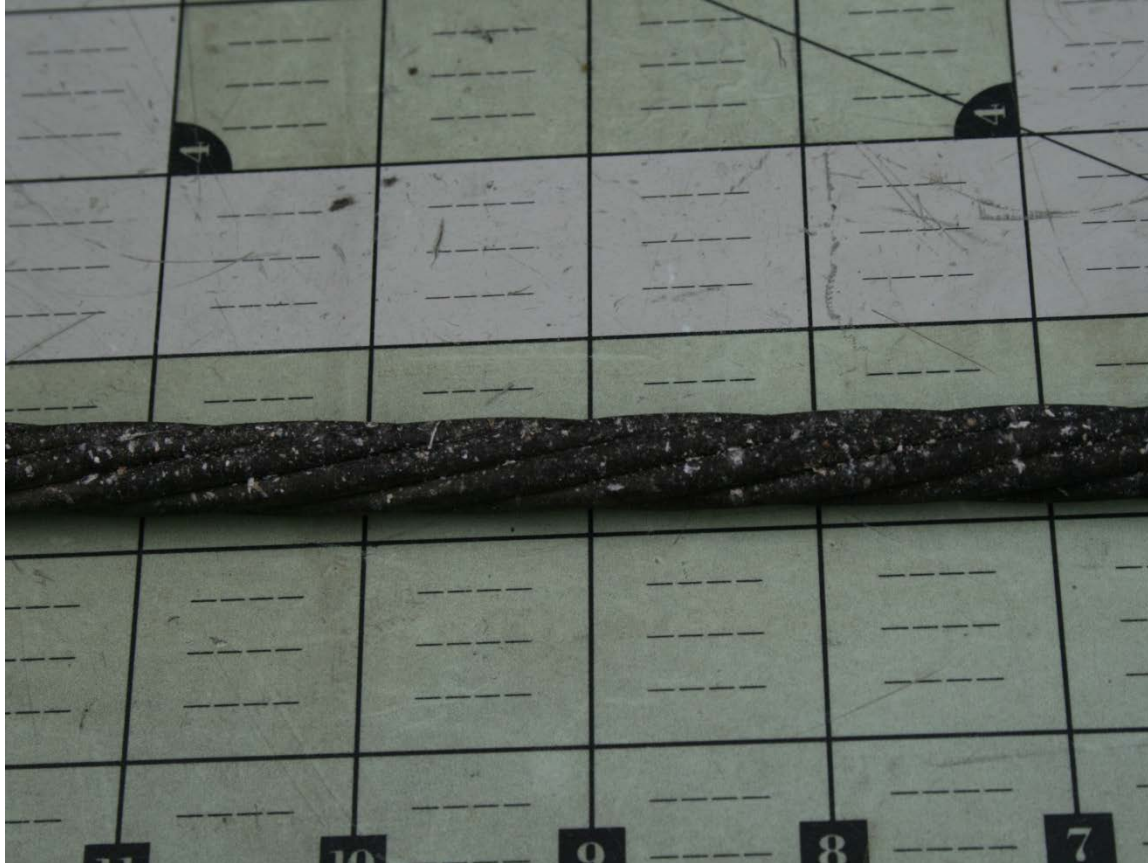
**Photo 99**

Close up of powerline conductor (Evidence Item 3). Series of photos starting from east end of item to the west after conductor was rolled to view other side. Close up of discoloration visible on the conductor.

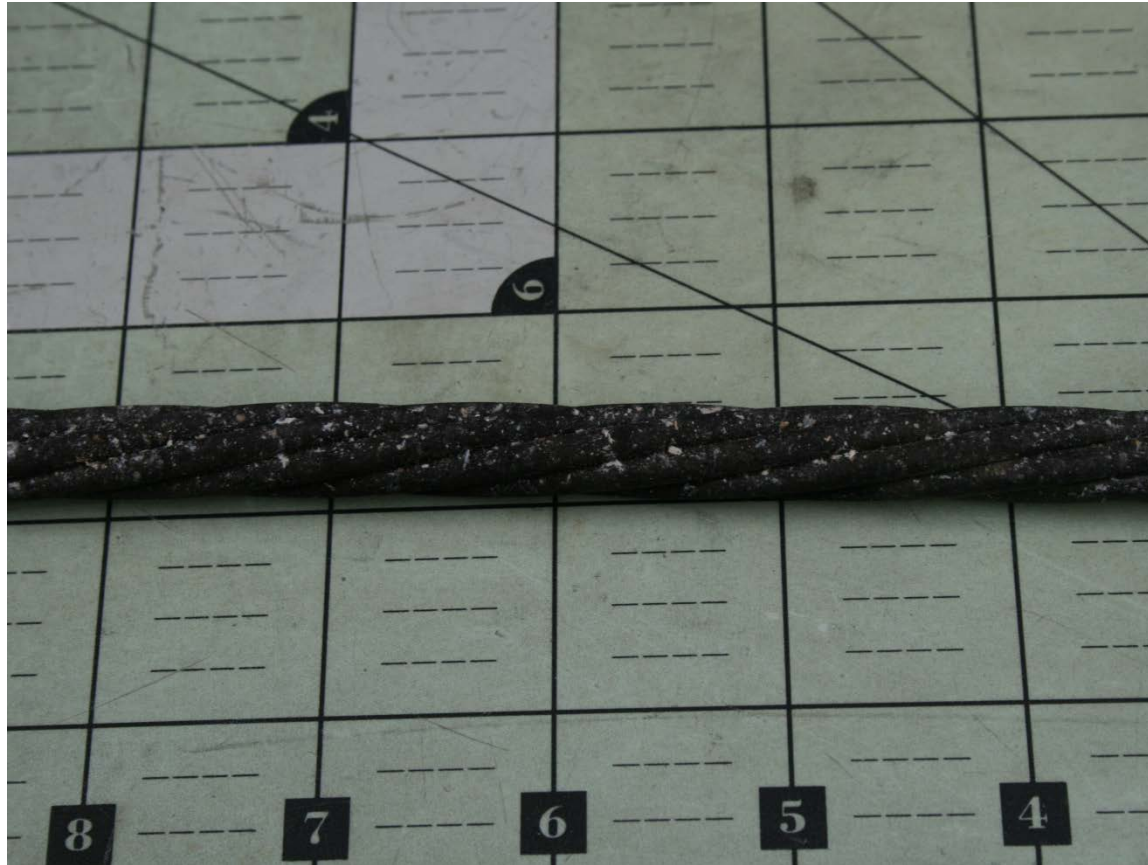
**Photo 100**

Close up of powerline conductor (Evidence Item 3). Series of photos starting from east end of item to the west after conductor was rolled to view other side. Close up of discoloration visible on the conductor.

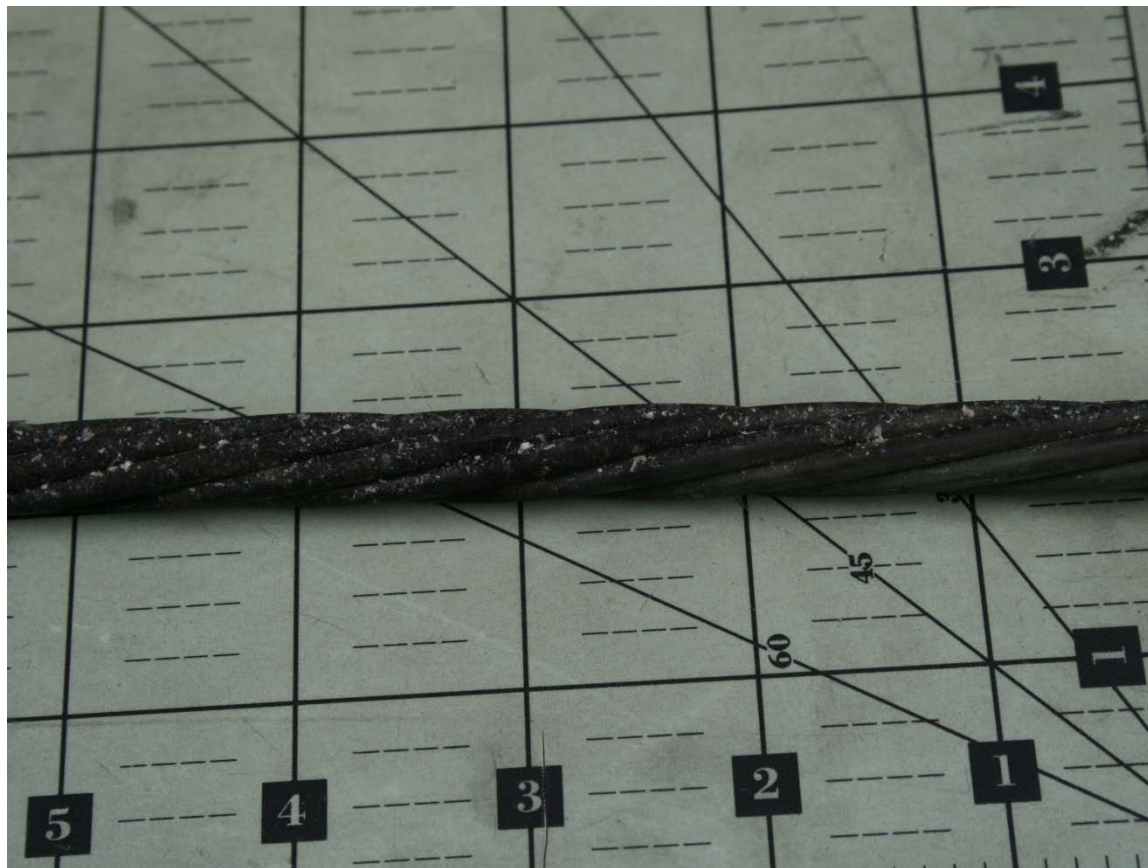
**Photo 101**

Close up of powerline conductor (Evidence Item 3). Series of photos starting from east end of item to the west after conductor was rolled to view other side. Close up of discoloration visible on the conductor.
