**Butte Incident**

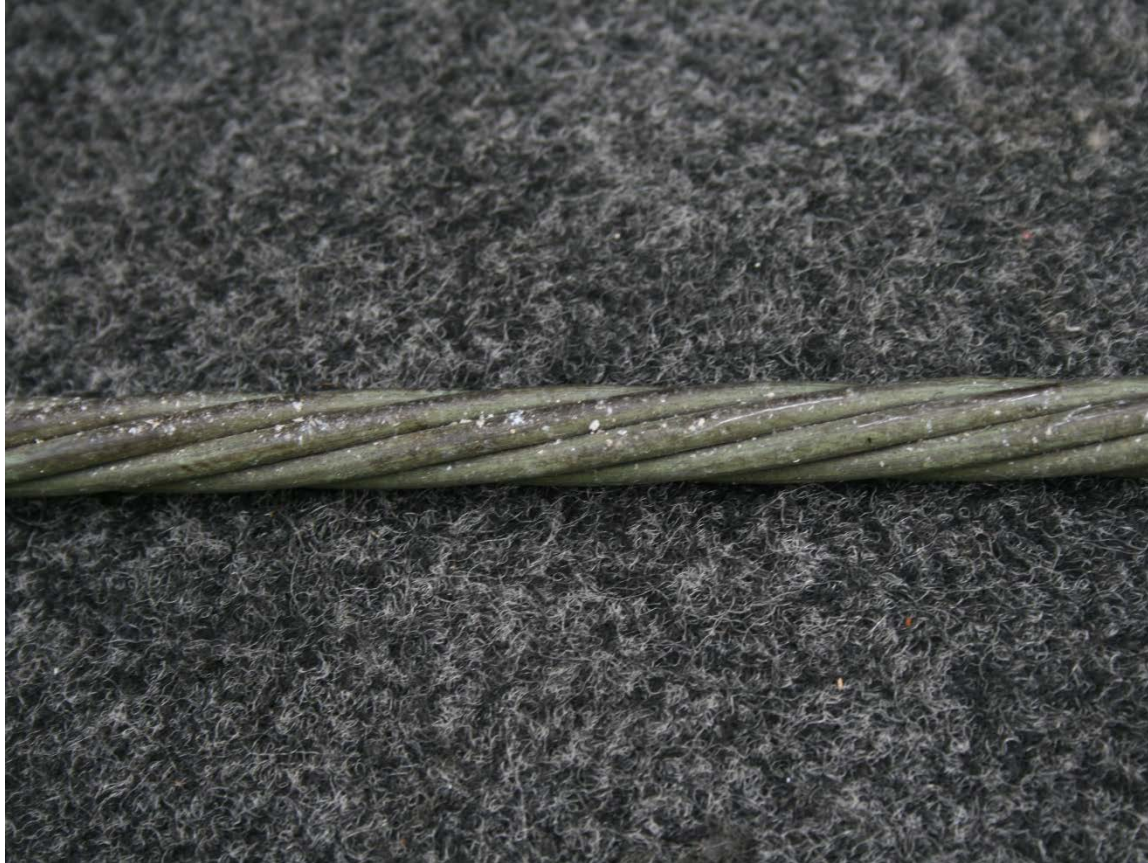
**Photo 103**

Close up of powerline conductor (Evidence Item 3). Series of photos starting from east end of item to the west after conductor was rolled to view other side. Close up of discoloration visible on the conductor.

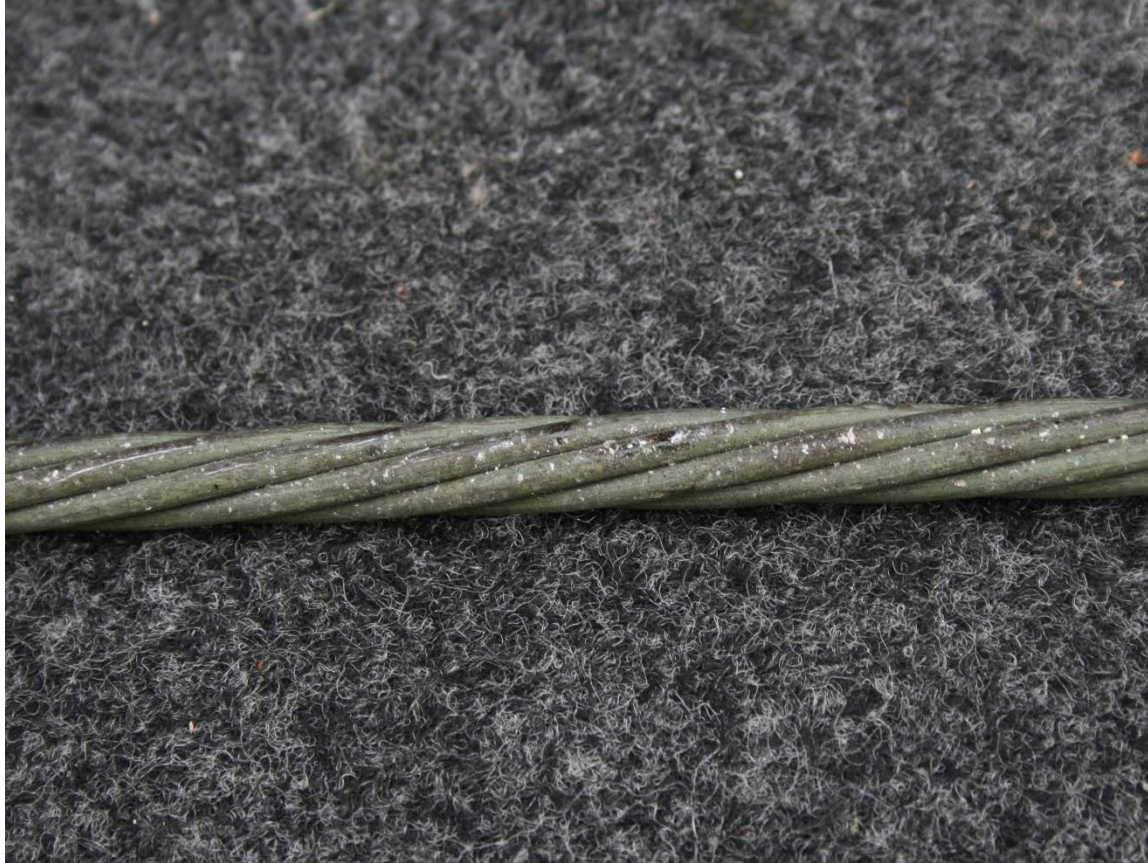
**Photo 104**

Close up of powerline conductor (Evidence Item 3). Series of photos starting from east end of item to the west after conductor was rolled to view other side. Close up of discoloration visible on the conductor.

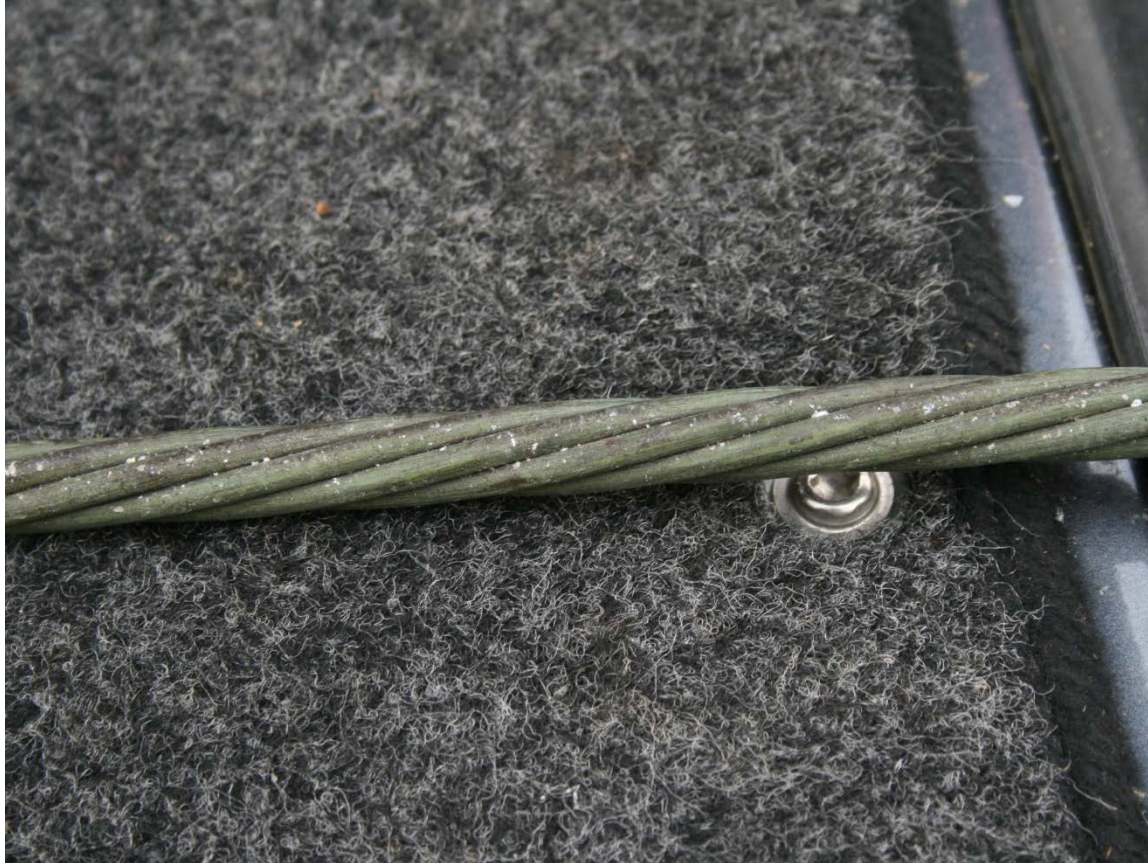
**Photo 105**

Close up of powerline conductor (Evidence Item 3). Series of photos starting from east end of item to the west after conductor was rolled to view other side. Close up of discoloration visible on the conductor.

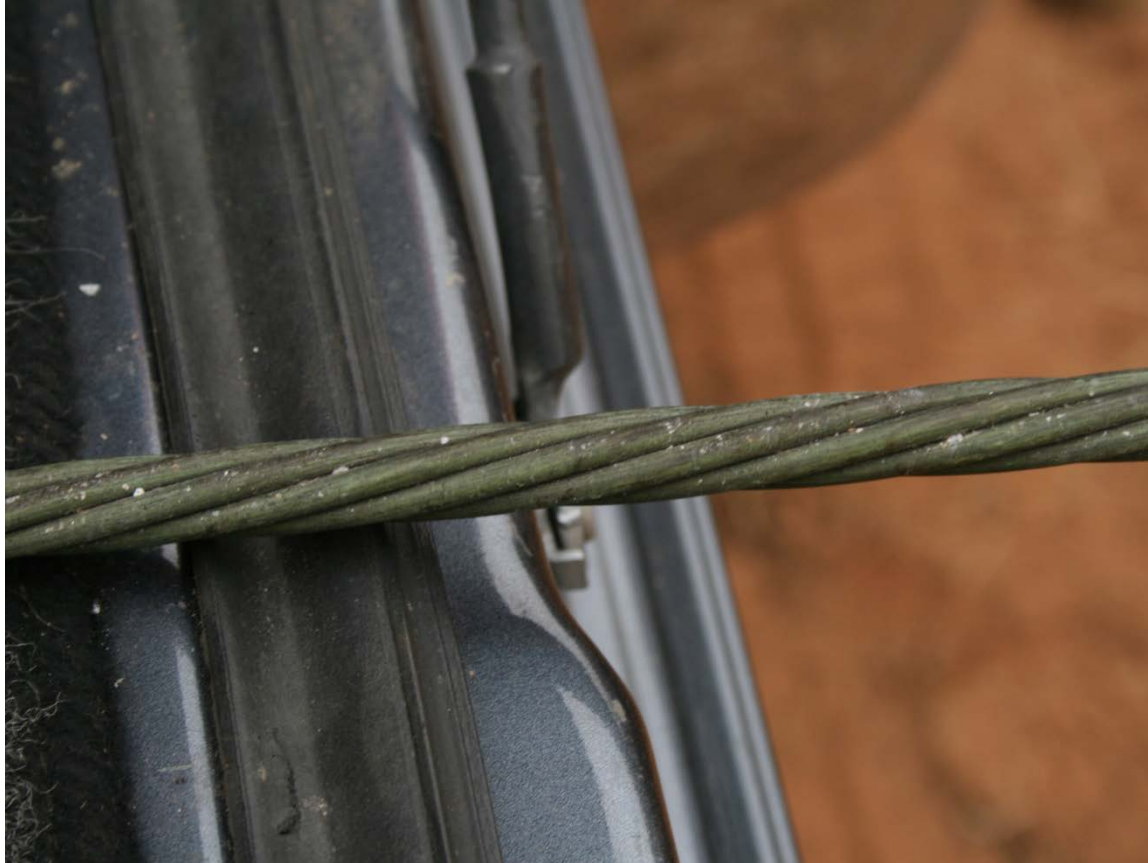
**Photo 106**

Close up of powerline conductor (Evidence Item 3). Series of photos starting from east end of item to the west after conductor was rolled to view other side. Close up of discoloration visible on the conductor.

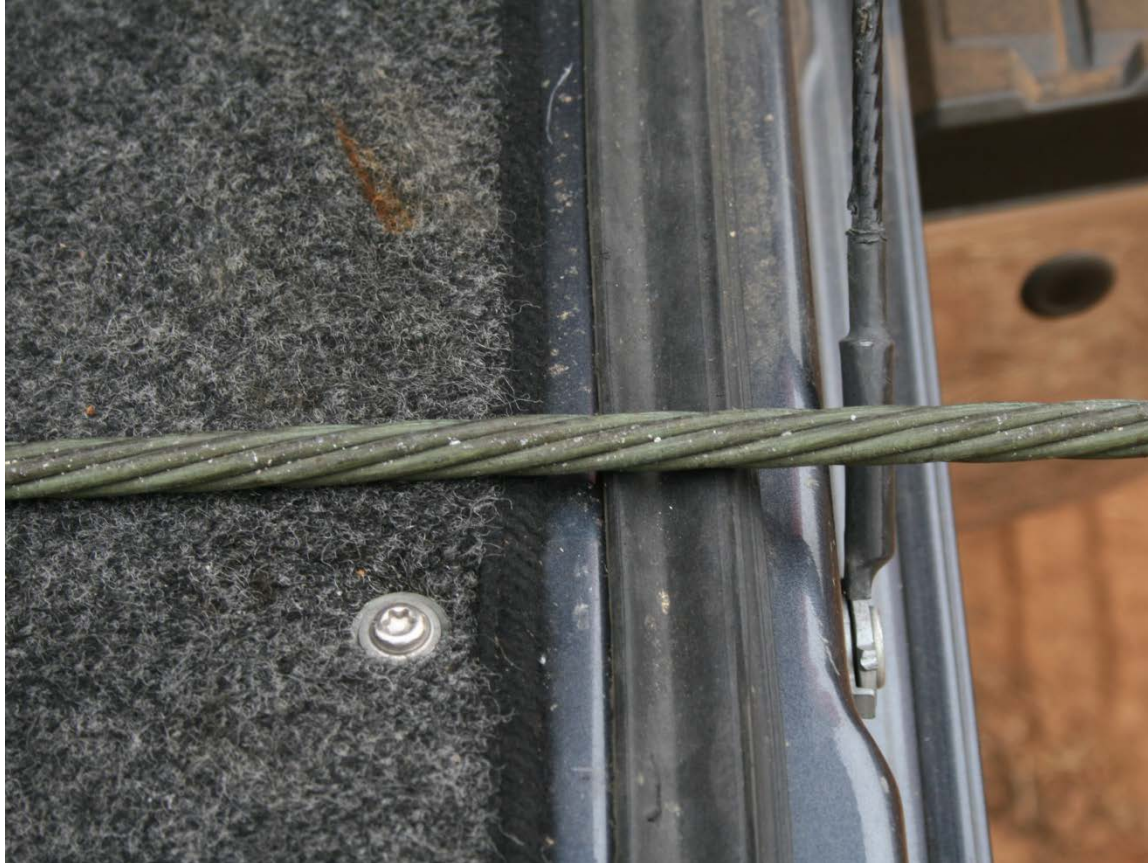
**Photo 107**

Close up of powerline conductor (Evidence Item 3). Series of photos starting from west end of item to the east after conductor was rolled to view other side. Discoloration visible on the conductor.

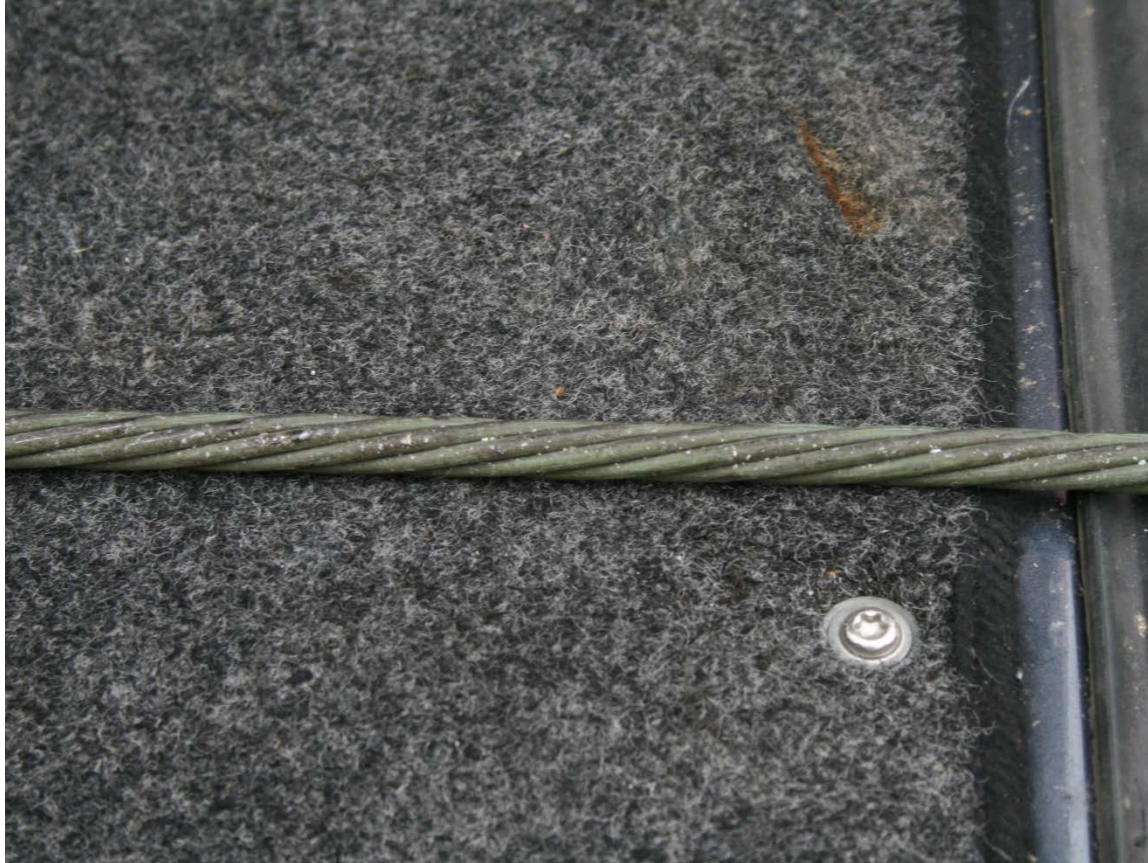
**Photo 108**

Close up of powerline conductor (Evidence Item 3). Series of photos starting from west end of item to the east after conductor was rolled to view other side. Discoloration visible on the conductor.

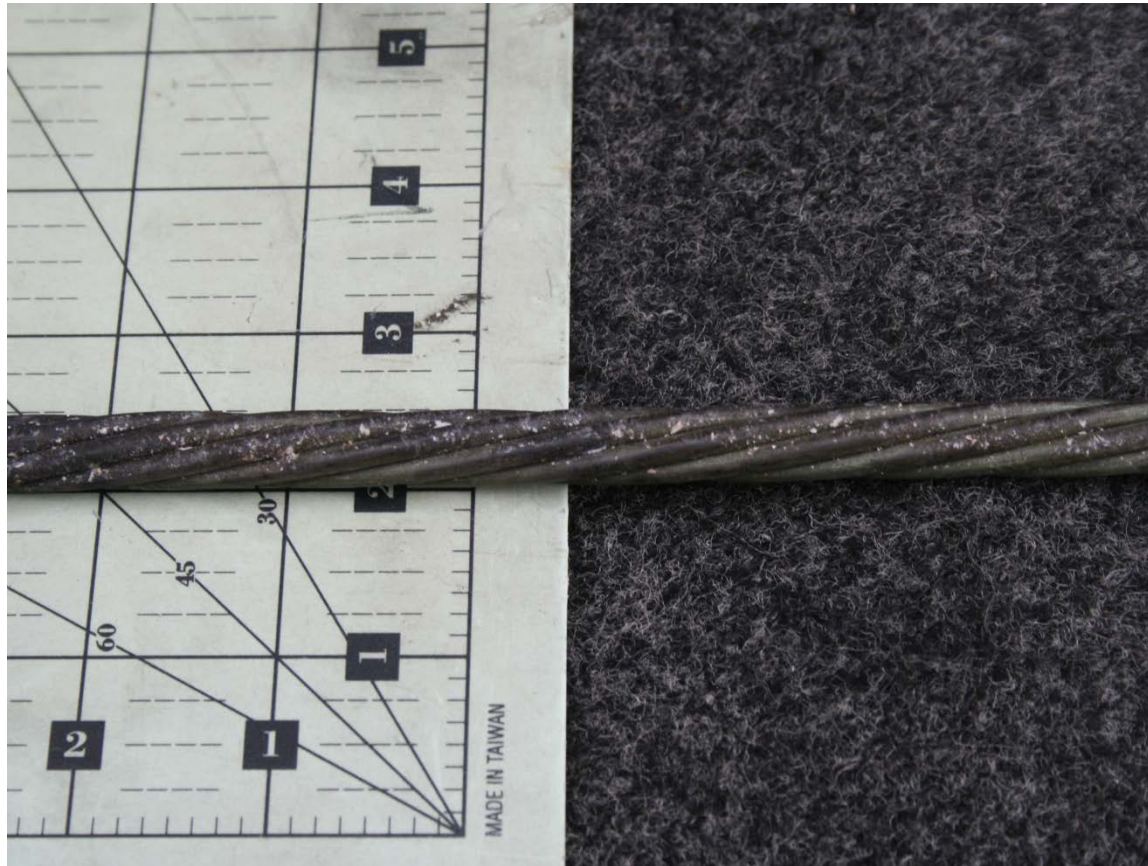
**Photo 110**

Close up of powerline conductor (Evidence Item 3). Series of photos starting from west end of item to the east after conductor was rolled to view other side. Discoloration visible on the conductor.

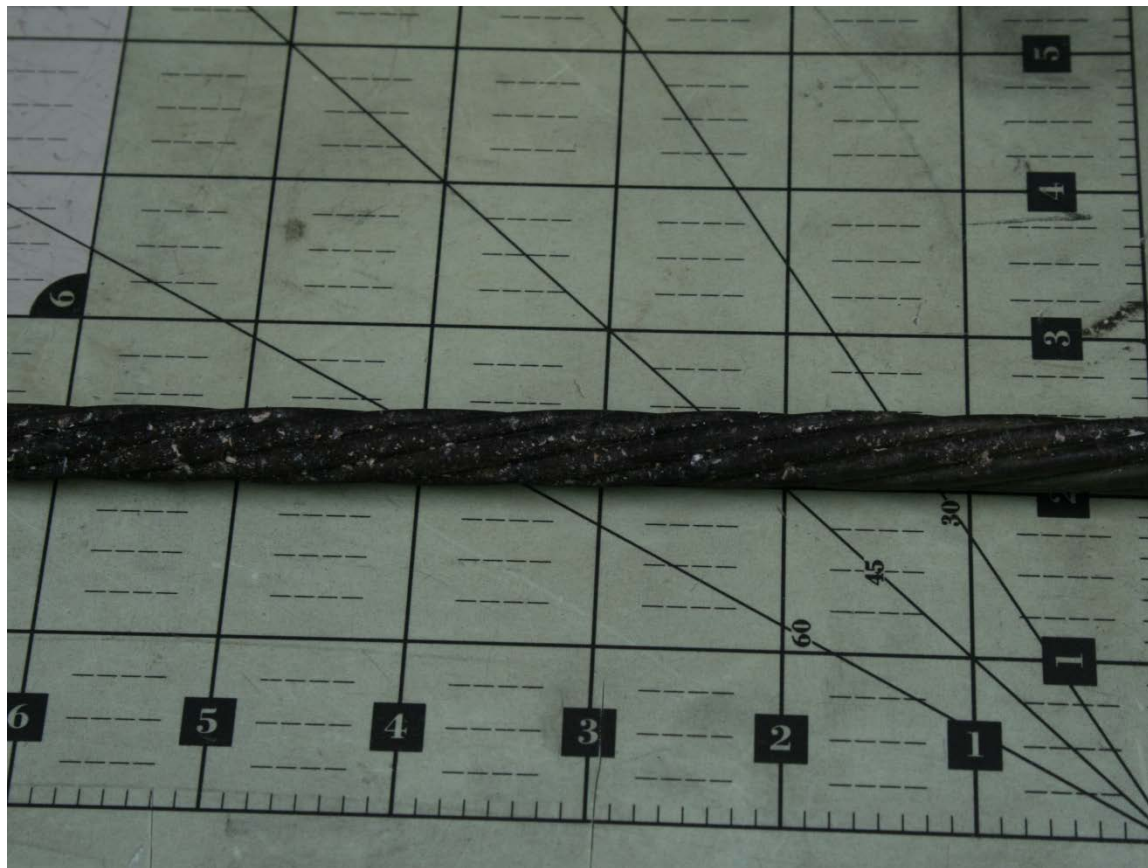
**Photo 111**

Close up of powerline conductor (Evidence Item 3). Series of photos starting from west end of item to the east after conductor was rolled to view other side. Discoloration visible on the conductor.

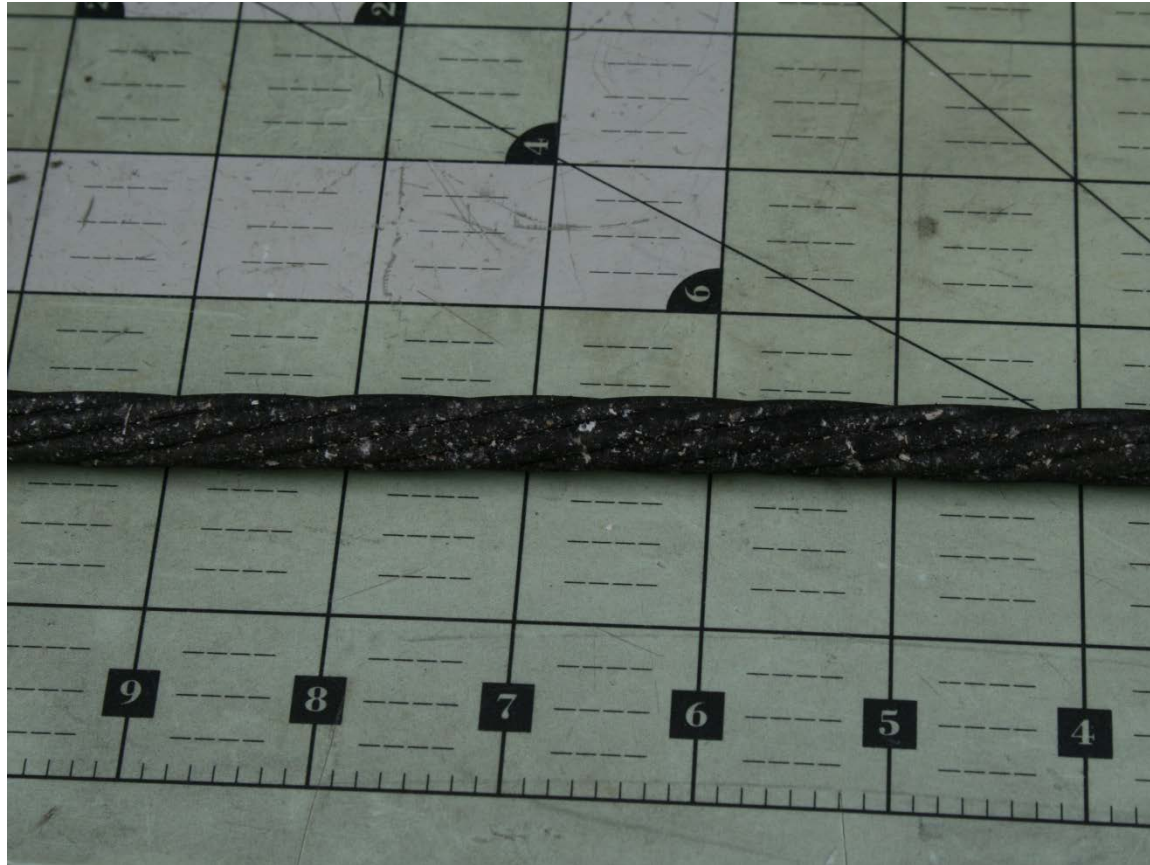
**Photo 112**

Close up of powerline conductor (Evidence Item 3). Series of photos starting from west end of item to the east after conductor was rolled to view other side. Discoloration visible on the conductor.

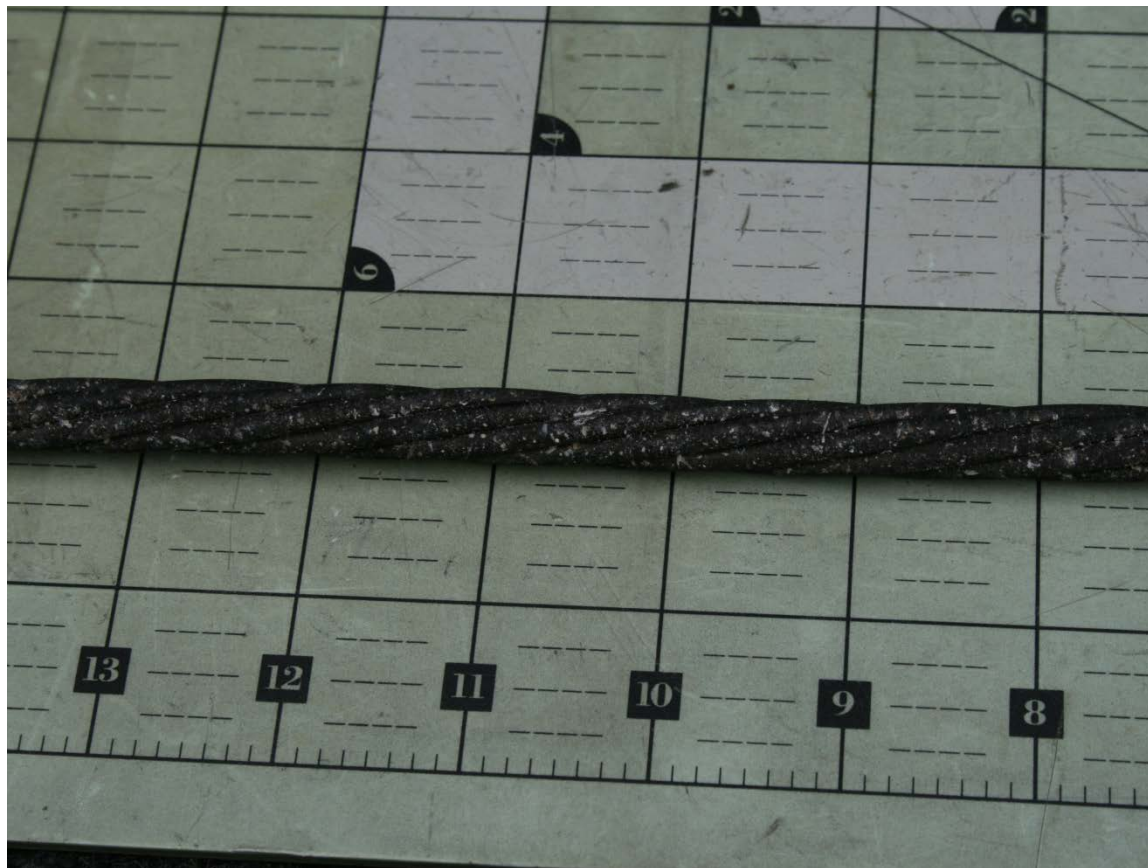
Close up of powerline conductor (Evidence Item 3). Series of photos starting from west end of item to the east after conductor was rolled to view other side. Discoloration visible on the conductor.

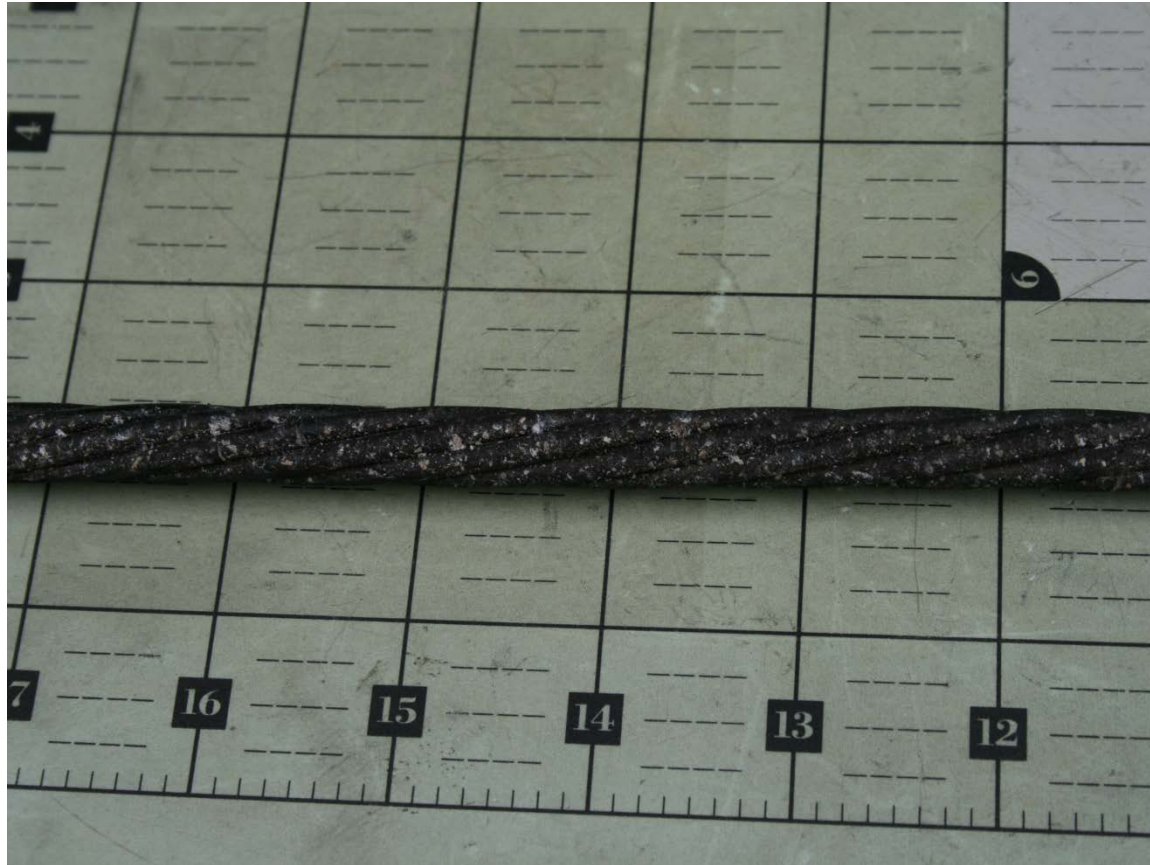
Close up of powerline conductor (Evidence Item 3). Series of photos starting from west end of item to the east after conductor was rolled to view other side. Discoloration visible on the conductor.

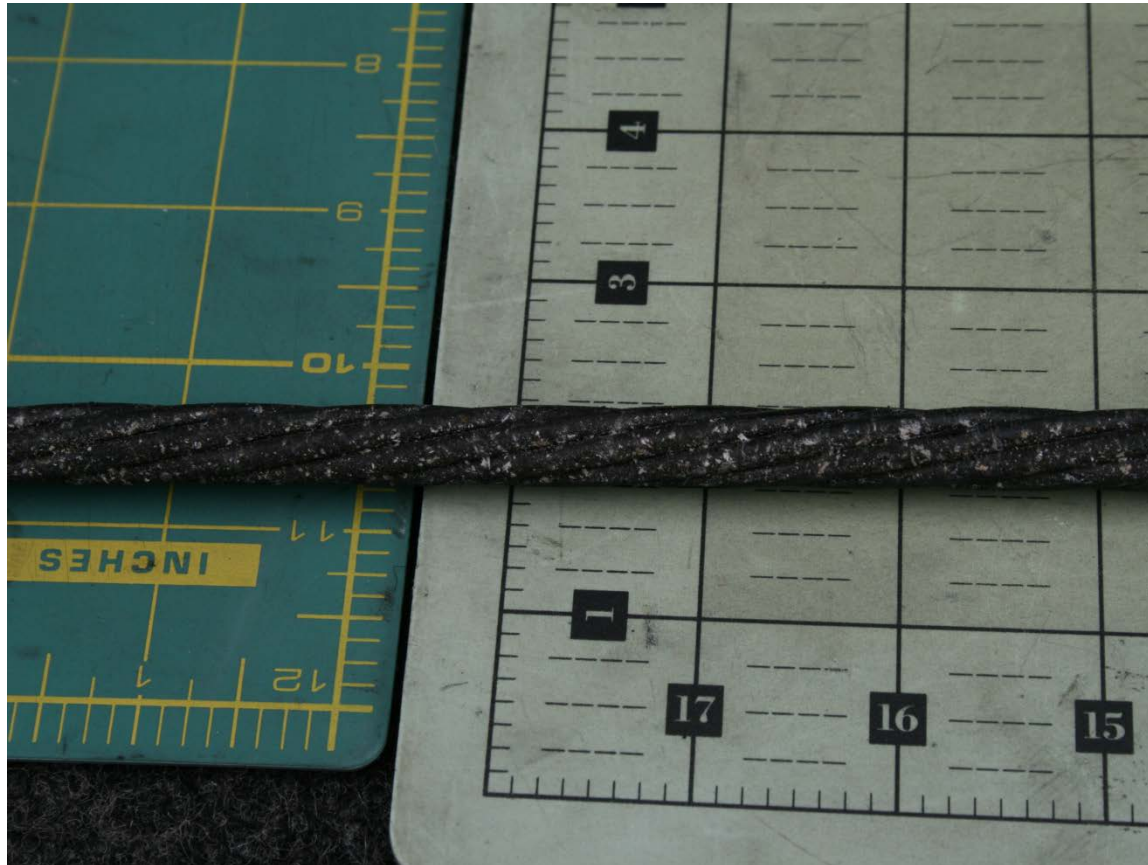
Close up of powerline conductor (Evidence Item 3). Series of photos starting from west end of item to the east after conductor was rolled to view other side. Discoloration visible on the conductor.

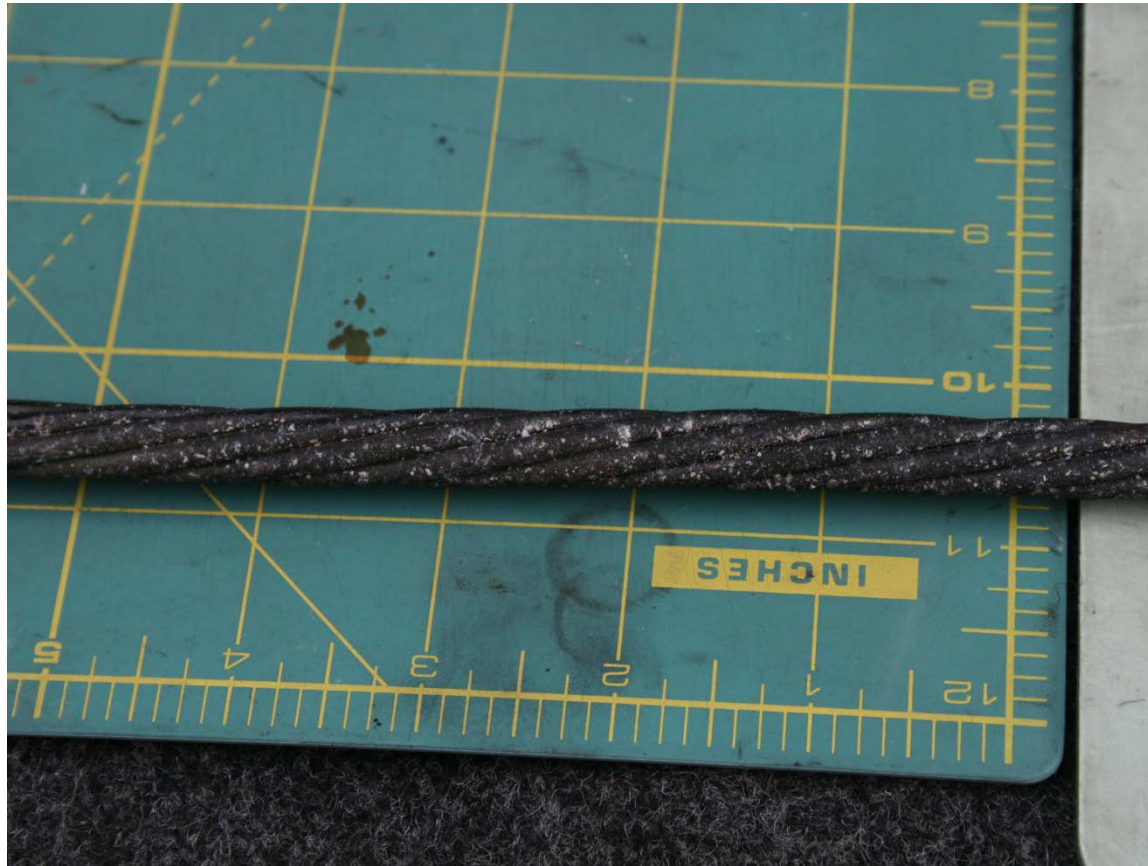
Close up of powerline conductor (Evidence Item 3). Series of photos starting from west end of item to the east after conductor was rolled to view other side. Discoloration visible on the conductor.

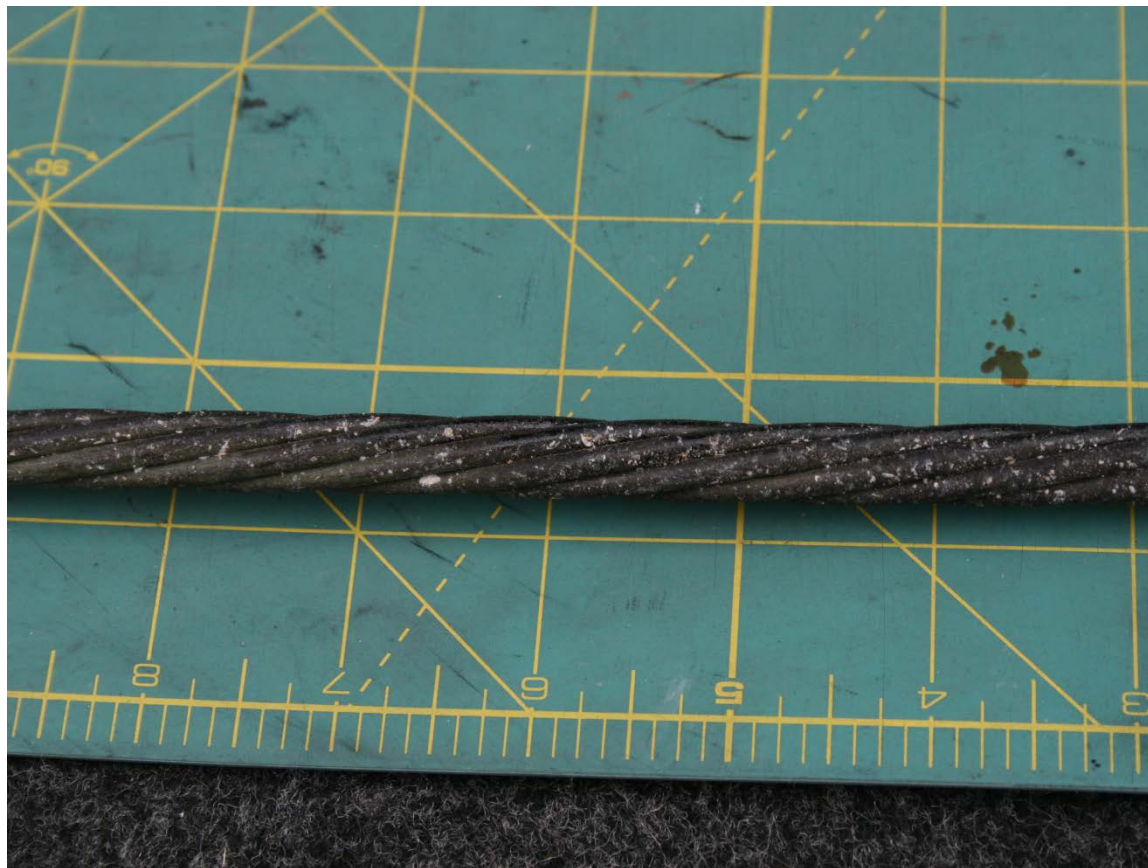
Close up of powerline conductor (Evidence Item 3). Series of photos starting from west end of item to the east after conductor was rolled to view other side. Discoloration visible on the conductor.

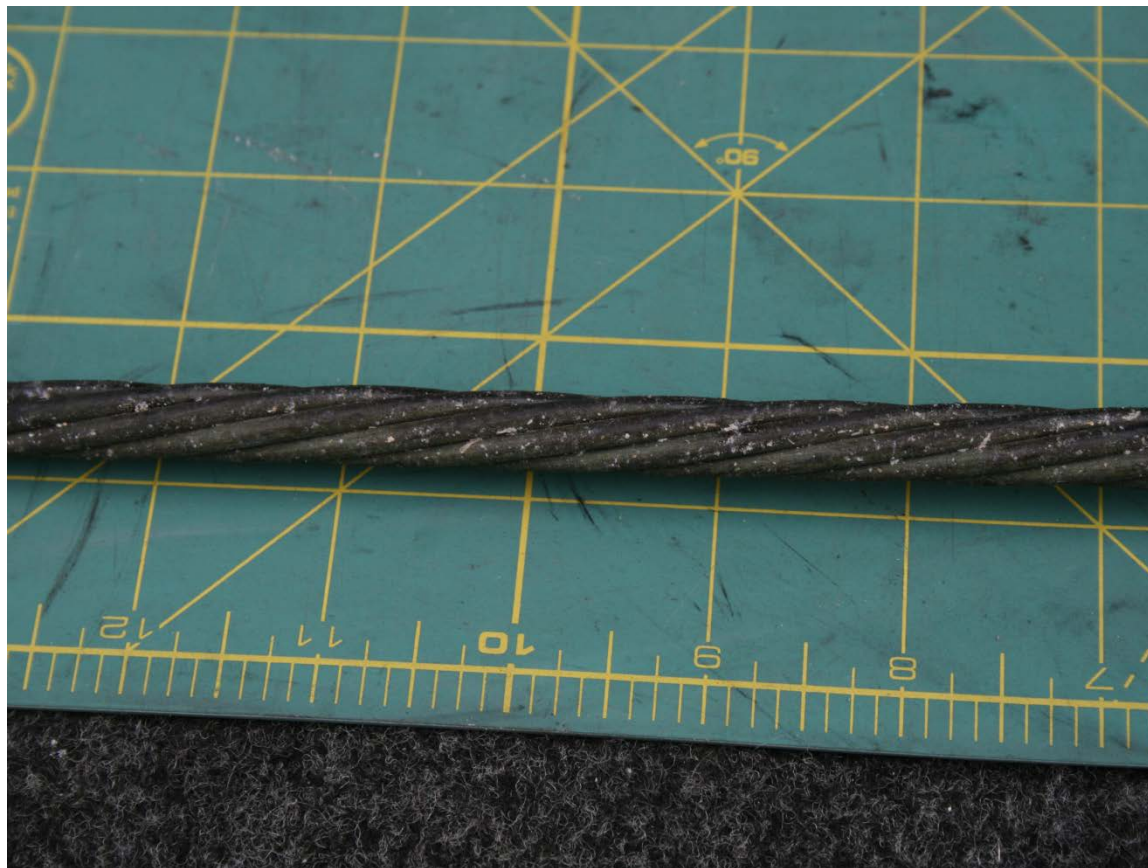
Close up of powerline conductor (Evidence Item 3). Series of photos starting from west end of item to the east after conductor was rolled to view other side. Discoloration visible on the conductor.

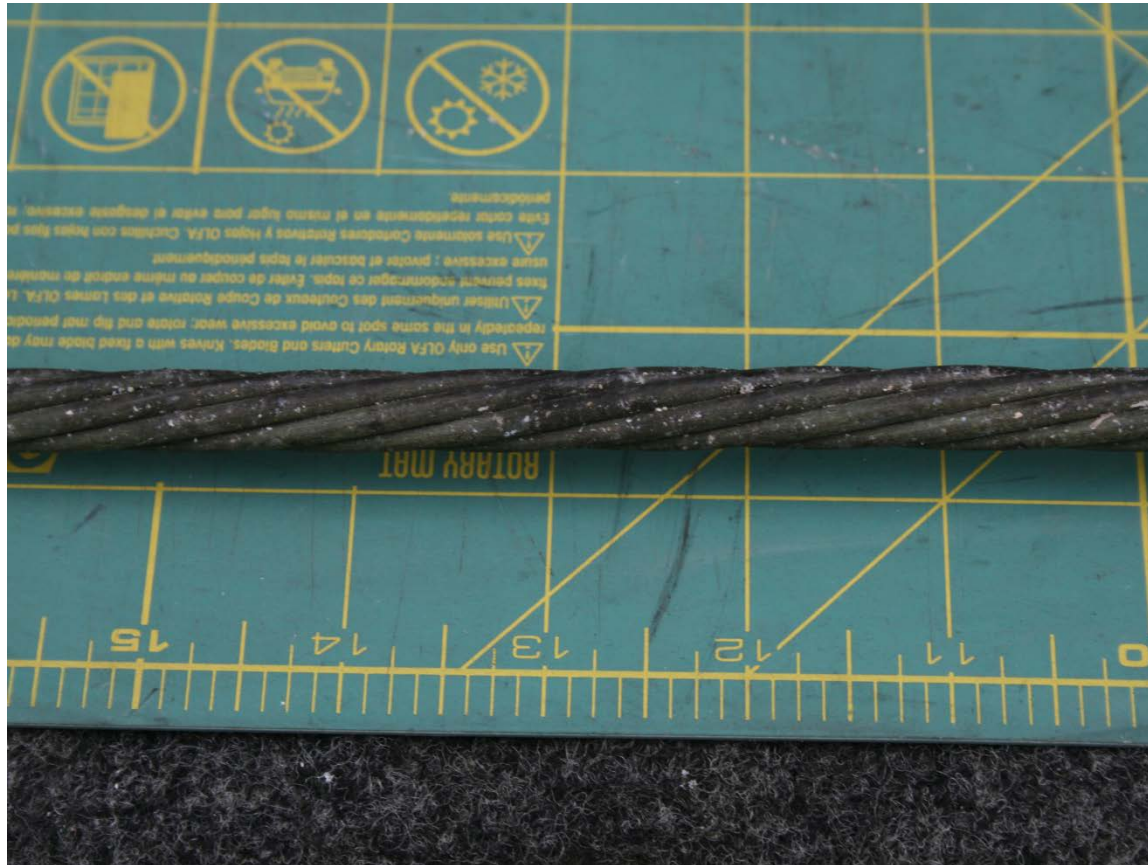
Close up of powerline conductor (Evidence Item 3). Series of photos starting from west end of item to the east after conductor was rolled to view other side. Discoloration visible on the conductor.

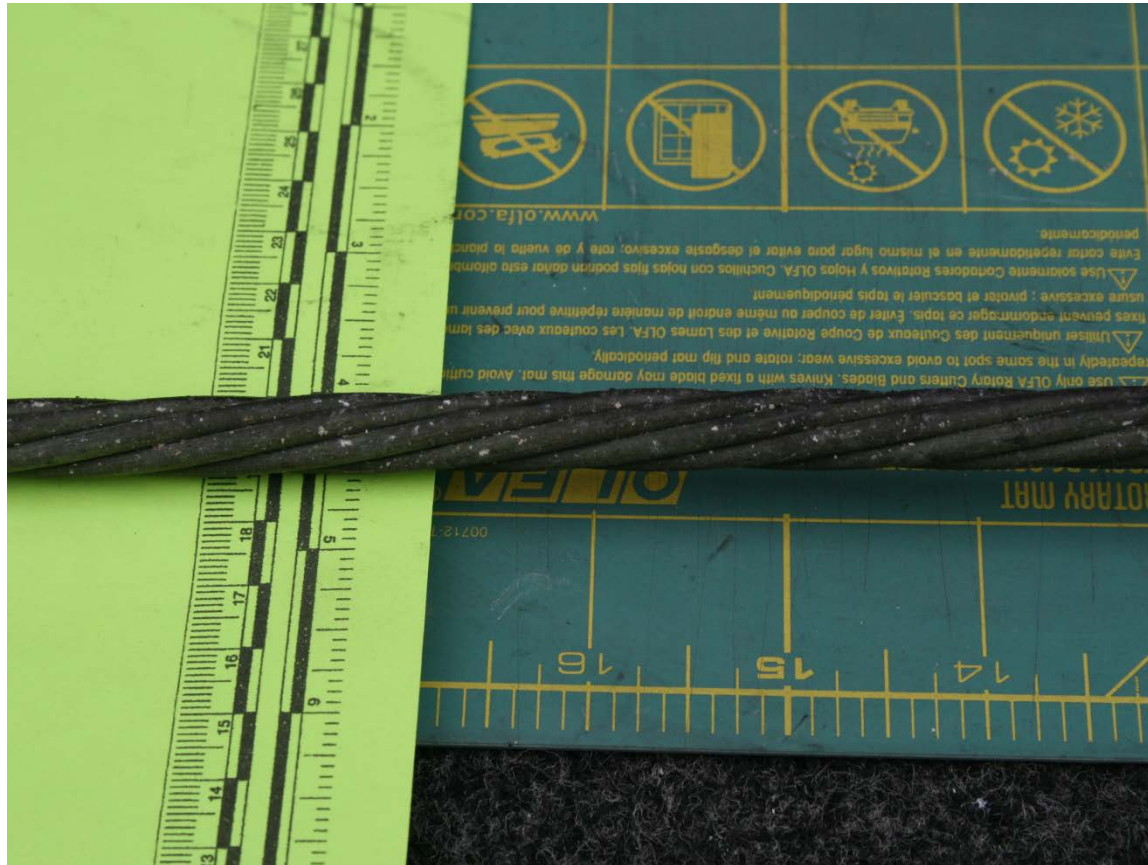
Close up of powerline conductor (Evidence Item 3). Series of photos starting from west end of item to the east after conductor was rolled to view other side. Discoloration visible on the conductor.

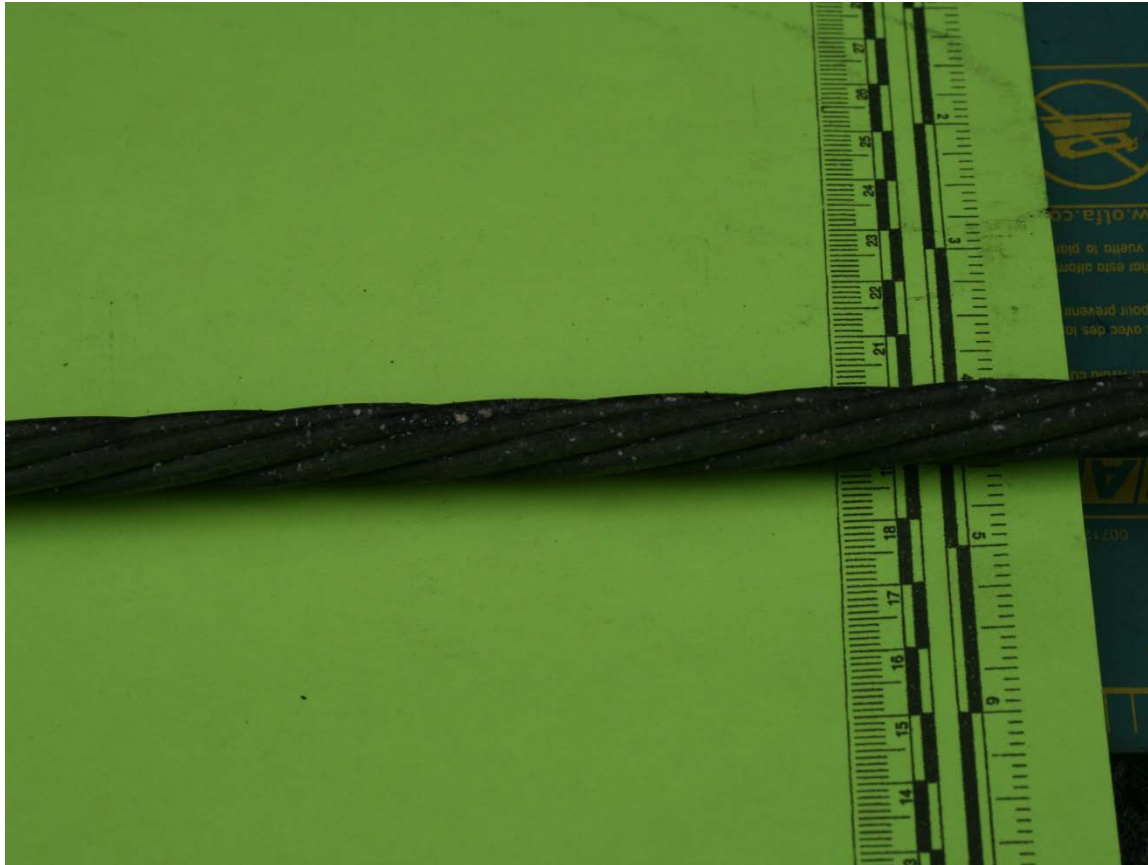
**Photo 121**

Close up of powerline conductor (Evidence Item 3). Series of photos starting from west end of item to the east after conductor was rolled to view other side. Discoloration visible on the conductor.

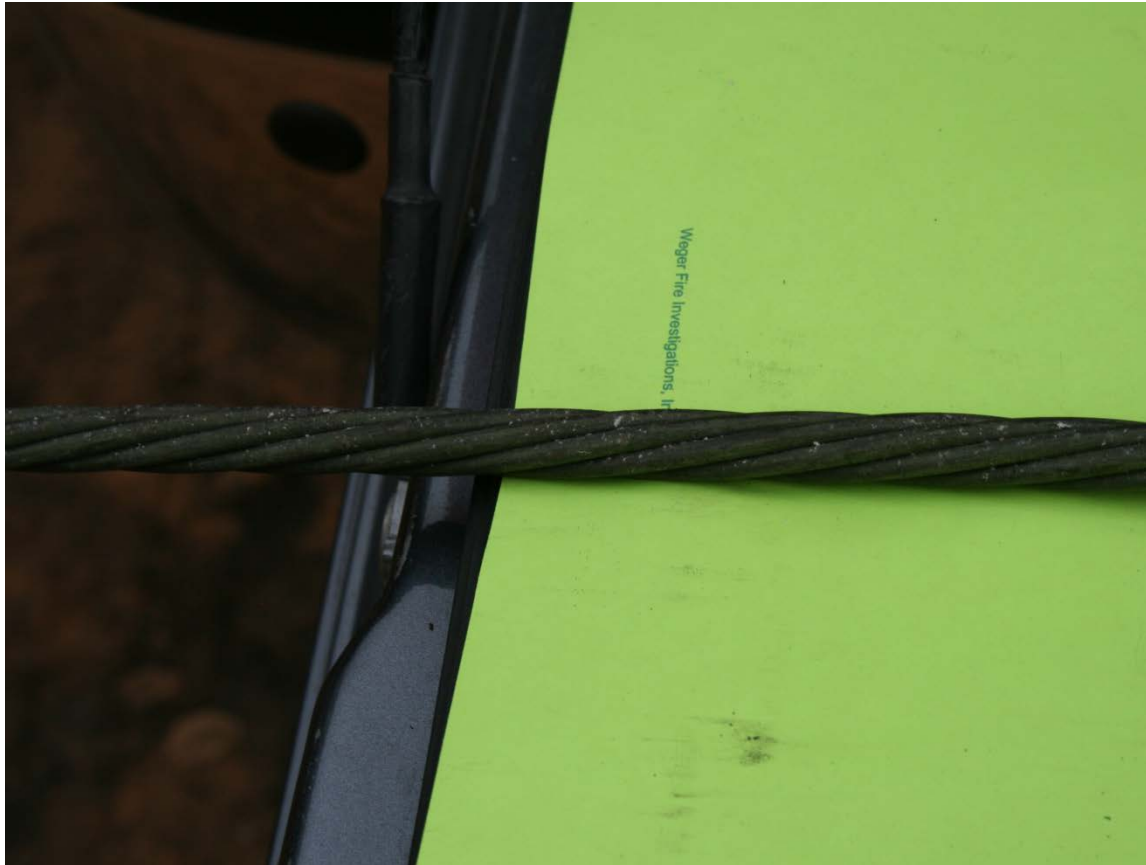
Close up of powerline conductor (Evidence Item 3). Series of photos starting from west end of item to the east after conductor was rolled to view other side. Discoloration visible on the conductor.

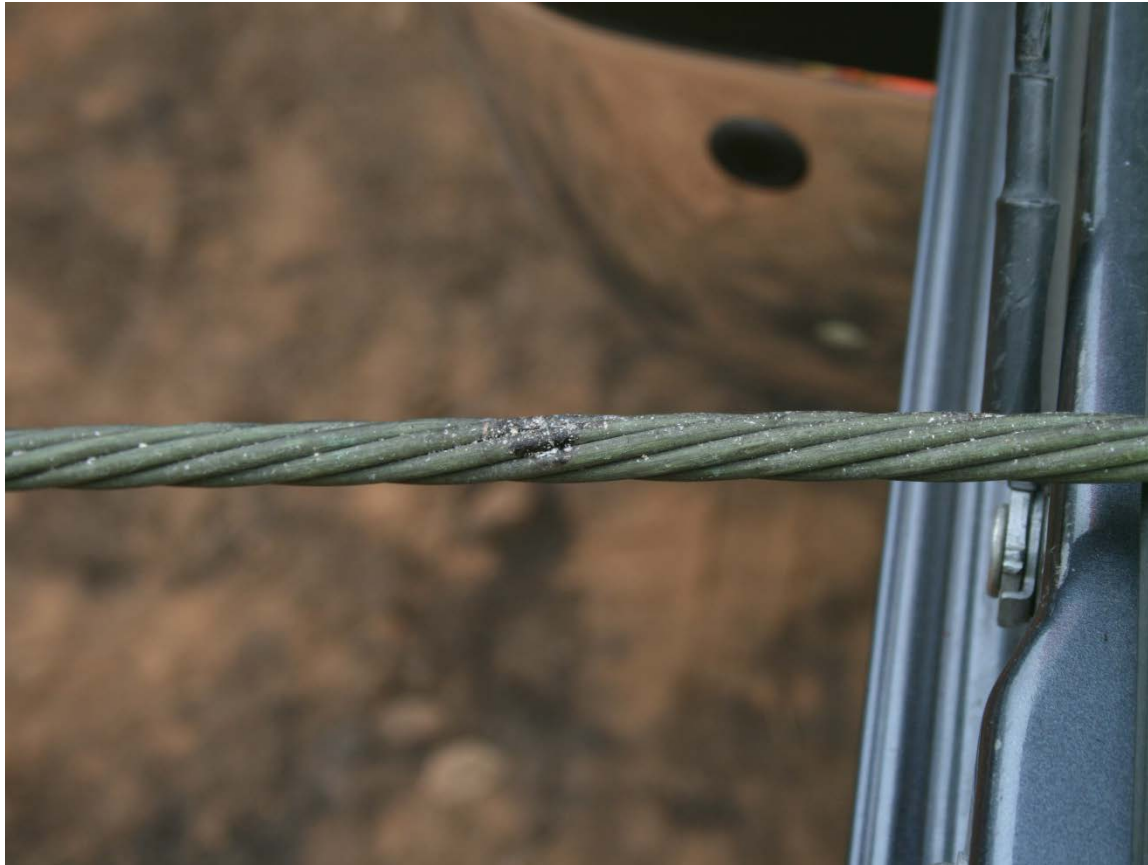
**Photo 124**

Close up of powerline conductor (Evidence Item 3). Series of photos starting from west end of item to the east after conductor was rolled to view other side. Discoloration visible on the conductor.

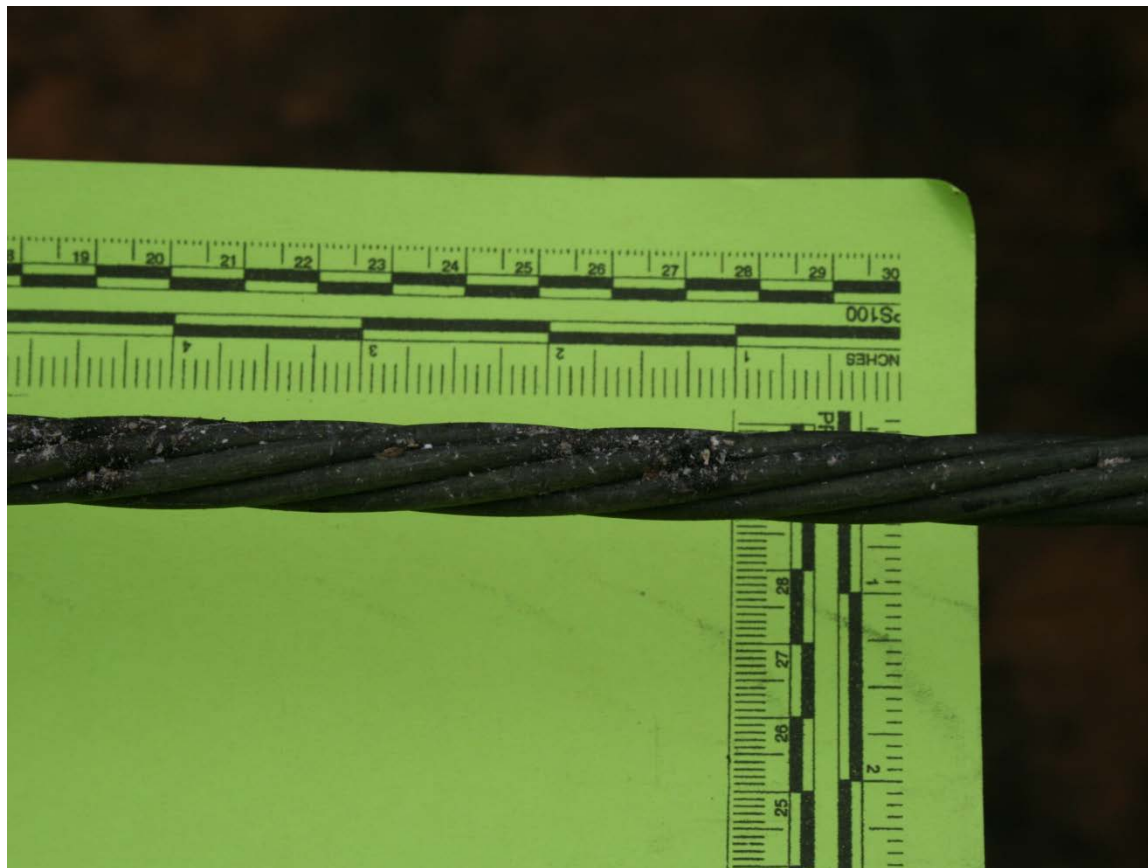
Close up of powerline conductor (Evidence Item 3). Close up of a portion of the discolored area showing substance stuck to the conductor.

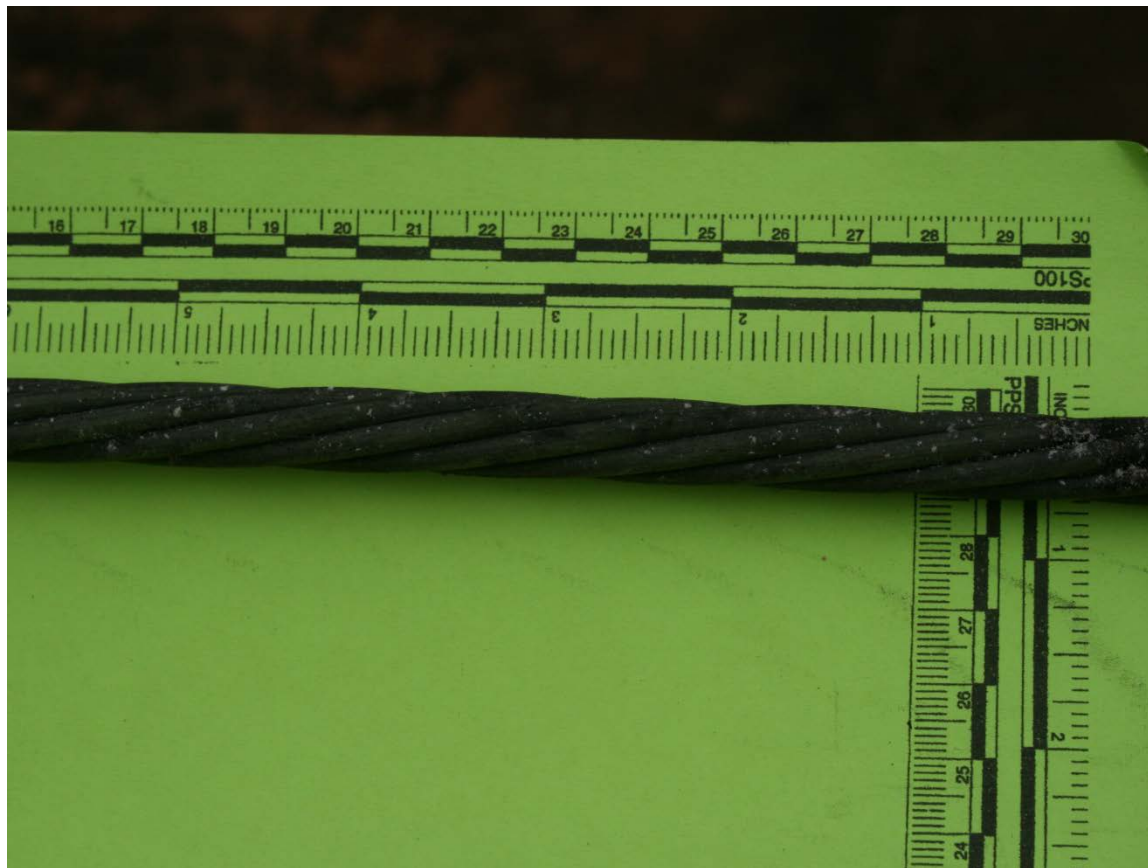
Close up of powerline conductor (Evidence Item 3). Close up of a portion of the discoloration in the area where it appears a substance is stuck to the conductor.
