**Butte Incident**

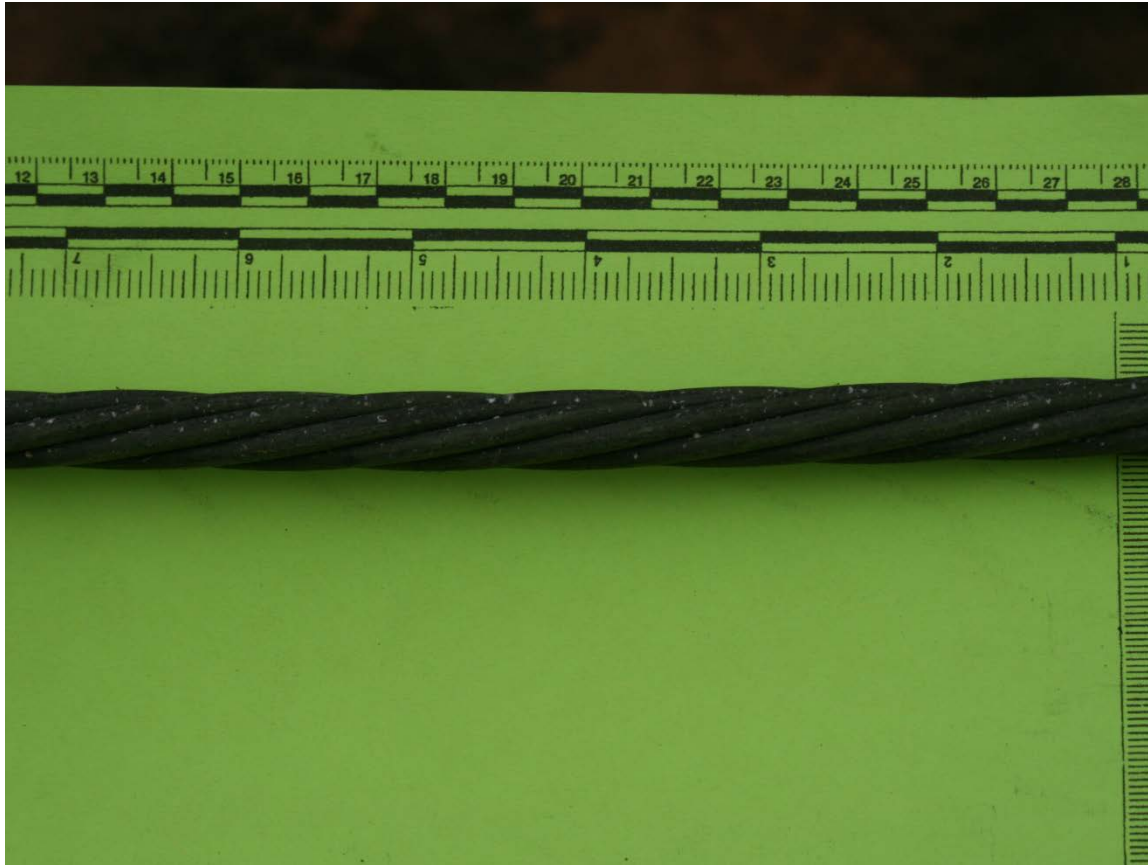
Close up of powerline conductor (Evidence Item 3). Close up of a portion of the discoloration in the area where it appears a substance is stuck to the conductor.

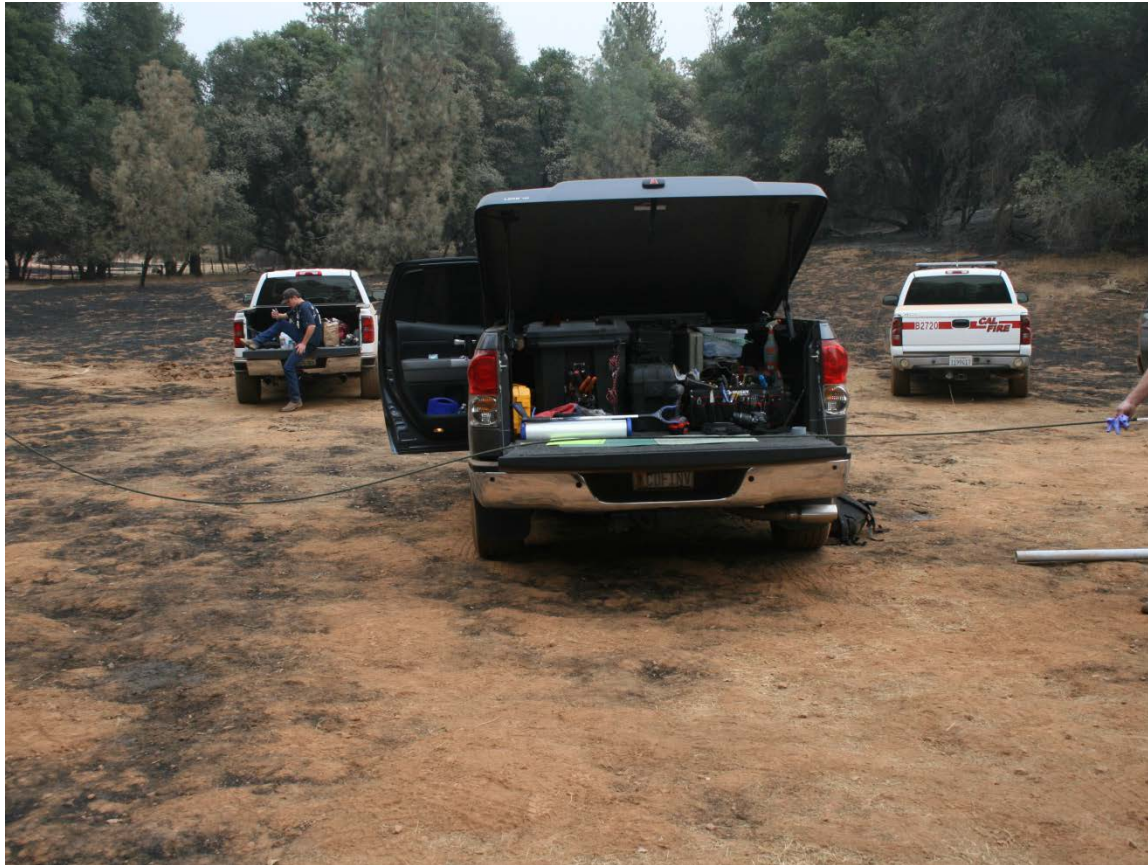
**Photo 129**

Overview of Evidence Item 3.

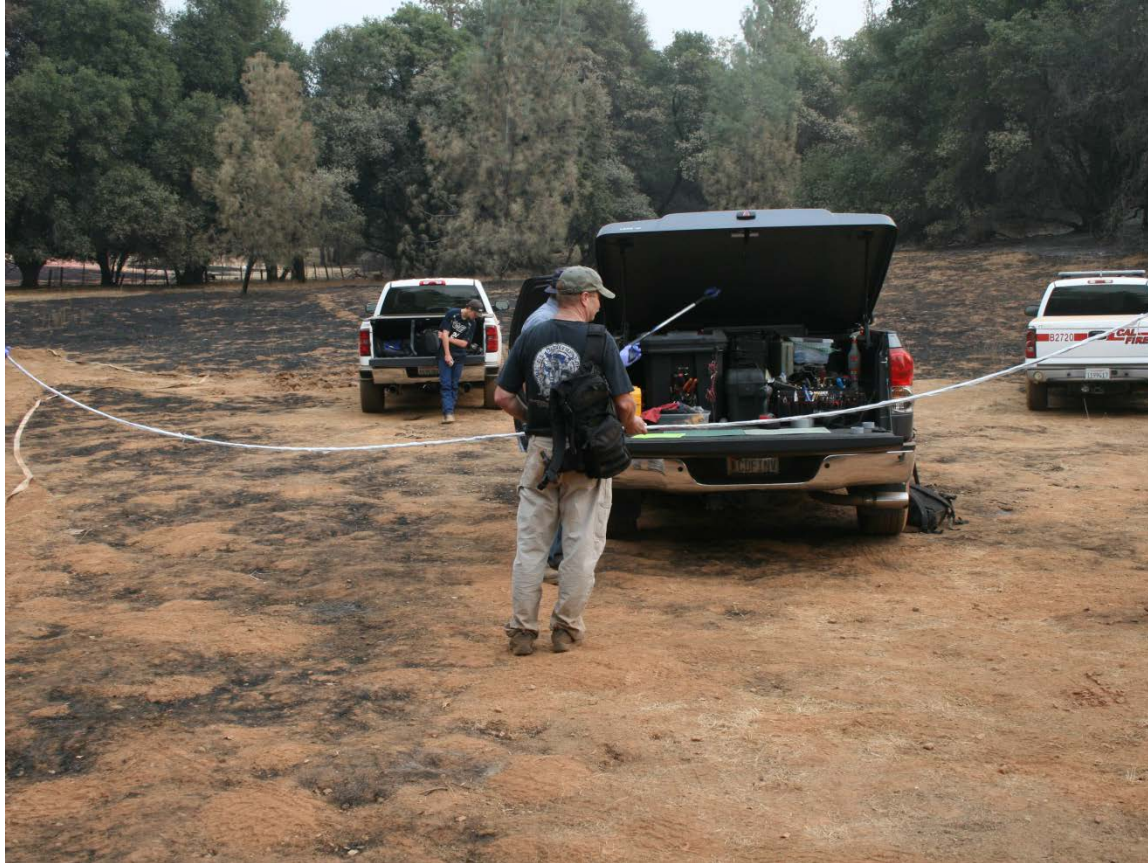
**Photo 130**

Evidence Item 3 being packaged as evidence.

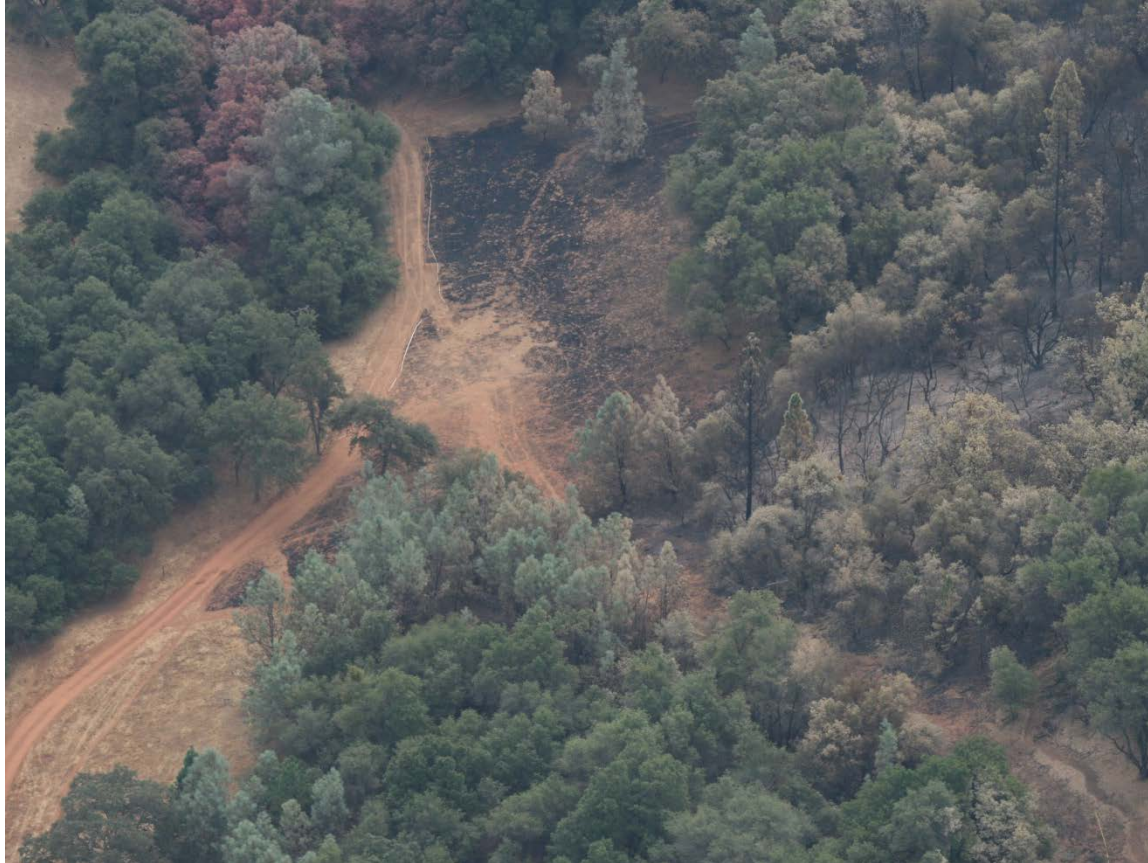
**Photo 136**

Taken from helicopter, facing south to southeast, closer view of the origin area and powerline corridor.

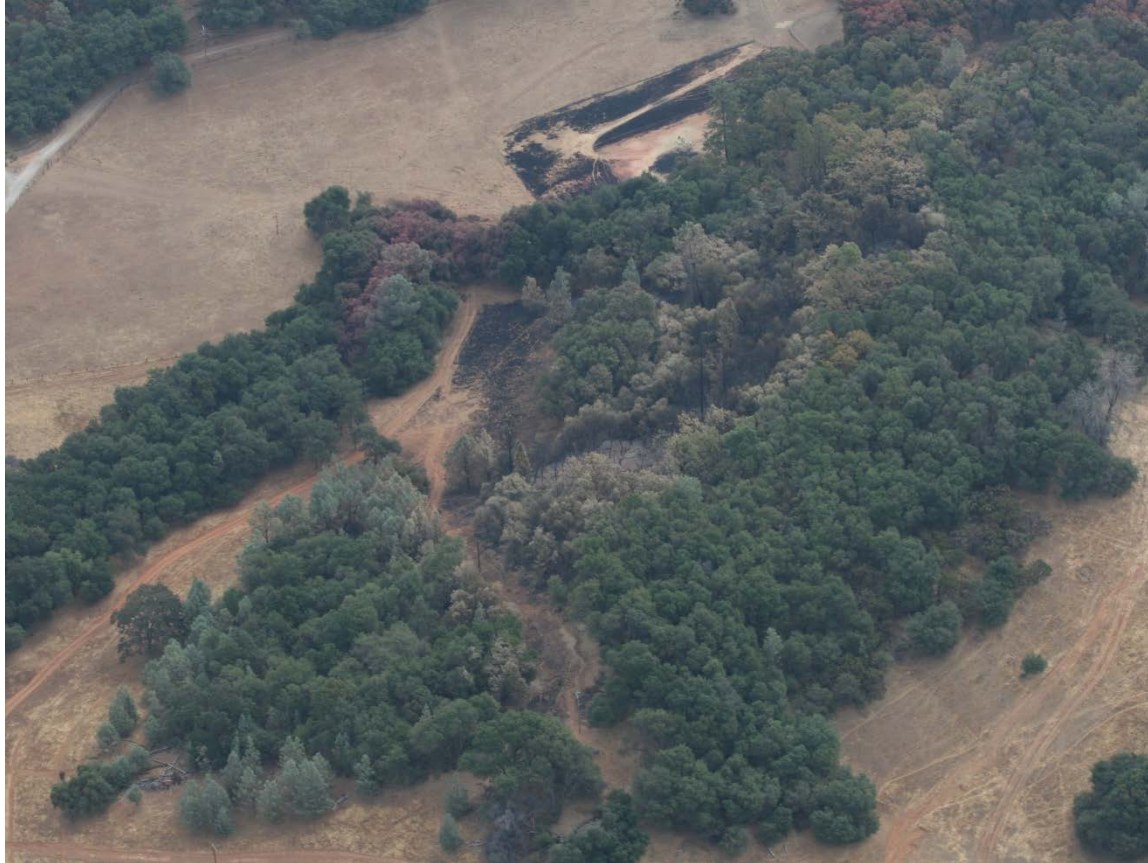
**Photo 137**

Taken from helicopter, facing east to southeast, overview of the powerline corridor and origin area.

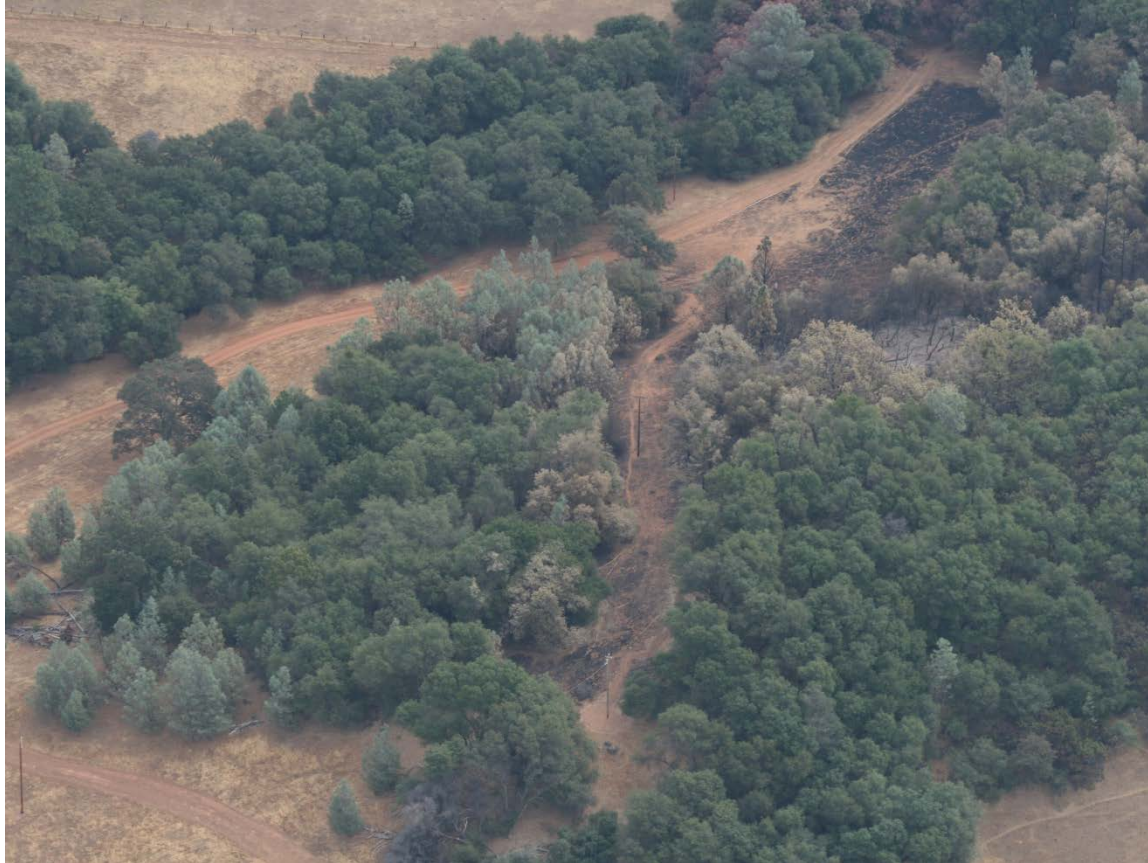
**Photo 138**

Taken from helicopter, facing east, looking down the powerline corridor at the origin area.

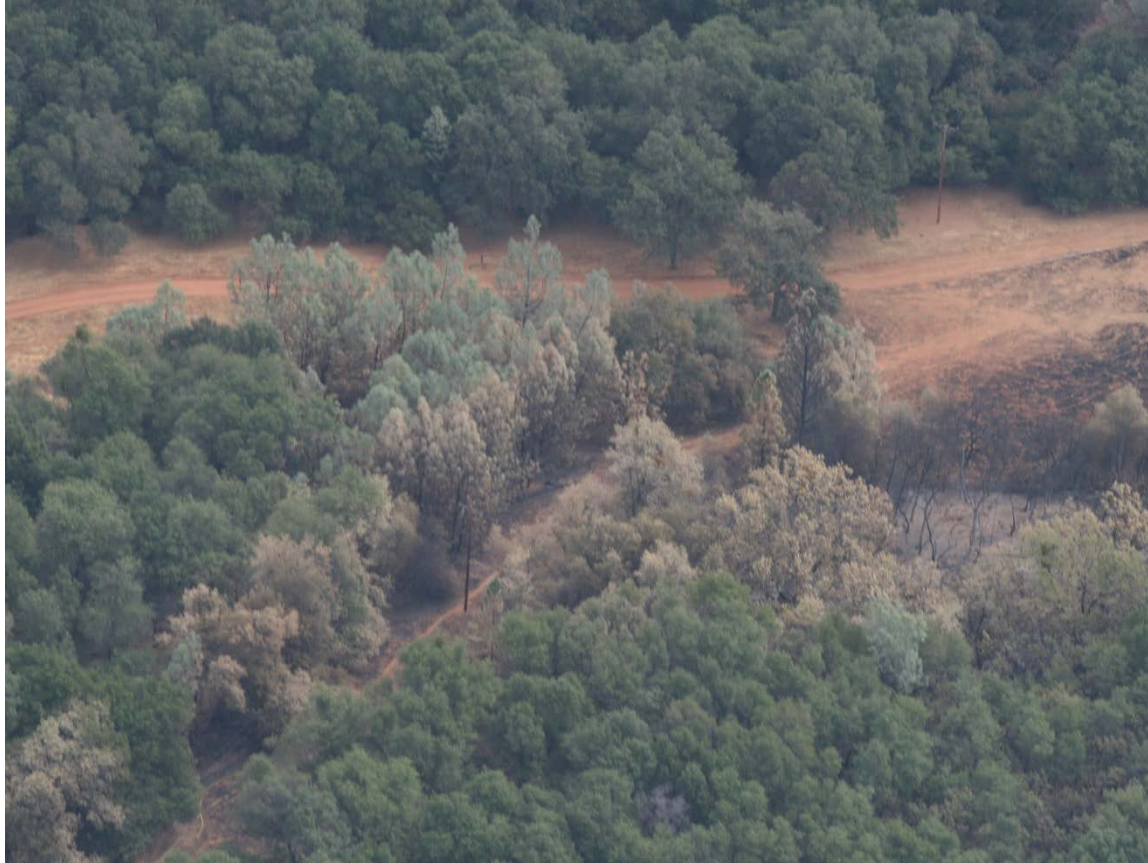
**Photo 140**

Taken from helicopter, facing east to northeast, looking back at the powerline corridor and the origin area.

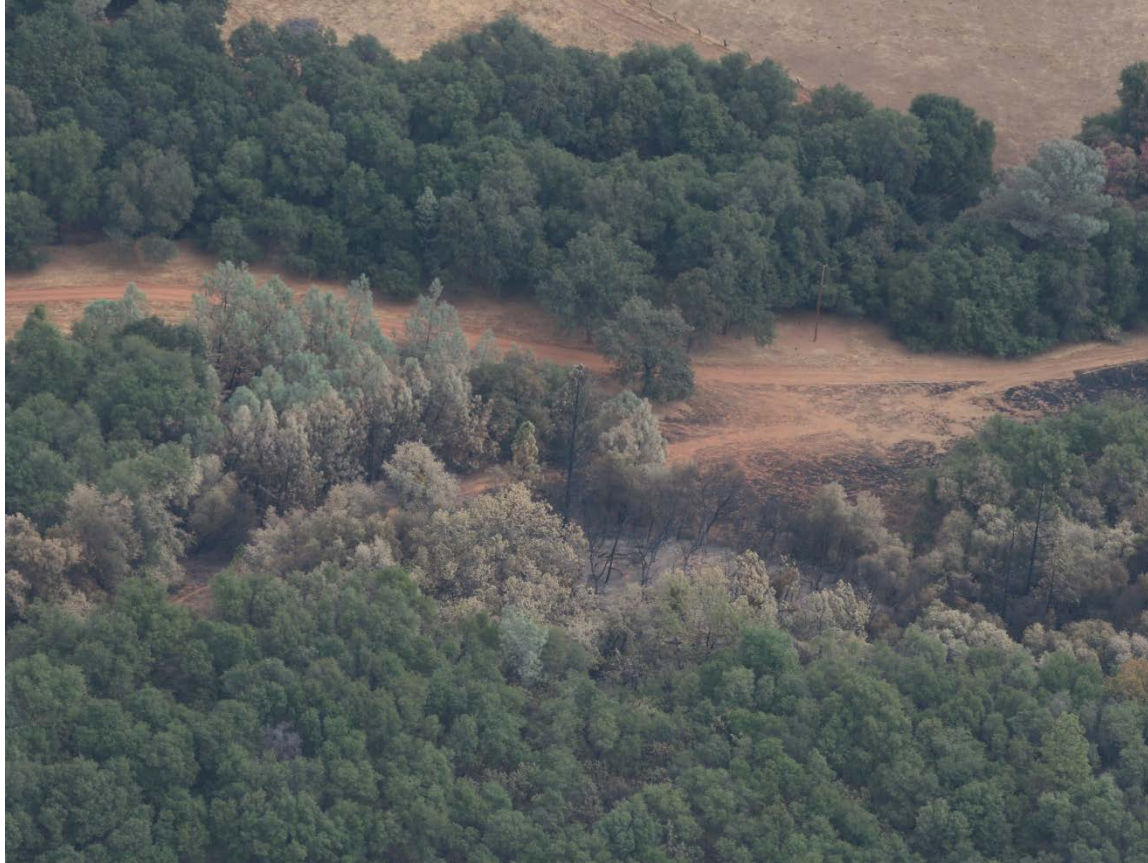
**Photo 141**

Taken from helicopter, facing northeast, looking back at the origin area.

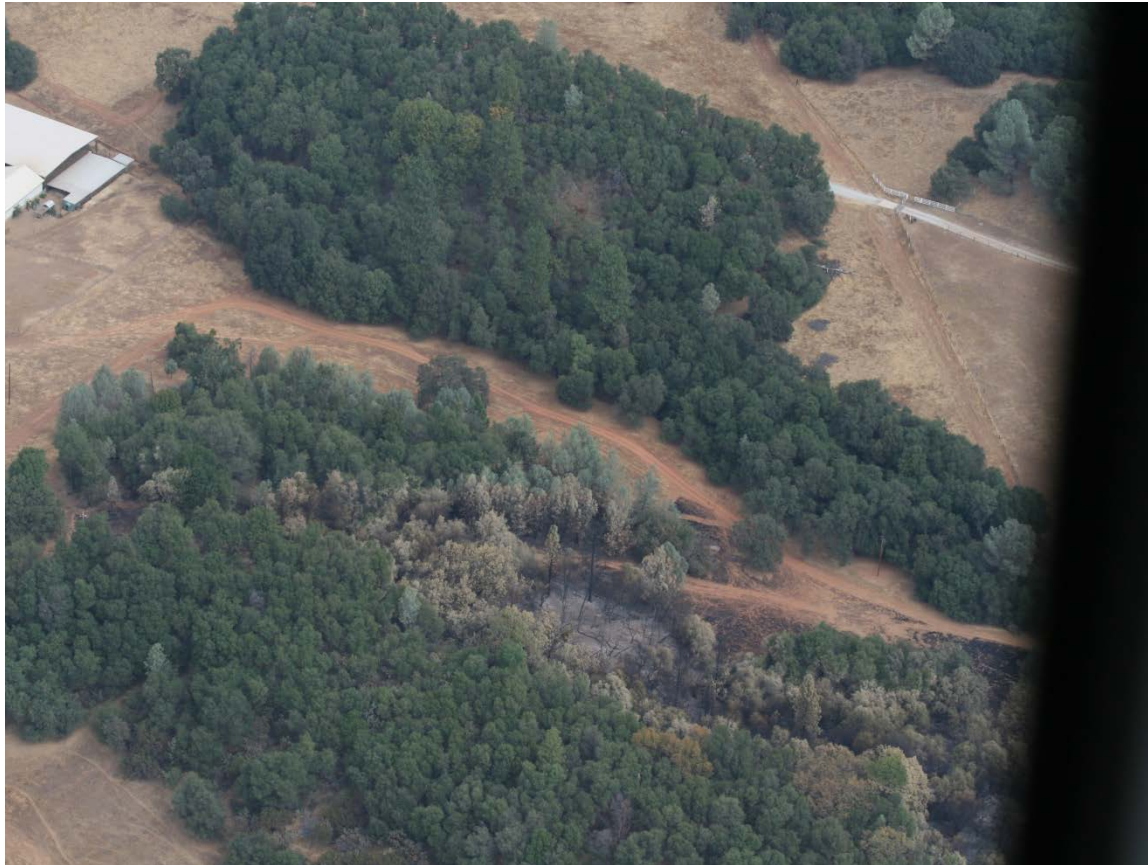
Taken from helicopter, facing northeast, overview of the origin area.

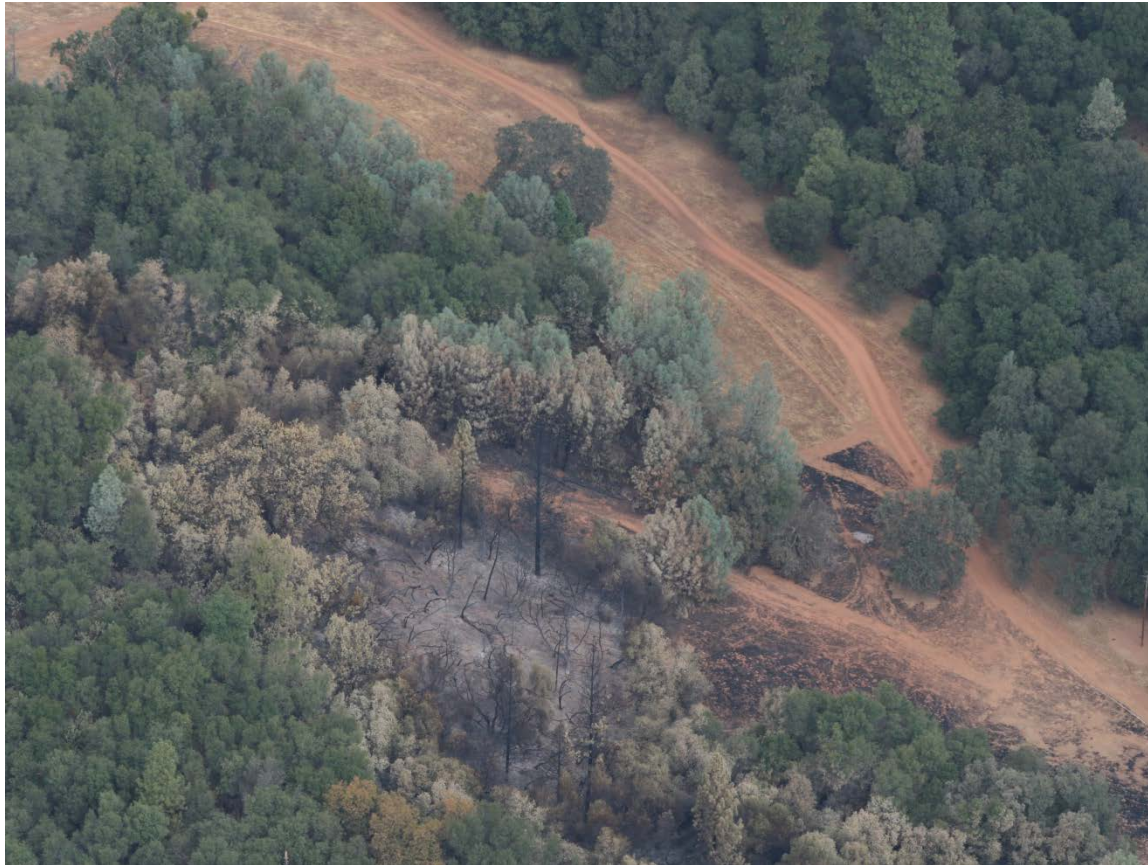
**Photo 143**

Taken from helicopter, facing north to northeast, looking through the advancing (head) of the fire towards the origin area.

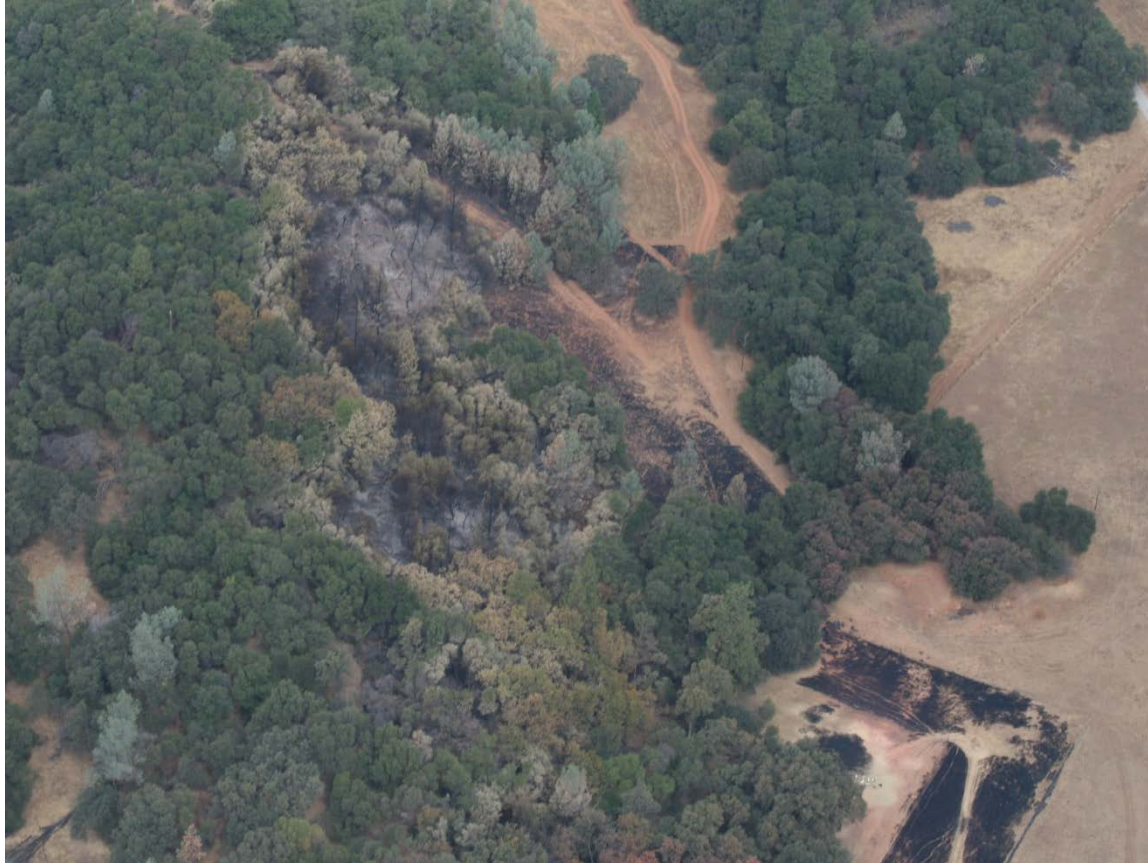
**Photo 144**

Taken from helicopter, facing north, overview of the origin area, from over the top of the last residence on Charamuga Ranch Road.

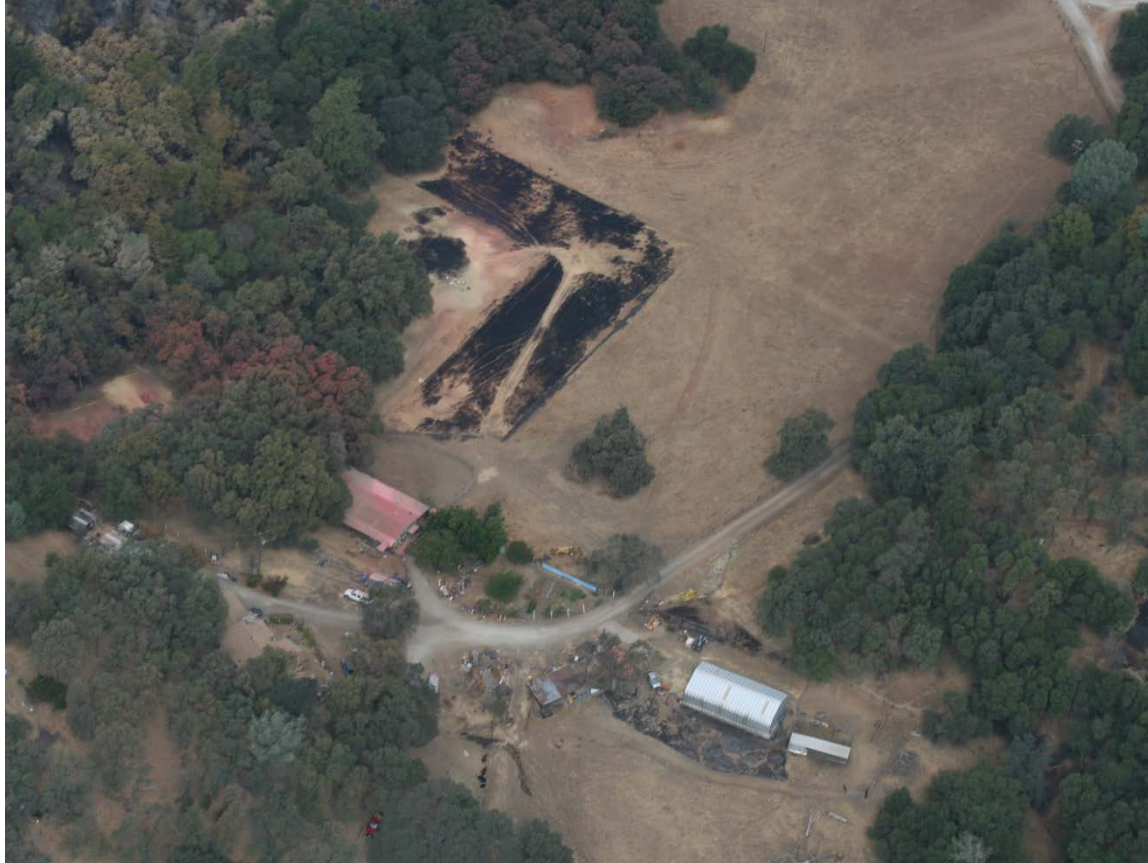
**Photo 145**

Taken from helicopter, overview of residence at the end of Charamuga Ranch Road. Residence was just south of origin area where initial spot fires were observed.

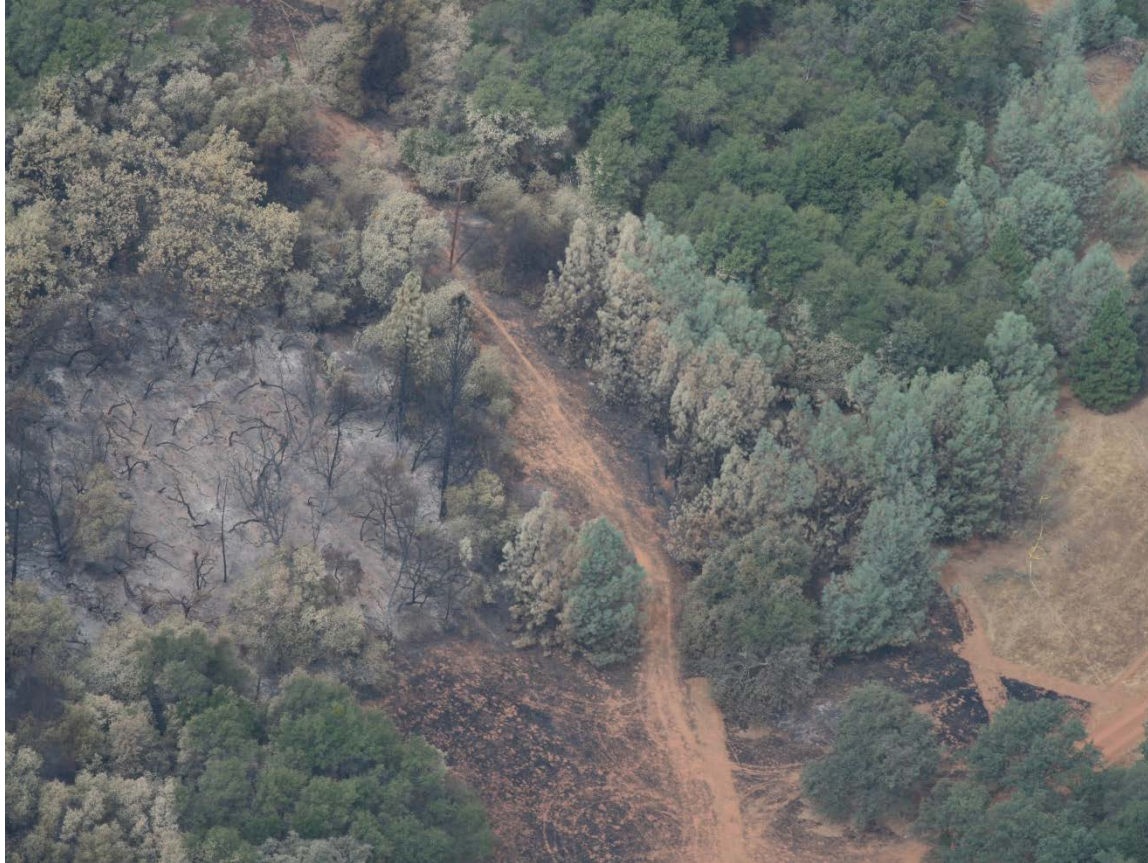
**Photo 146**

Taken from helicopter, facing northwest, overview of the origin area.

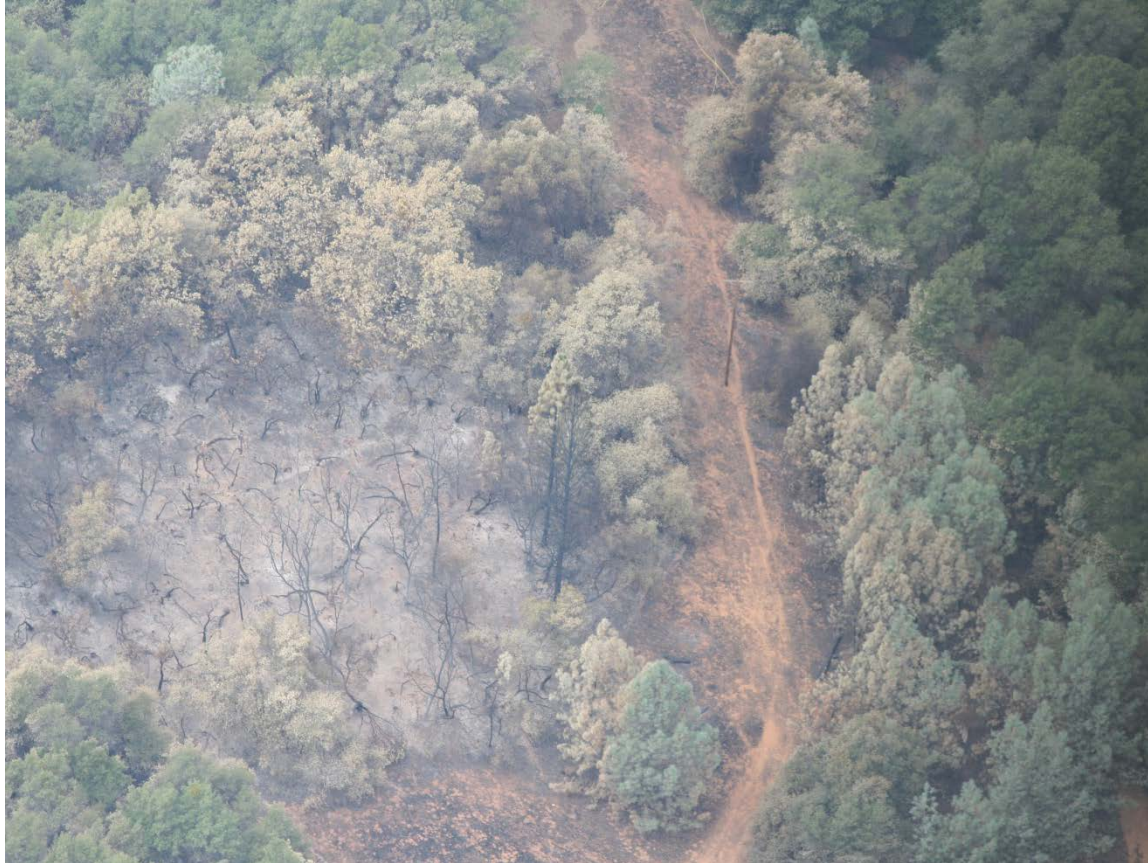
**Photo 147**

Taken from helicopter, facing west, overview of the origin area, looking down powerline corridor.

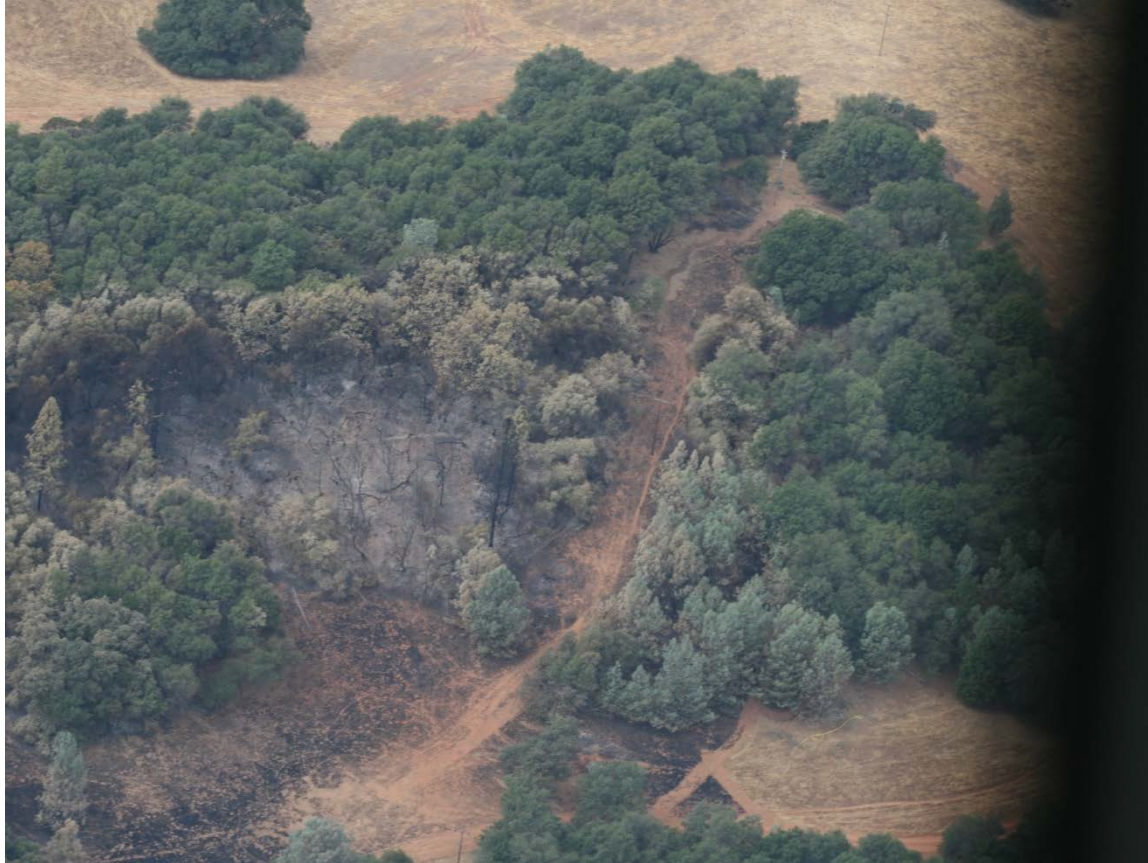
**Photo 148**

Taken from helicopter, facing west, overview of the origin area, looking down powerline corridor.

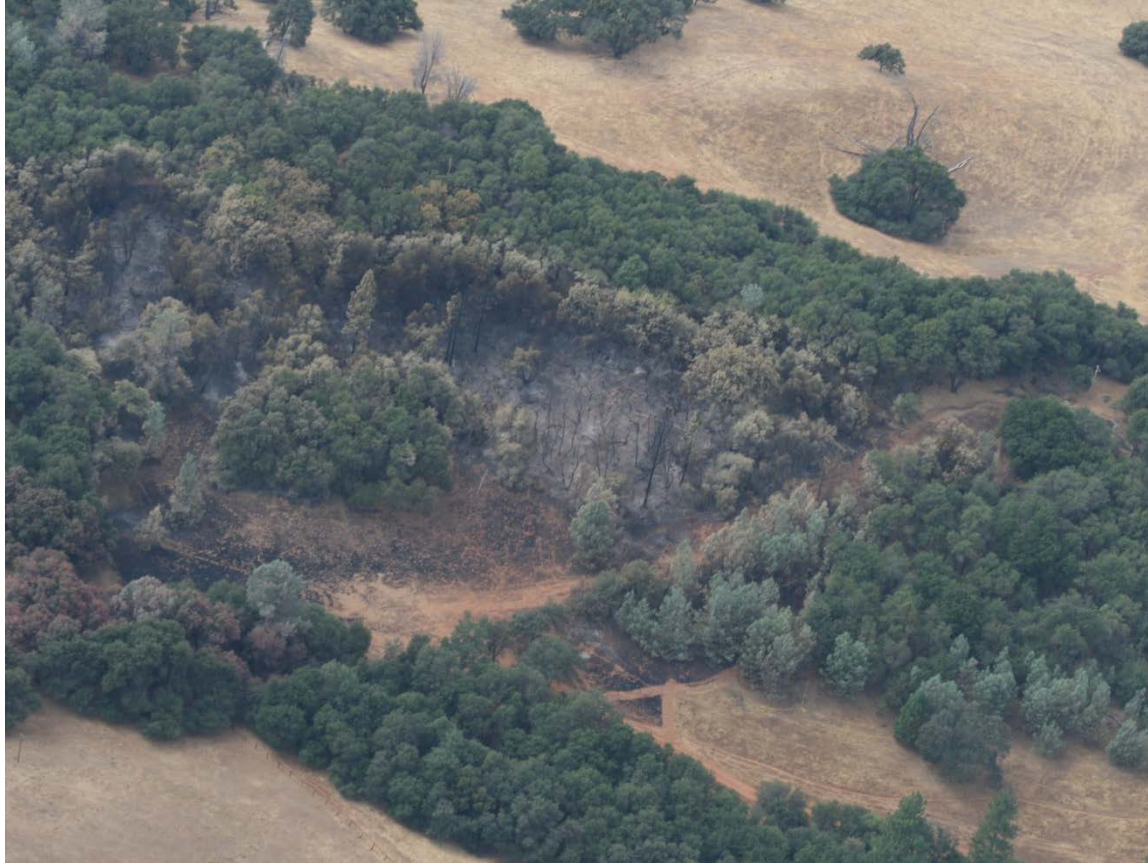
**Photo 150**

Taken from helicopter, facing southwest, overview of the origin area.

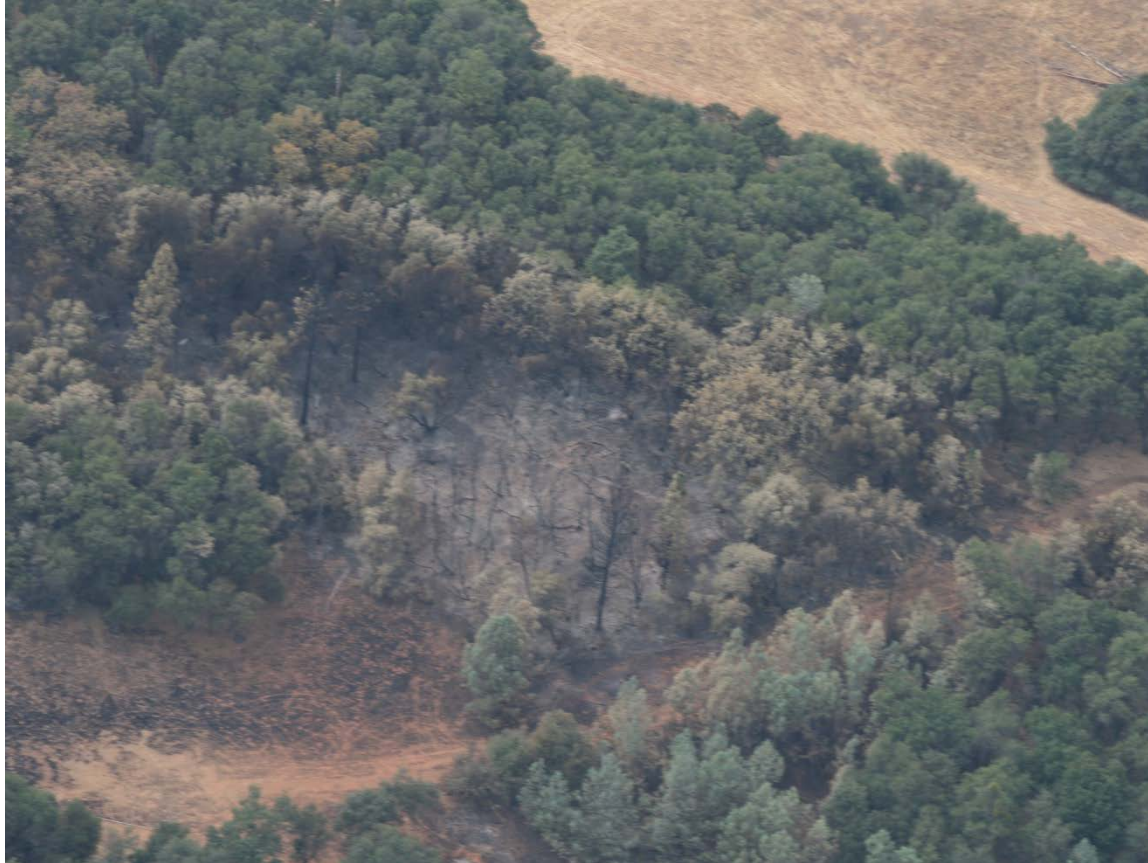
**Photo 151**

Taken from helicopter, facing southwest, overview of the origin area.

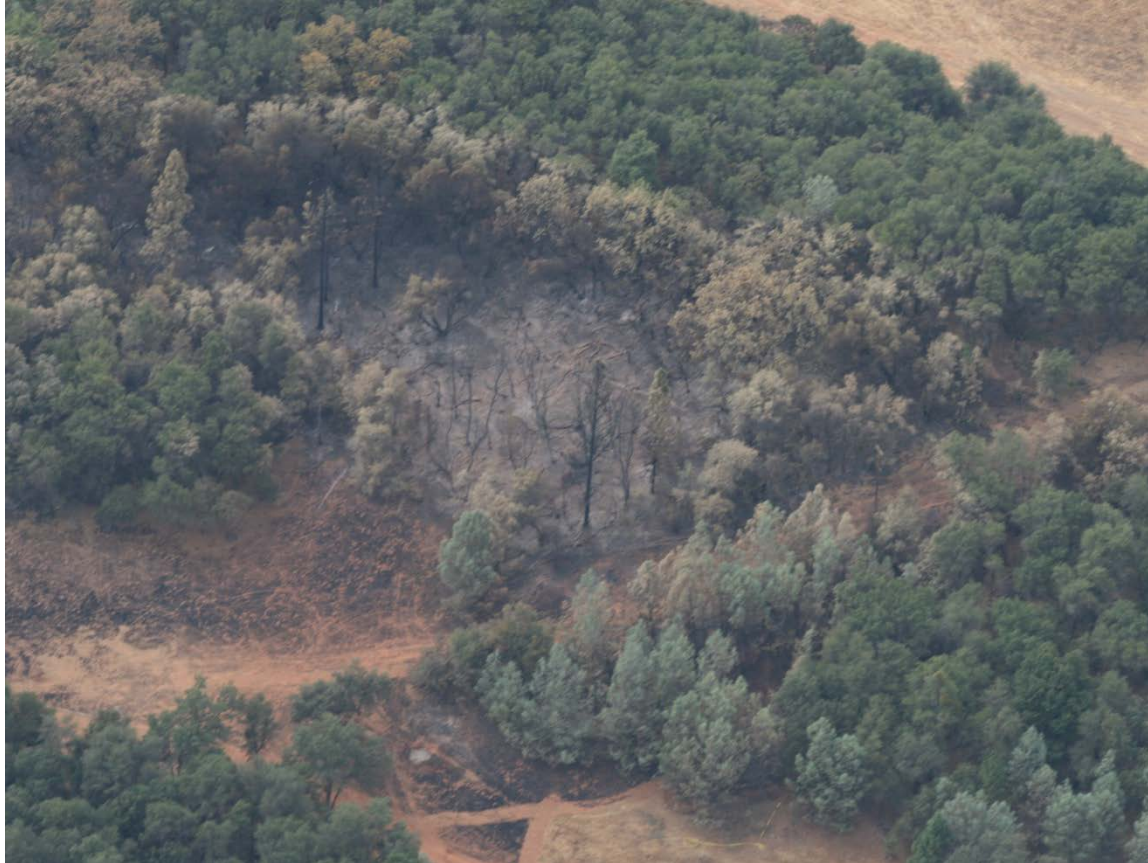
**Photo 152**

Taken from helicopter, facing southwest, overview of the origin area.

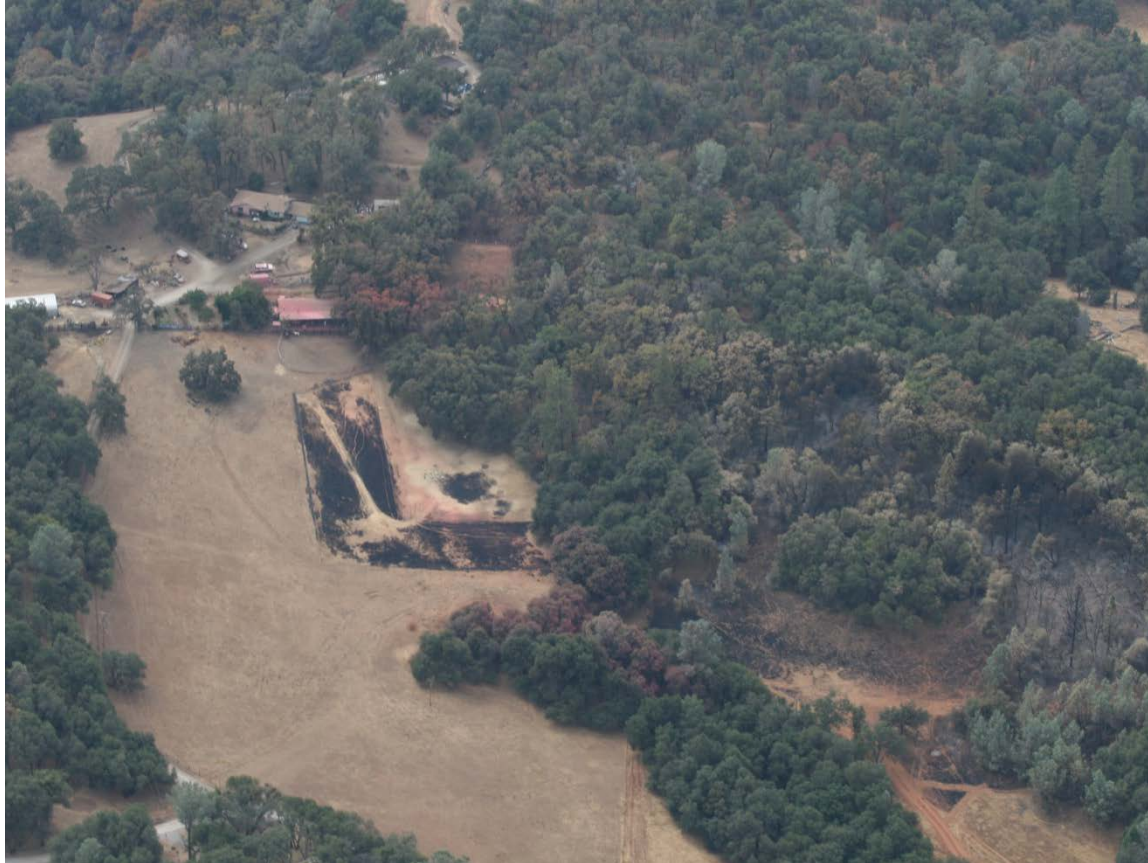
**Photo 153**

Taken from helicopter, facing south, residence at the end of Charamuga Ranch Road.

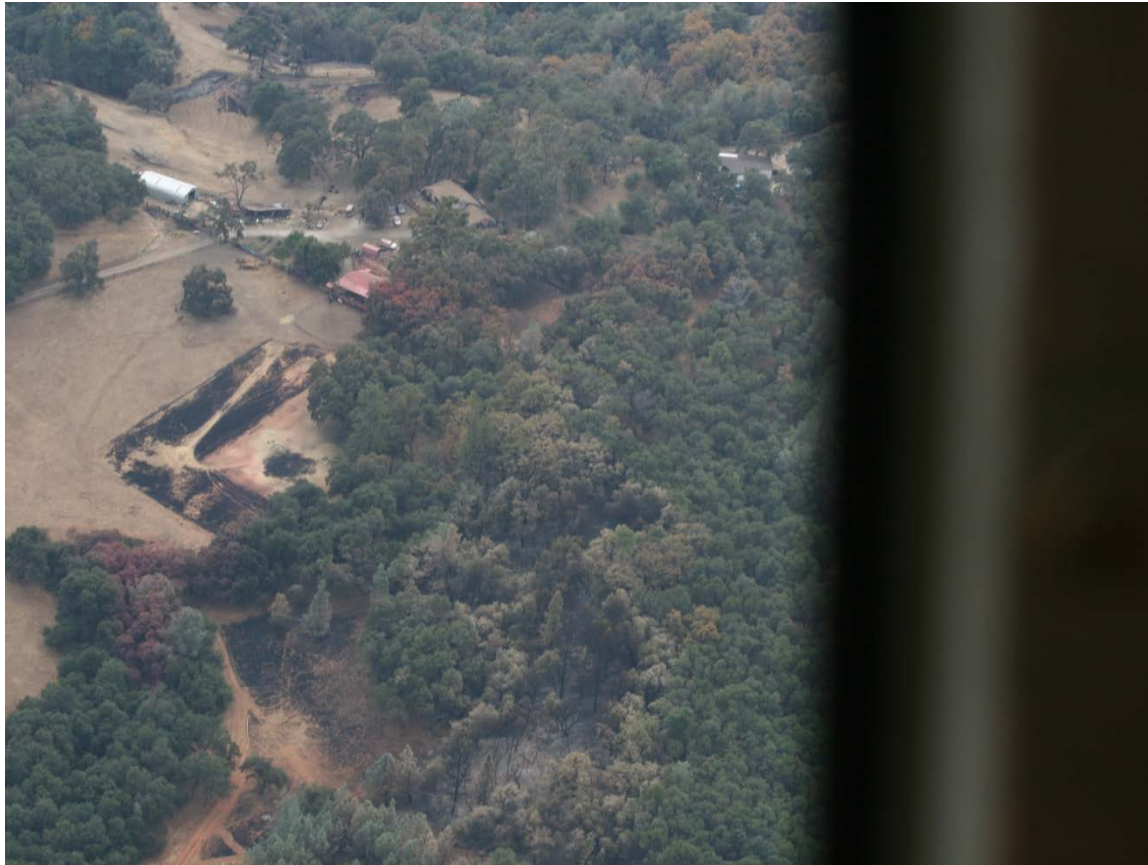
**Photo 154**

Taken from helicopter, facing south, overview of the origin area and residence at the end of Charamuga Ranch Road.

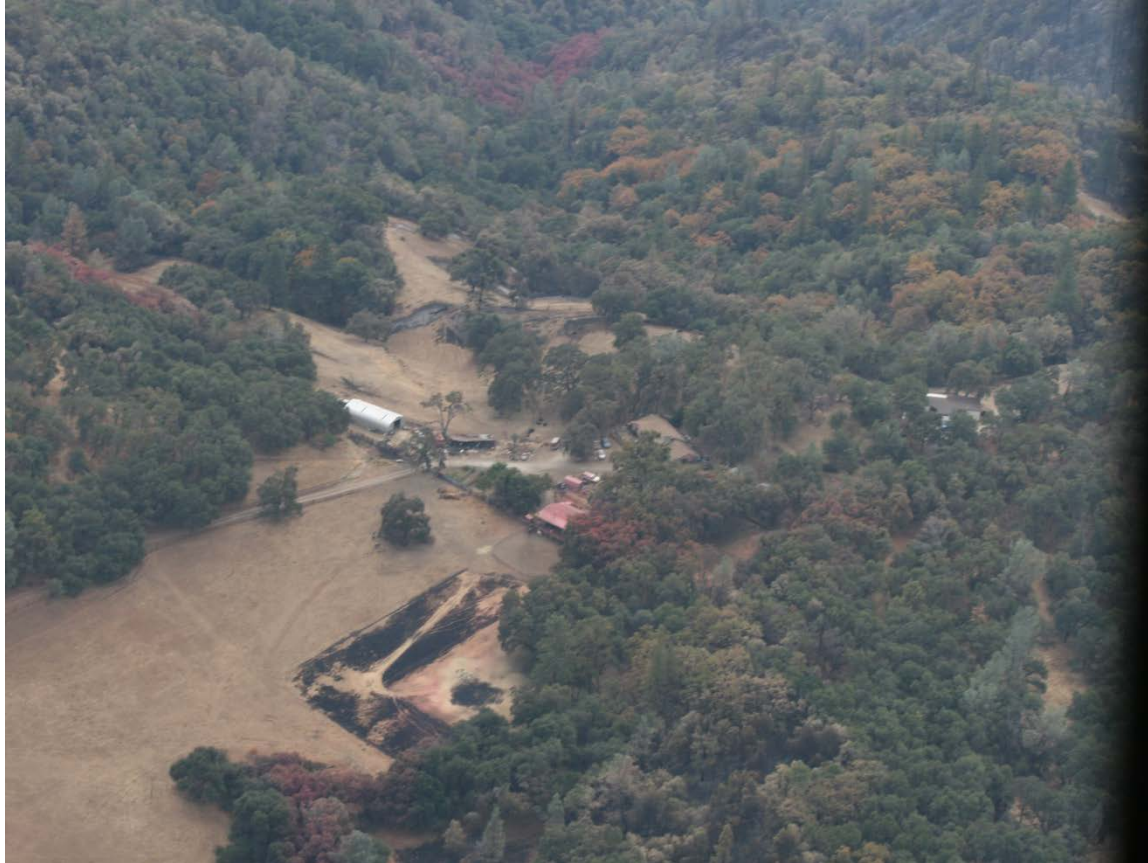
**Photo 155**

Taken from helicopter, facing southeast, overview of the residence at the end of Charamuga Ranch Road.

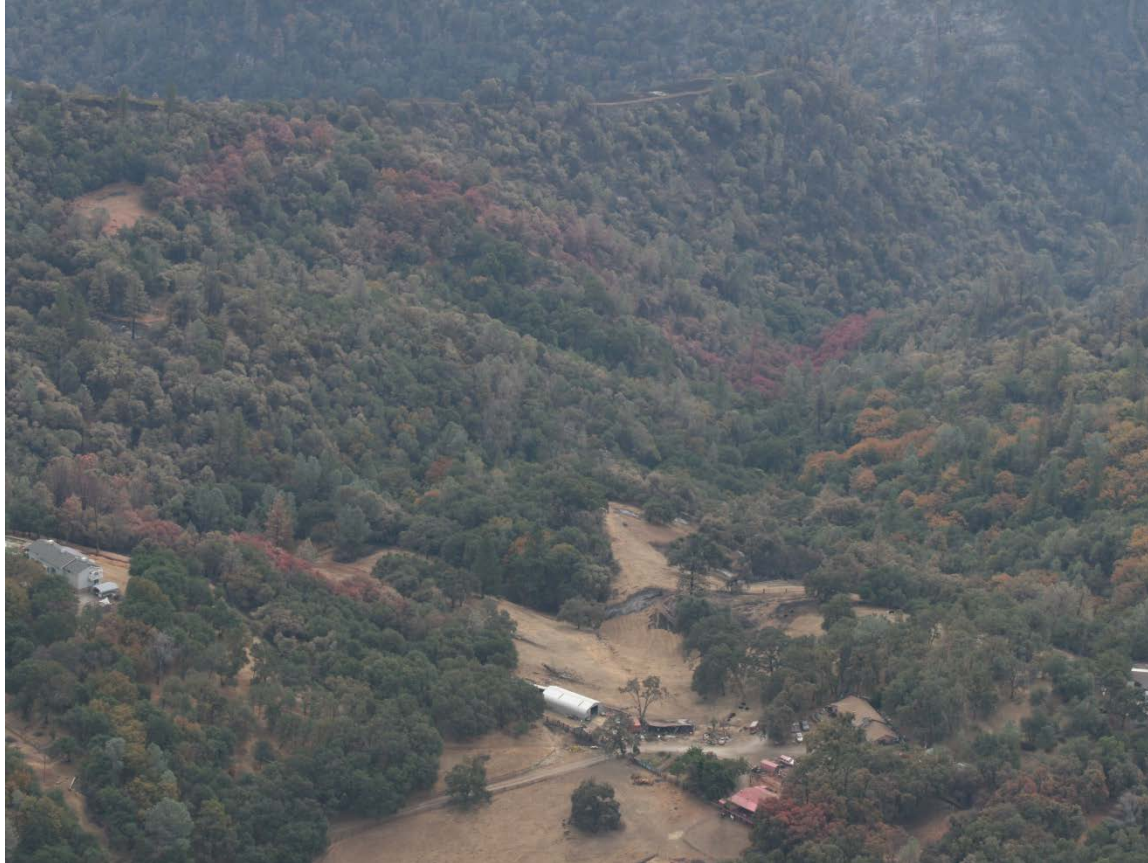
**Photo 156**

Taken from helicopter, facing southeast, view from above the origin area looking into the Mokelumne River drainage.
