**Butte Incident**

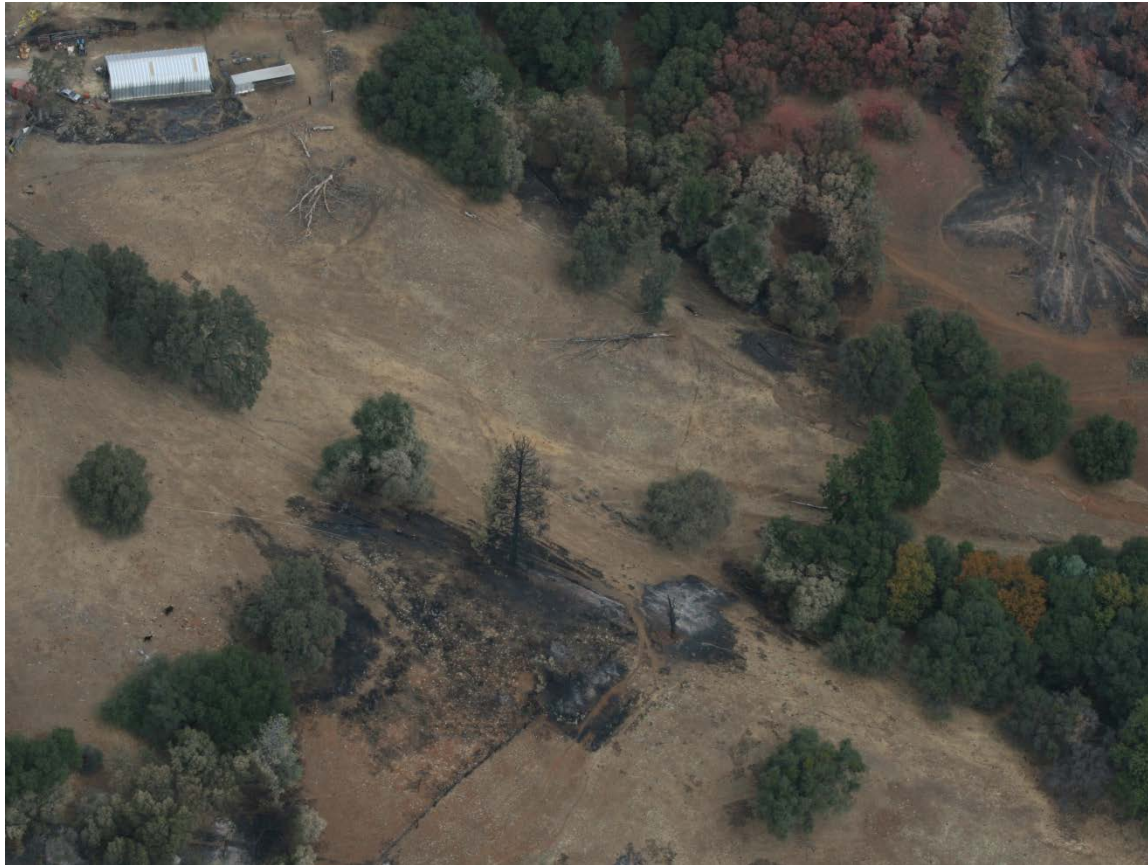
**Photo 157**

Taken from helicopter, view of some of the spot fires south of the residence at the end of Charamuga Ranch Road.

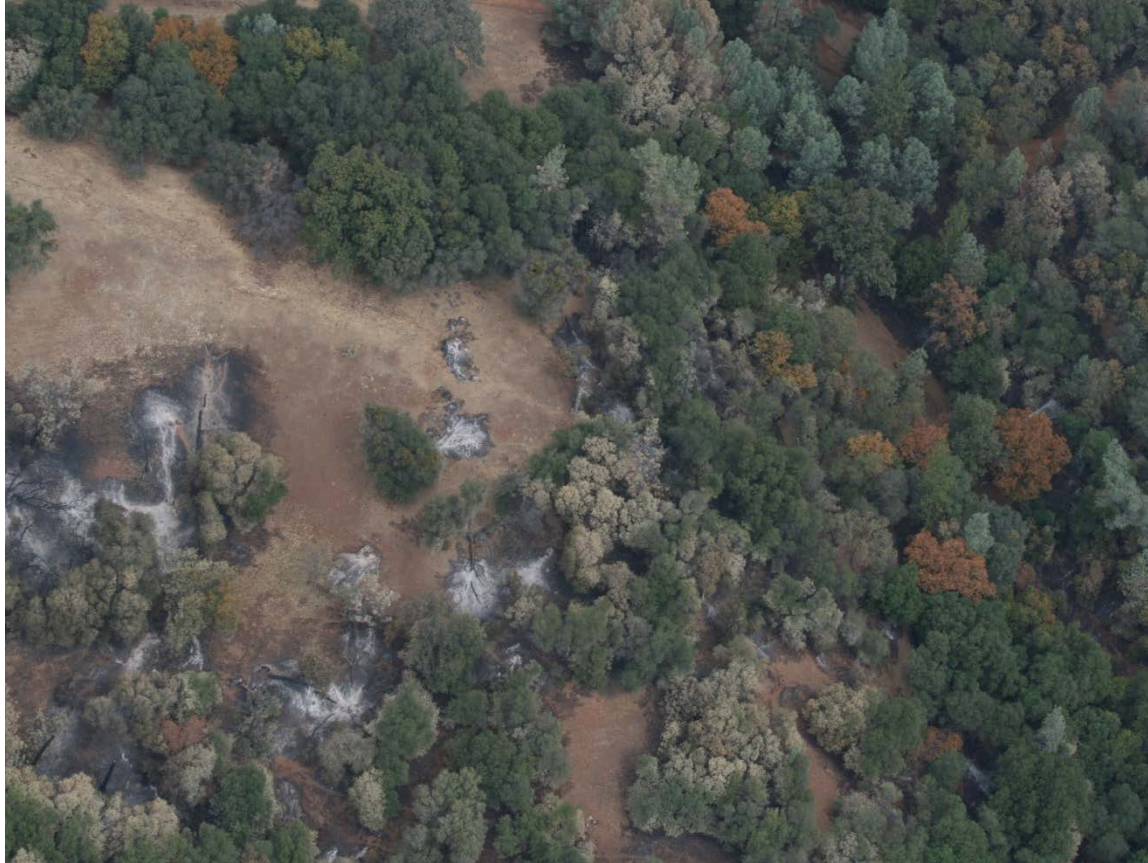
**Photo 158**

Taken from helicopter, view of fire area south of residence at the end of Charamuga Ranch Road.

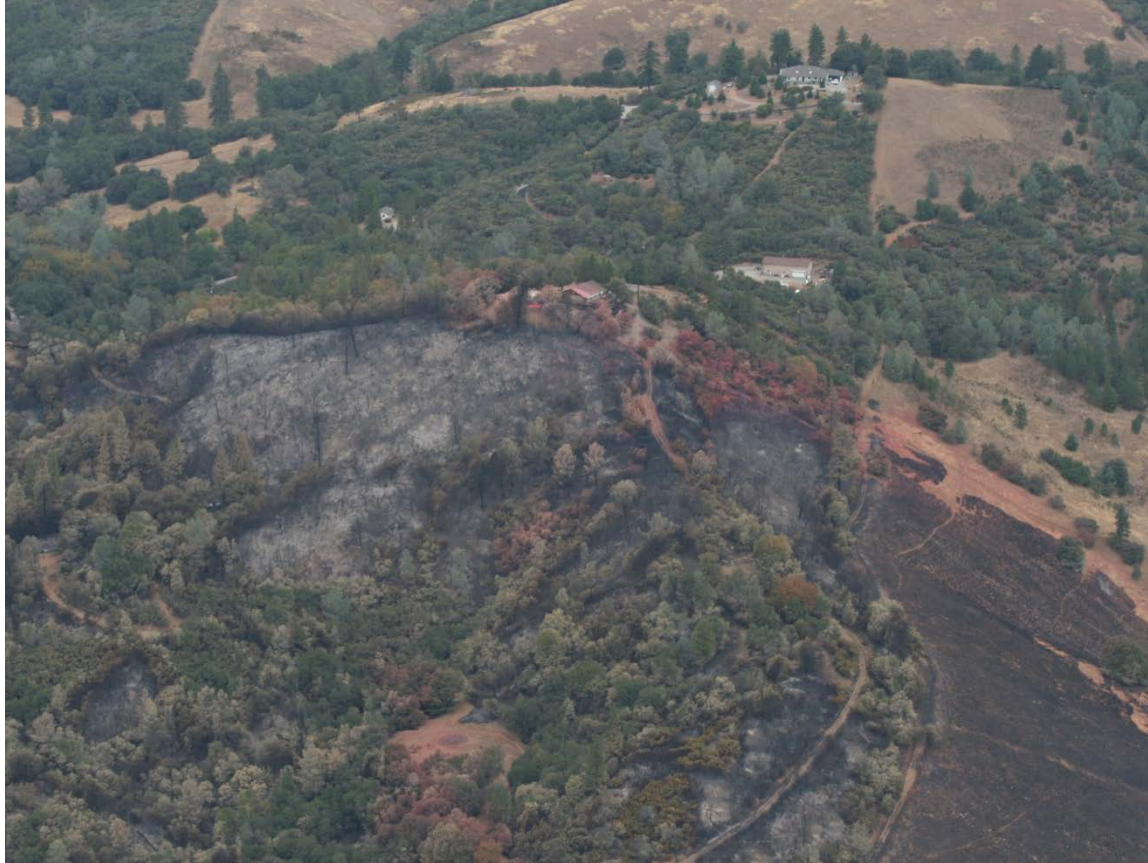
**Photo 159**

Taken from helicopter, facing north, view of fire area just east of Charamuga Ranch Road.

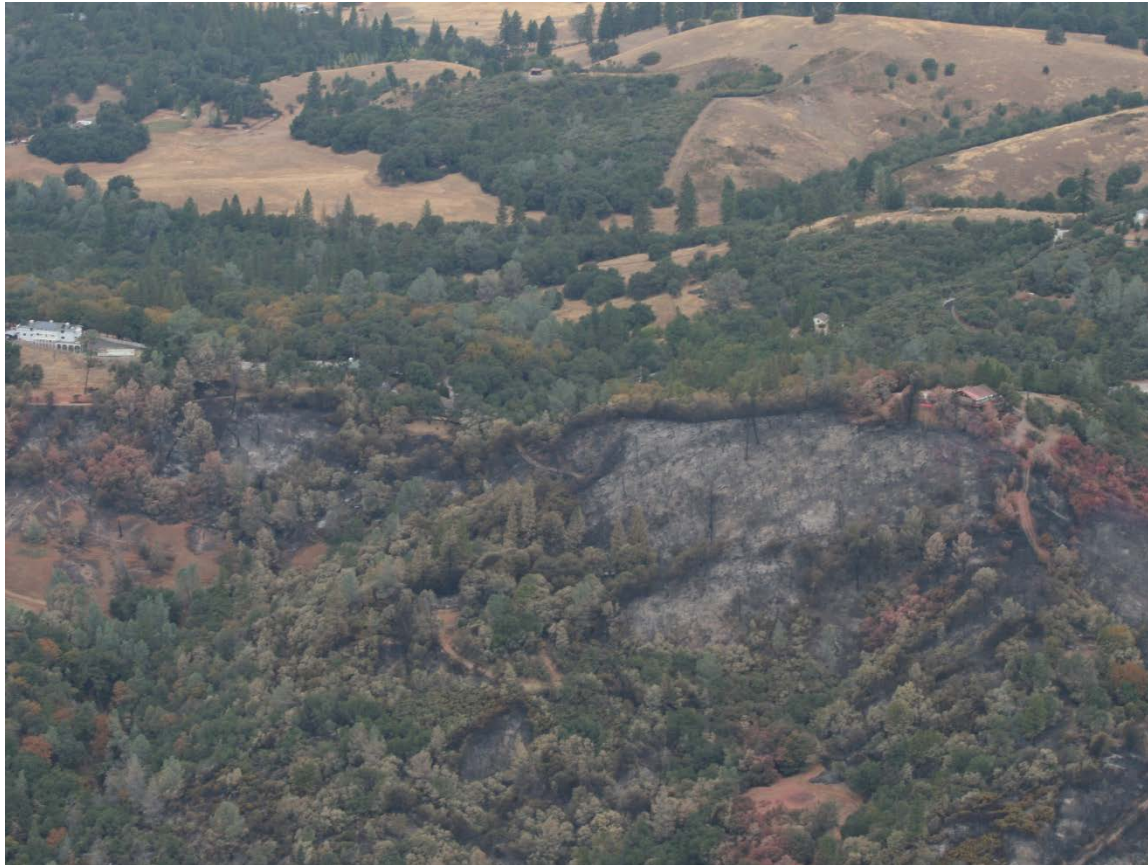
**Photo 160**

Taken from helicopter, facing north, view of fire area just east of Charamuga Ranch Road.

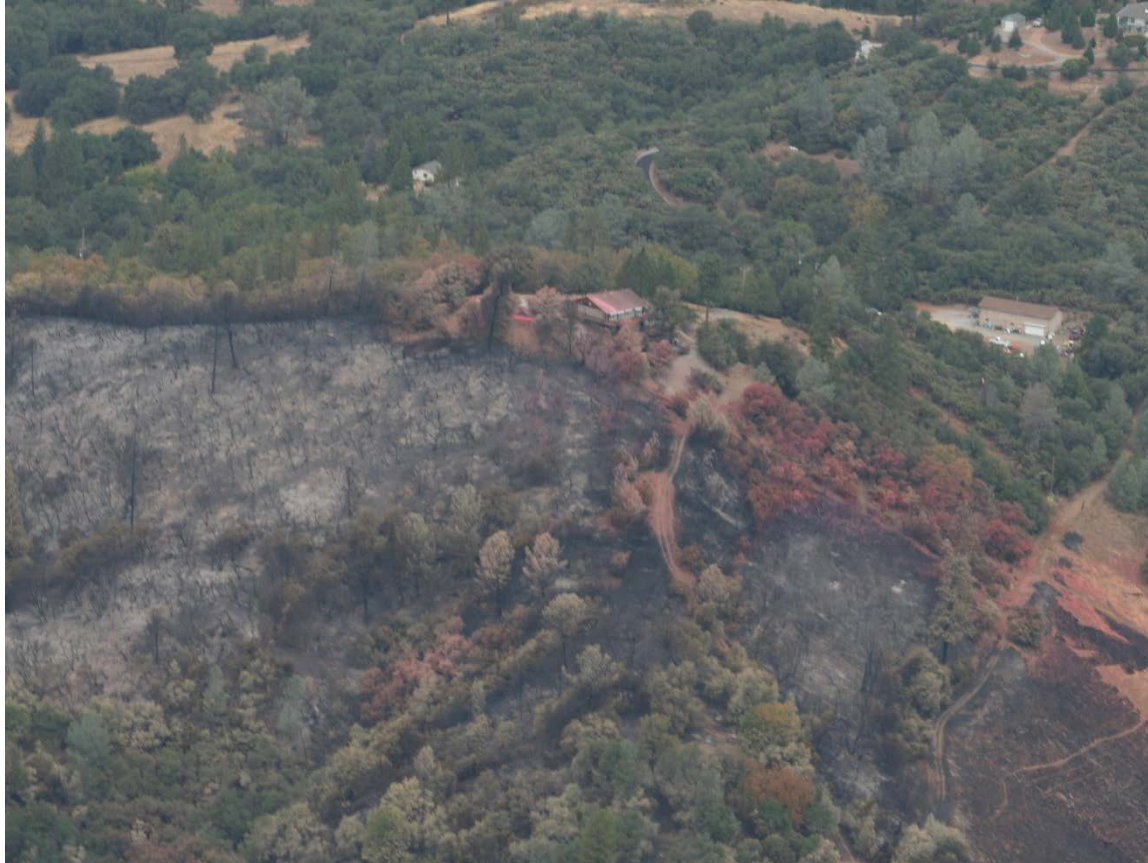
**Photo 161**

Taken from helicopter, facing north, view of fire area just east of Charamuga Ranch Road.

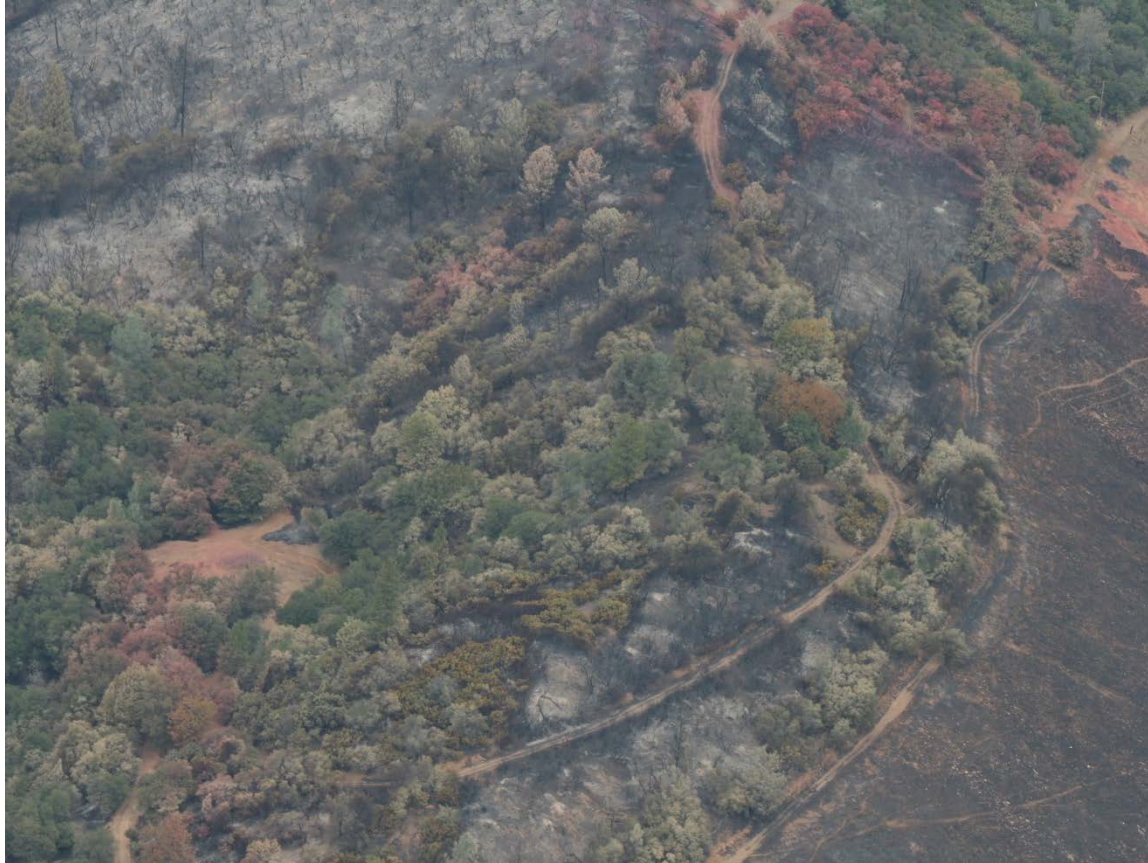
**Photo 162**

Taken from helicopter, view of fire area east of Charamuga Ranch Road along the north rim of the Mokelumne River drainage.

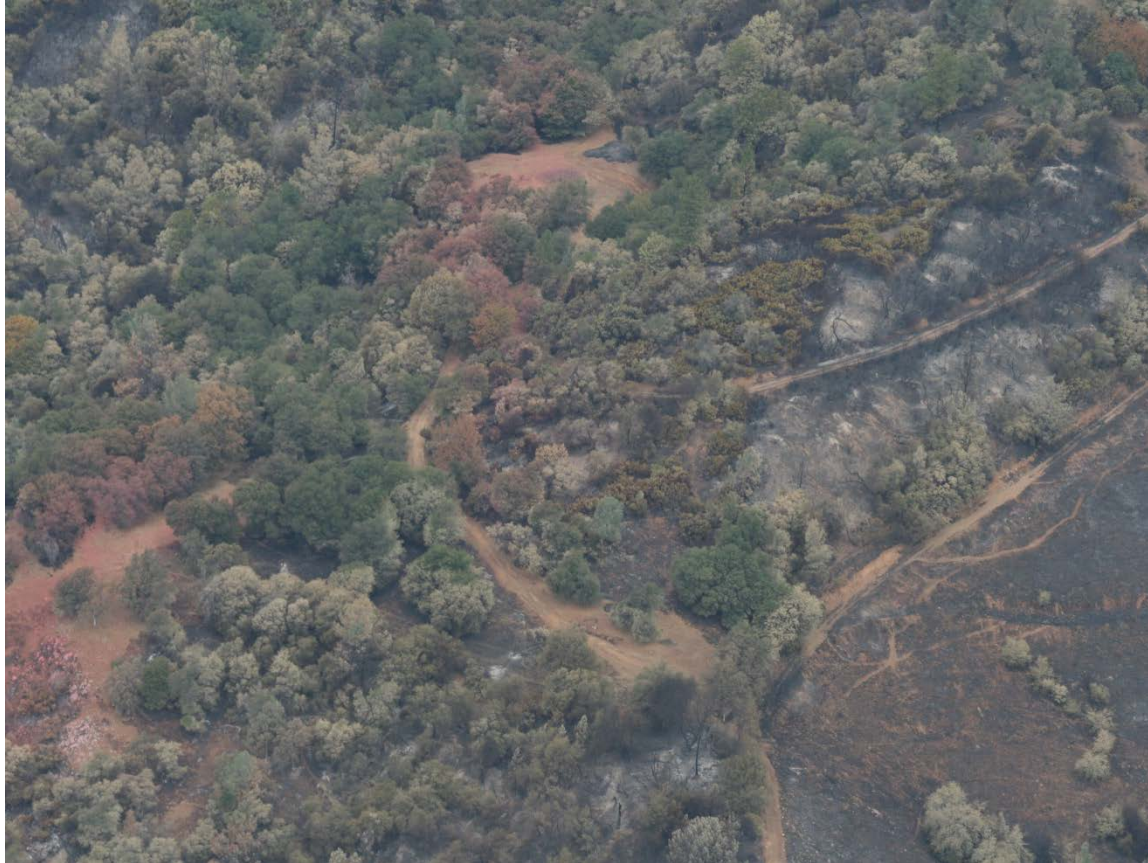
**Photo 163**

Taken from helicopter, view of fire area east of Charamuga Ranch Road along the north rim of the Mokelumne River drainage.

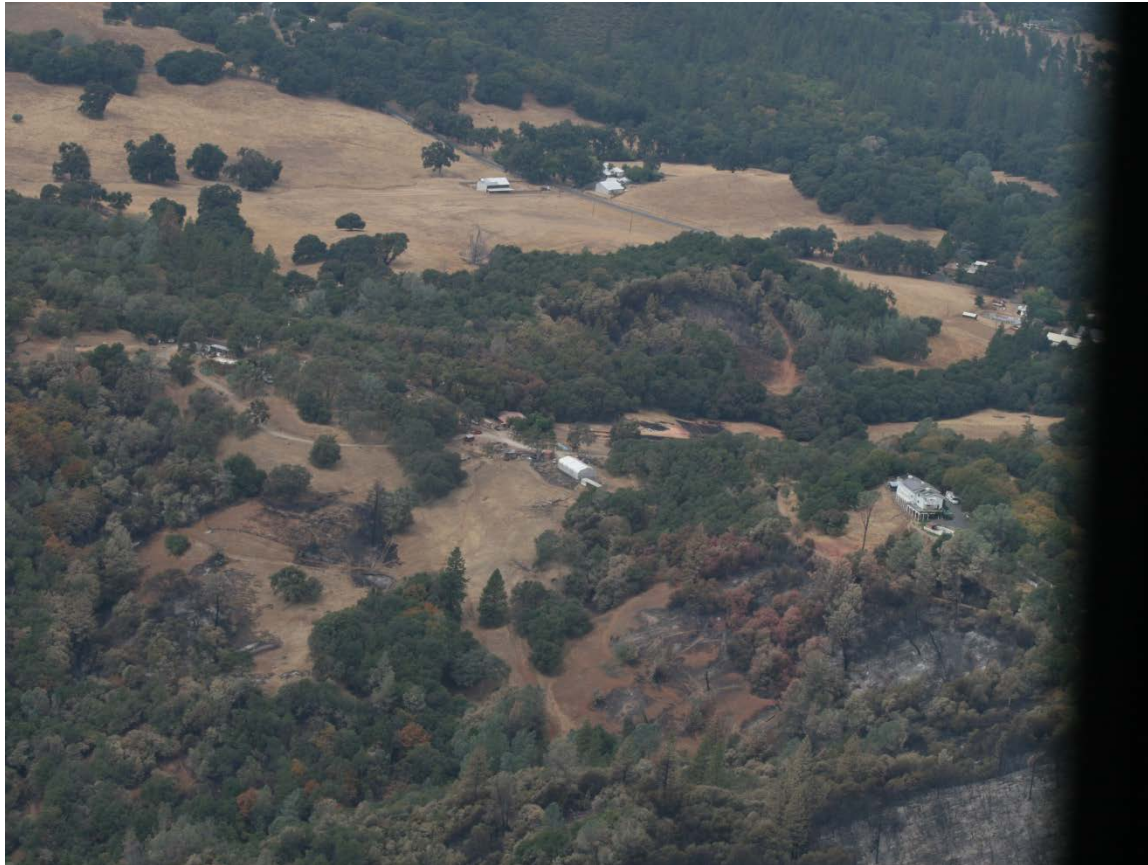
**Photo 164**

Taken from helicopter, facing northwest, view of the origin area and residences along Charamuga Ranch Road.

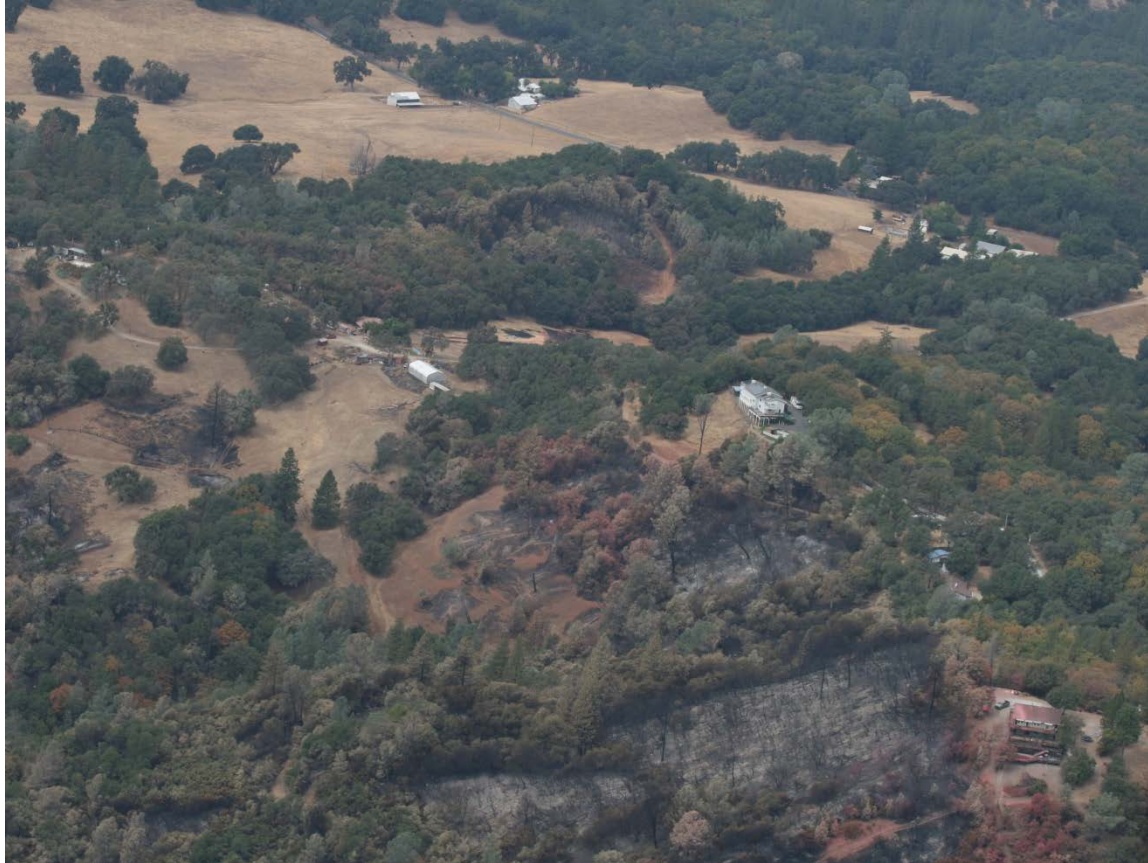
**Photo 165**

Taken from helicopter, facing northwest, view of the origin area and residences along Charamuga Ranch Road.
